**Municipality of
Huron Shores**

DEAN LAKE BRIDGE

**Load Evaluation and
Condition Assessment**

**19-1414
October 2020**

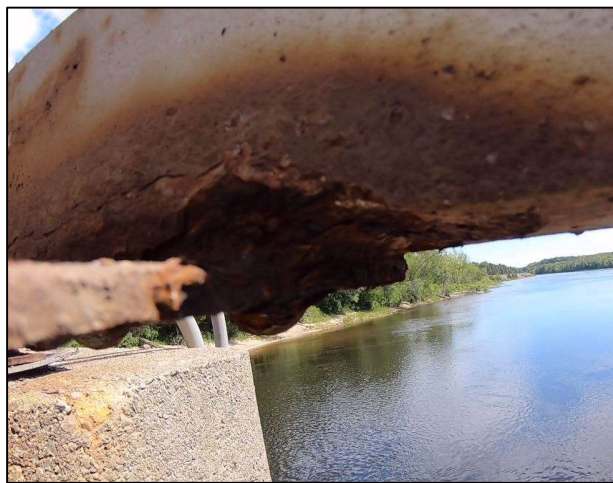
The exposed steel through trusses above the bridge deck are in fair to poor condition with light localized surface corrosion and minor impact damage. The bottom chord is severely corroded in localized areas due to winter sand/gravel buildup as shown in Figure 2 below. Several loose and missing rivets were noted on the top chords, diagonal members and top brace bays which are suspected to have been missing since original construction.

Figure 2 - Severe Section Loss in Bottom Chord

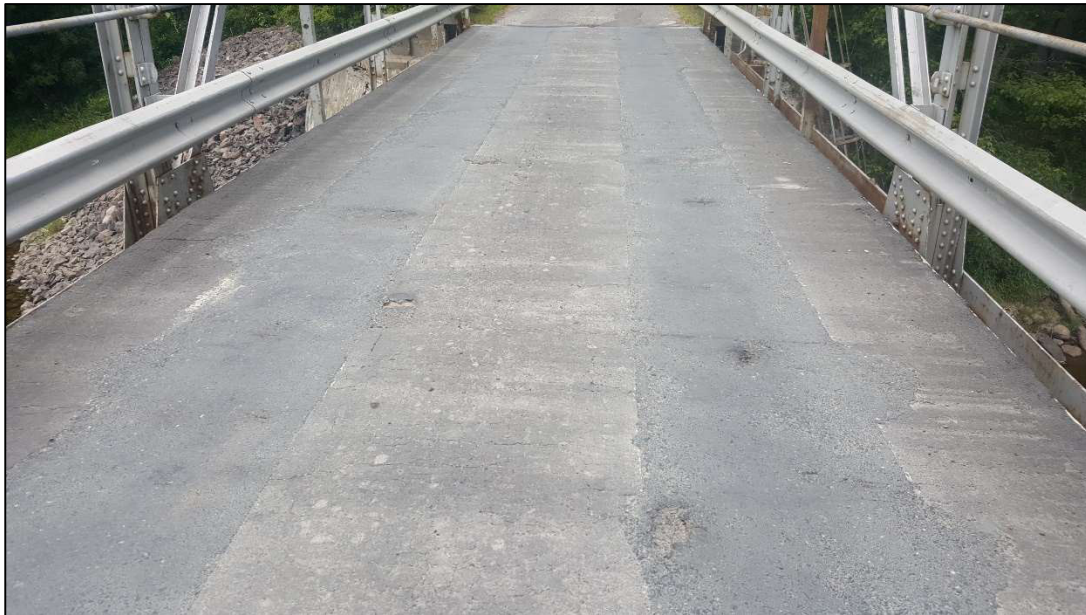
The asphalt wearing surface is generally in fair condition with light wear throughout, light to medium transverse cracking, patching at intermediate deck joints, wheel rutting on the north span, and localized potholes. Figure 5 below shows the typical deck wearing surface.

Figure 5 - Typical Wearing Surface on North Span (Patching of the 1st installed deck panel)

• Isolated steel repairs to the truss	Now
• Wearing surface shall be sealed with a flush coat of asphalt sealer to prevent water infiltration. Sand shall be broadcast into the sealer for traction on the bridge deck	<1 year

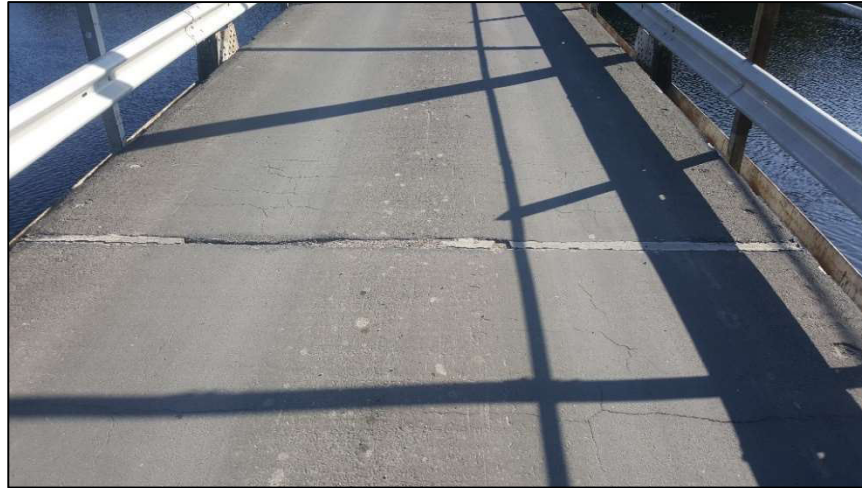
At the end of each span there is a protective armoring plate. The armoring plates have light to moderate wear and light corrosion, which is typical at all joint locations along the bridge length. The joints between deck panels within each span consist of a cementitious material. These joints have narrow to wide cracking, separation or debonding, missing sections, and sections which have been previously patched. The joints are in poor condition overall.

Figure 6 - Typical Deck Joint

• Deck joints and seals need to be replaced and armouring angles be reset	<1 year
• Upgrade approach guiderail end treatments	<1 year
• Install delineator signs at ends of guiderail and install speed limit sign on south approach	<1 year

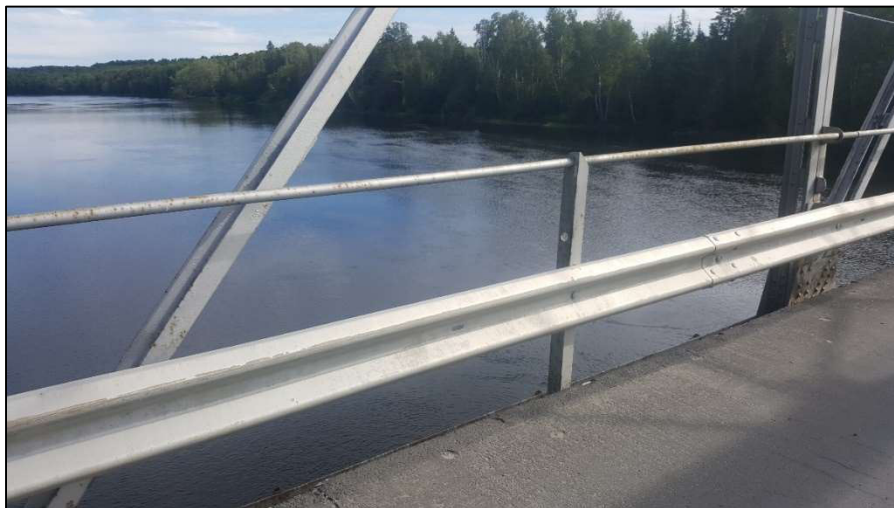
There were no curbs present on the structure at the time of inspection. The steel flex beam guardrail on the bridge is bolted to the truss vertical members and has localized impact damaged, scrape damage, and light corrosion throughout as shown in Figure 7 below. A loose guiderail bolt was also noted in center span on the east truss.

Figure 7 - Typical Guiderail and Railing on Structure

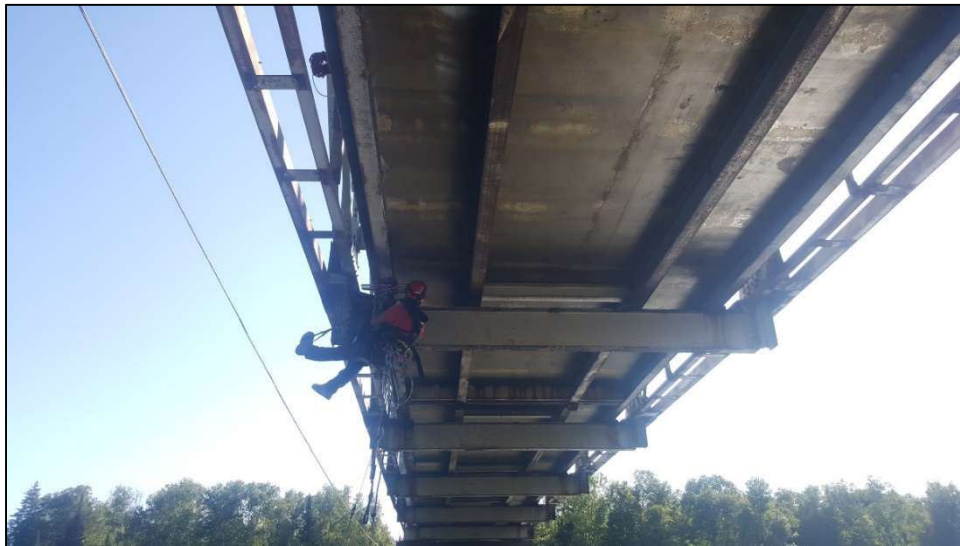
The steel stringers which support the deck are in good condition with light to moderate corrosion on the top flange directly below the deck panel joint. The floor beams are generally in fair condition with medium to severe corrosion/section loss at connection locations. The corrosion/section loss is being accelerated by the buildup of gravel and debris that migrates from the top of the bridge deck down onto the connections. Figure 8 below shows the typical stringer and floor beam layout. Rust jacking of the gusset plates at connection locations was also noted throughout the bridge during the inspection. This rust jacking is typical across the bridge structure at connection locations and is shown in Figure 9 on the following page. The floor beam connections have fairly significant breakdown of the protective coating as shown in Figure 9 on the following page.

Figure 8 – Typical Deck Soffit Layout

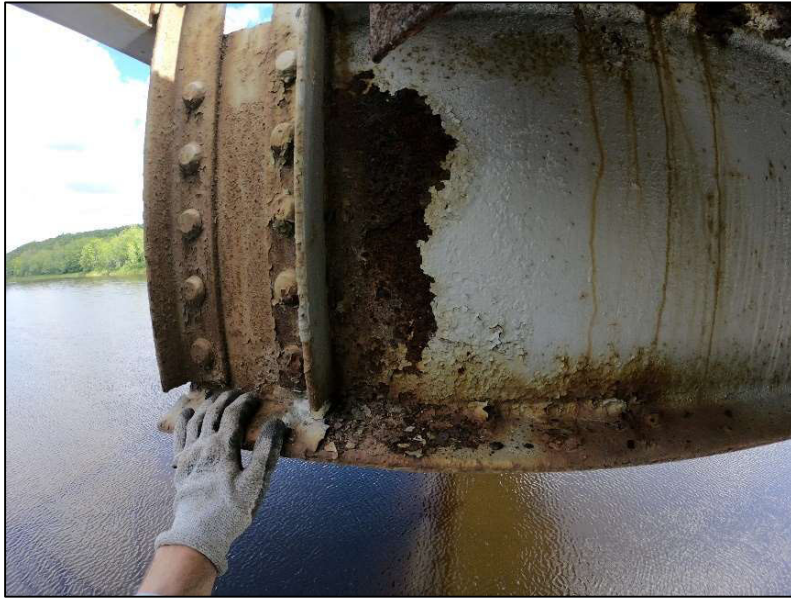
Figure 9 - Typical Floor Beam Connection/Flaking of Protective Coating

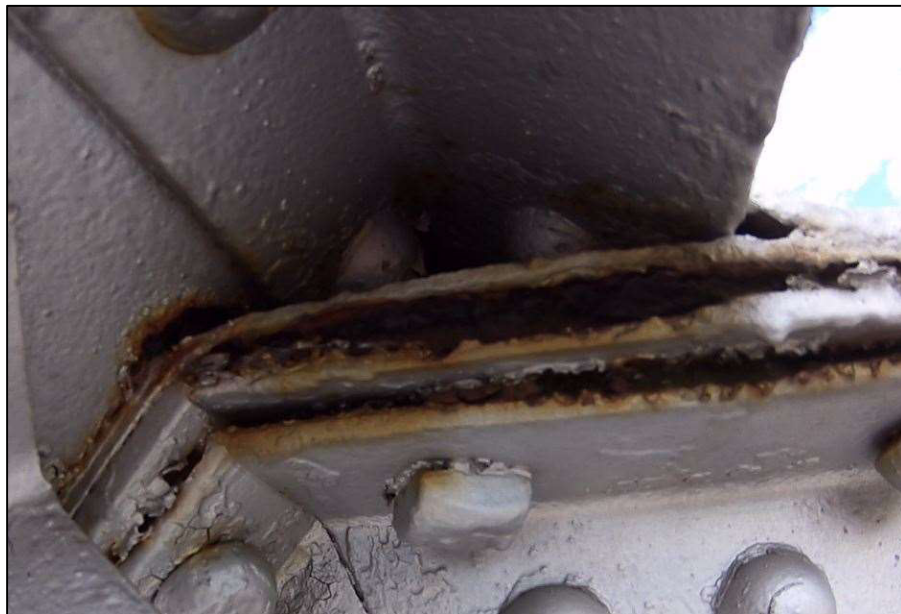
During the inspection, several loose and missing rivets were noted on the top chords, diagonal members and top brace bays. The majority of the loose rivets were in the top chord and diagonal bracing of the south span. Figure 10 below shows typical rust jacking at upper truss connections. Figure 11 below shows a missing rivet and a number of loose rivets in one connection in the south span.

Figure 10 - Typical Rust Jacking at Upper Truss Connections

• Change out severely corroded rivets with equal size structural bolts	<1 year
• Replace wood deck panels (if sealing and joints are not replaced/repared the deck will deteriorate faster and lower the replacement timeline)	1-5 years

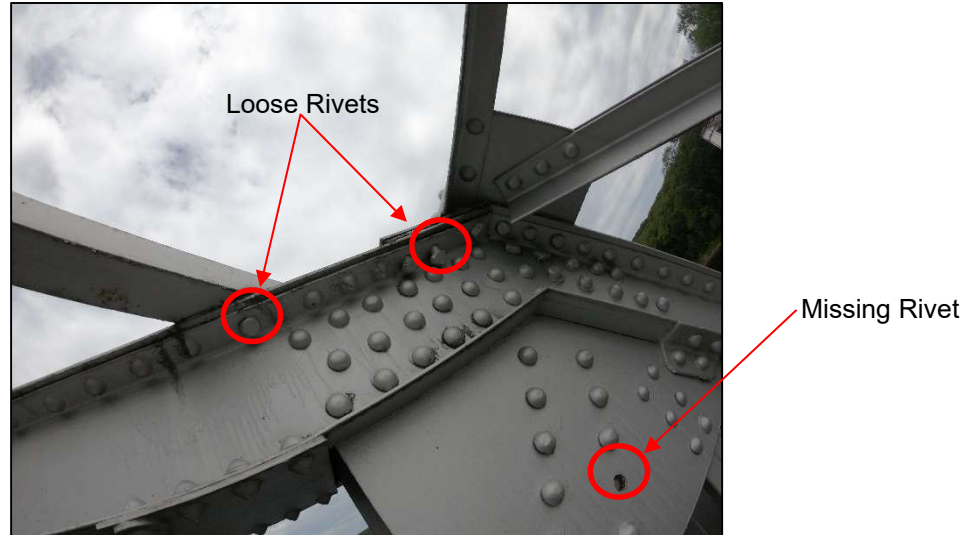
Figure 11 - Missing/Loose Rivets in South Span

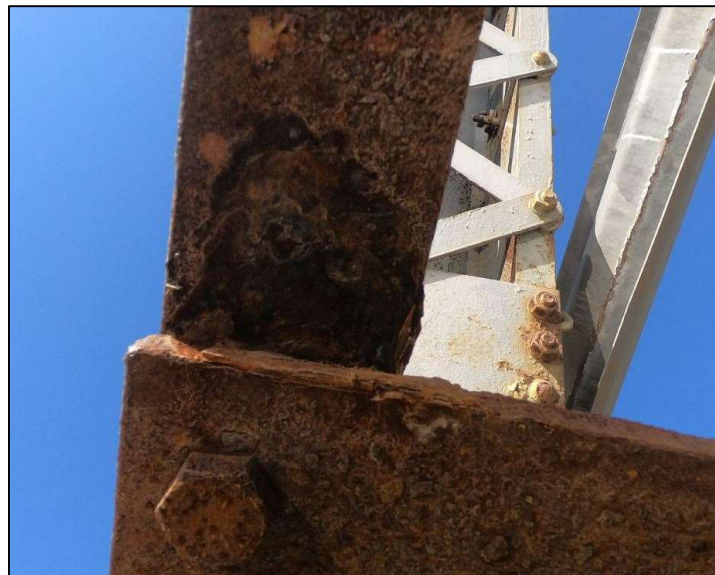
The steel trusses primarily have light localized surface corrosion where the protective coating has blistered and flaked off. The failure of the coat may be attributed to poor surface preparation or contaminants below the latest coating. The bottom chord has severe to very severe section loss (see Appendix C) in multiple members due to gravel/sand/debris constantly residing on the steel as shown below in Figure 12. Figure 13 shows a deflection in the bottom chord. The cause and date of when the deflection began surfacing is unknown. The truss elements are in fair condition with localized sections that are in poor condition.

Figure 12 - Severe Section Loss in Bottom Chord at Connection Gusset Plate

- The steel trusses are in good to fair shape overall, however, are considered to be in poor condition due to the bottom chord which is severely corroded at locations (section loss up to 70% on one leg of the angles).

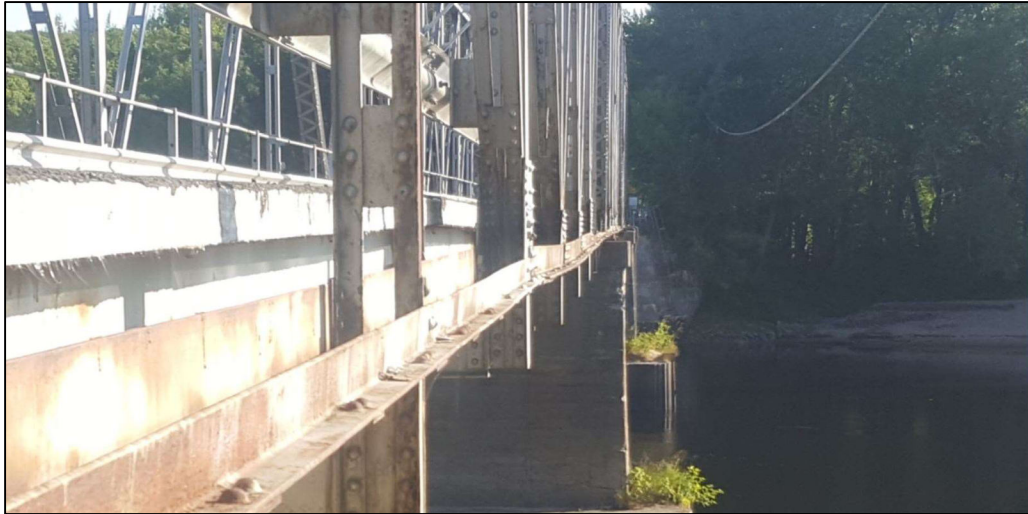
Figure 13 - Deflection in Bottom Chord (South Span)

- The bottom chord of the east truss has permanently deflected in the middle of the south span.
- The intermediate concrete piers and the concrete abutments are in fair to very poor condition and show spalling, delaminations, efflorescence, medium to wide map cracking and disintegration. The abutments are in worse condition than the piers.

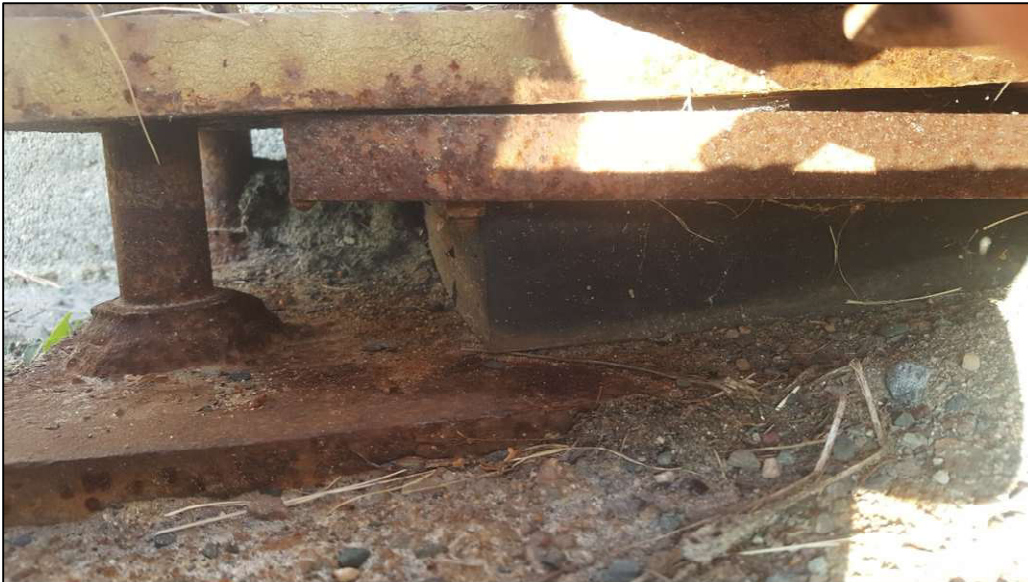
The bearing pads for each span consist of steel plates at the fixed ends and elastomeric bearing pads at the movement ends. The steel bearing pads exhibited light to moderate corrosion and pitting while the elastomeric bearing pads exhibited light cracking and weathering. The steel and elastomeric bearing pads were covered in gravel and debris at the time of inspection as shown below in Figure 14. The bearings are considered to be in good to fair condition.

Figure 14 - Gravel Buildup on Bearing Pad

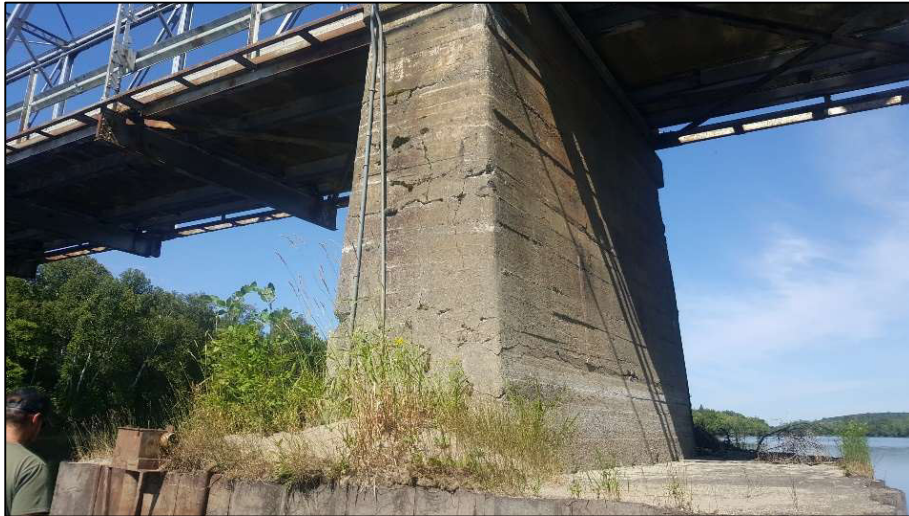
The concrete piers were generally in fair to poor condition. The face of the piers are highly weathered with light to severe spalls, scaling, wide cracking & efflorescence, and localized delamination throughout as shown below in Figure 15 and Figure 16. The top portion of the piers directly around the bearing seats have light to moderate spalls and have wide localized cracks. The armouring angles on the upstream faces have light surface corrosion and pitting. The piers appear to be mass concrete with no visible signs of rebar reinforcing.

Figure 15 - Spalls, Cracking and Efflorescence at South Intermediate Pier

• Decayed guiderail posts should be replaced immediately and monitored during annual maintenance inspections	Now
• Concrete repairs (substantial on abutments) and localized repairs on piers is required.	Now

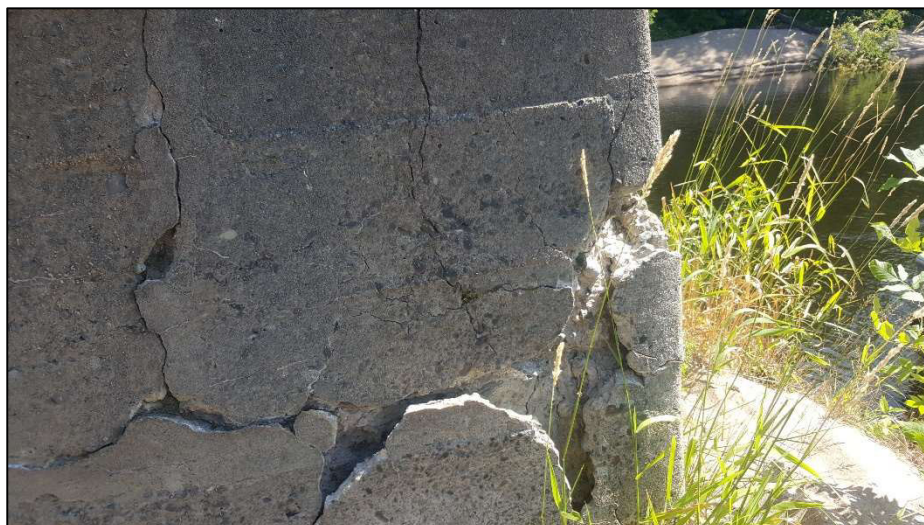
Figure 16 - Wide Crack and Severe Delamination at Bottom of South Intermediate Pier

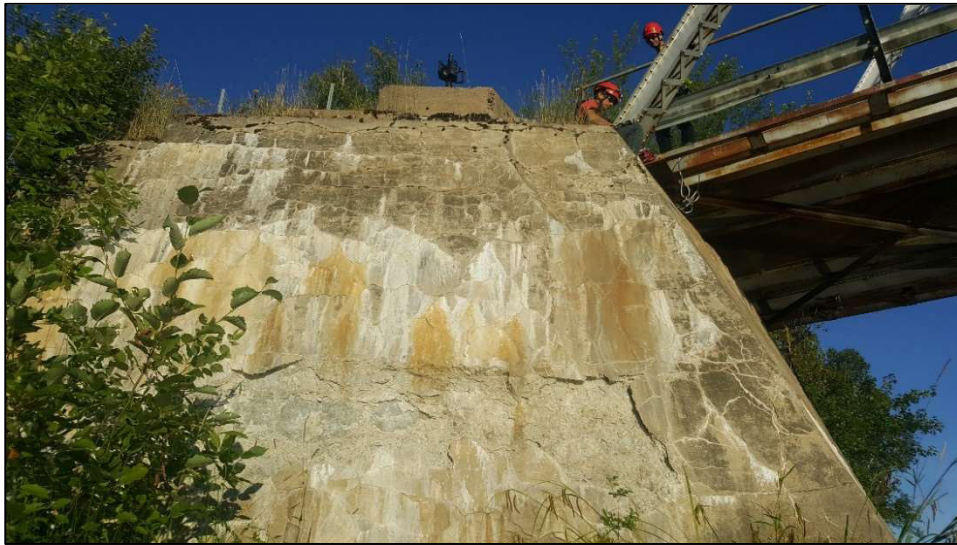
The concrete abutments are generally in poor condition. Similar to the intermediate support piers, the abutments are highly weathered with widespread spalls, scaling, wide horizontal and vertical cracks, delaminations, efflorescence and disintegration throughout as shown on the following page.

Figure 17 - Wide Cracks, Spalls, Delamination and Efflorescence and Map Cracking in Concrete Abutment/Wingwall

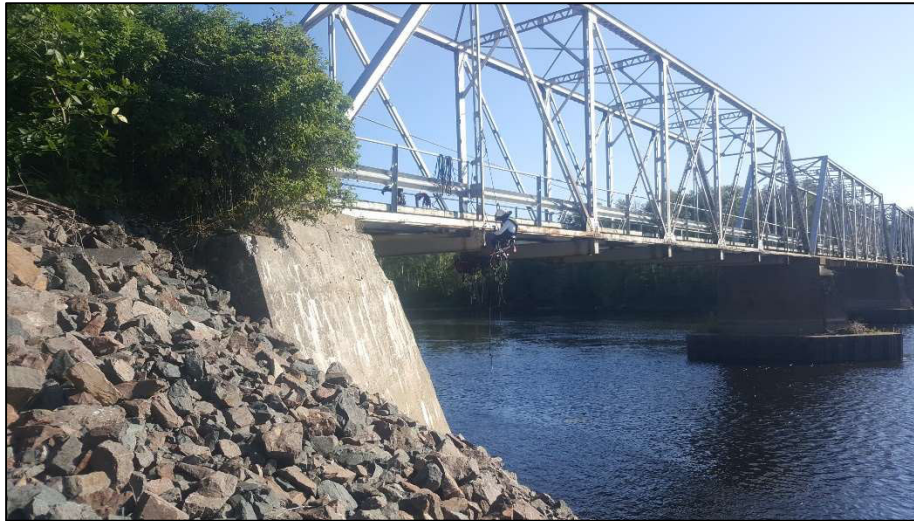
The exposed vegetated & rock protected slopes on the embankments surrounding the bridge were generally in good condition with no evidence of scouring or erosion. Rock protection is currently installed at the northwest quadrant along the riverbank which was planned previously to remediate scour issues. The rock protection in the northwest quadrant is stable and in good condition, shown below in Figure 18.

Figure 18 - Rock Protection in NW Quadrant Only

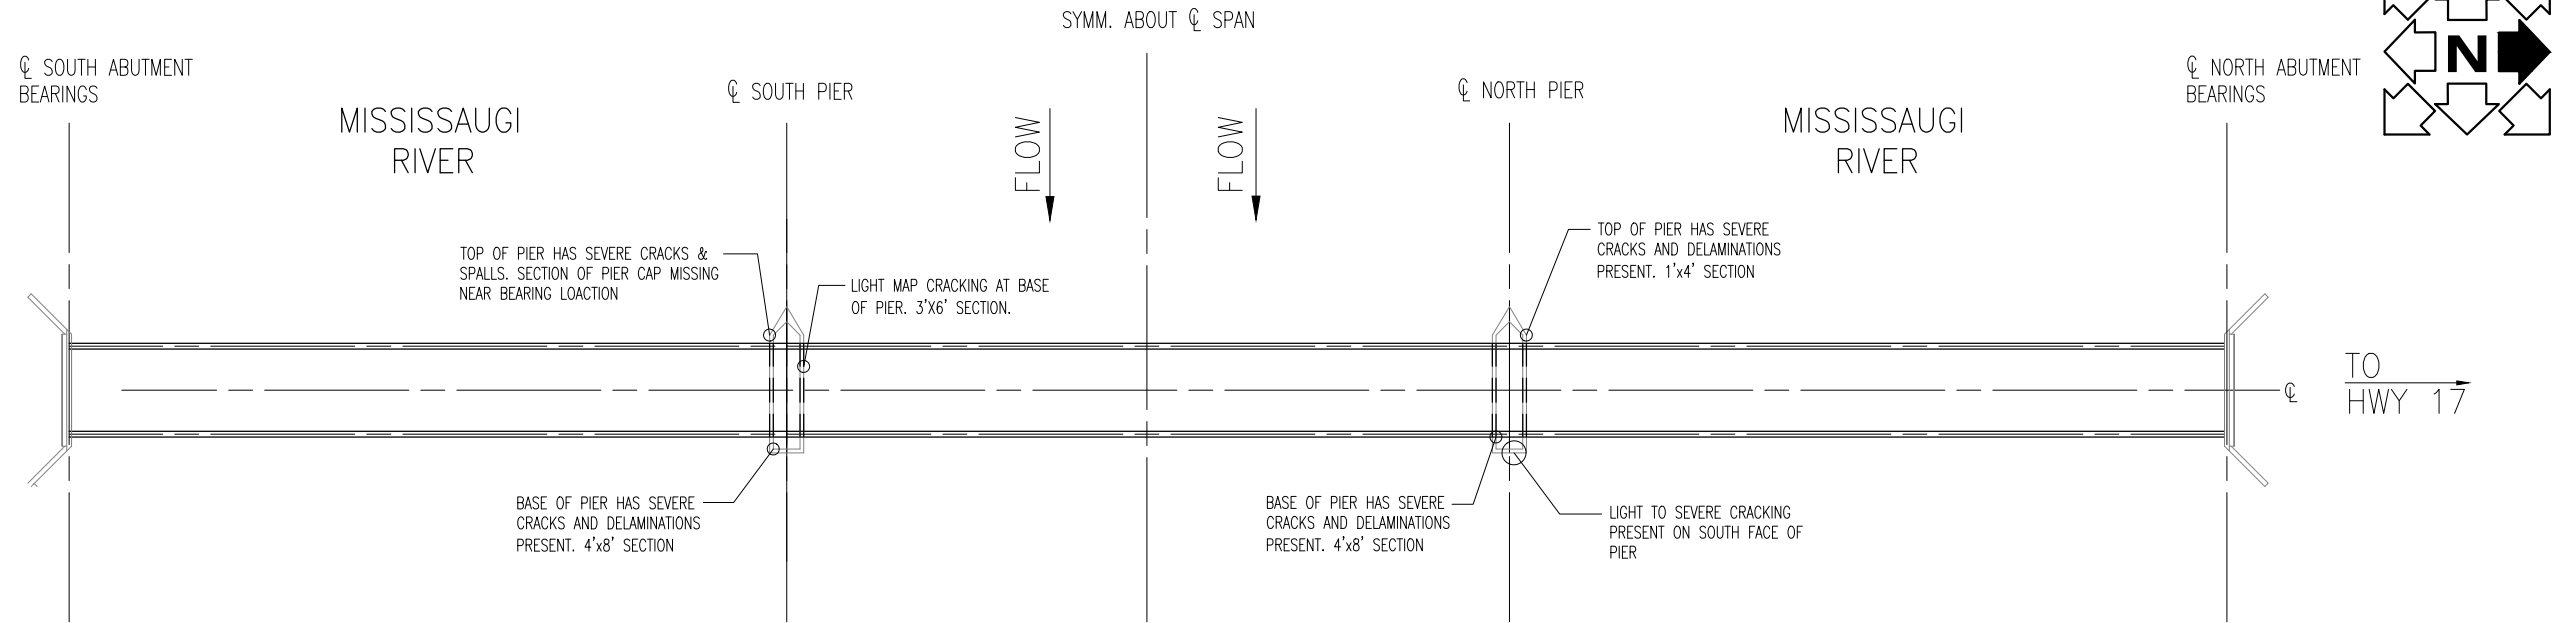
PLAN
SCALE 1/32"=1'-0"

NOTE: THE NORTH & SOUTH ABUTMENTS HAVE SEVERE SCALING, SPALLING, CRACKING, POP-OUTS AND EROSION PRESENT ON ALL SURFACES.

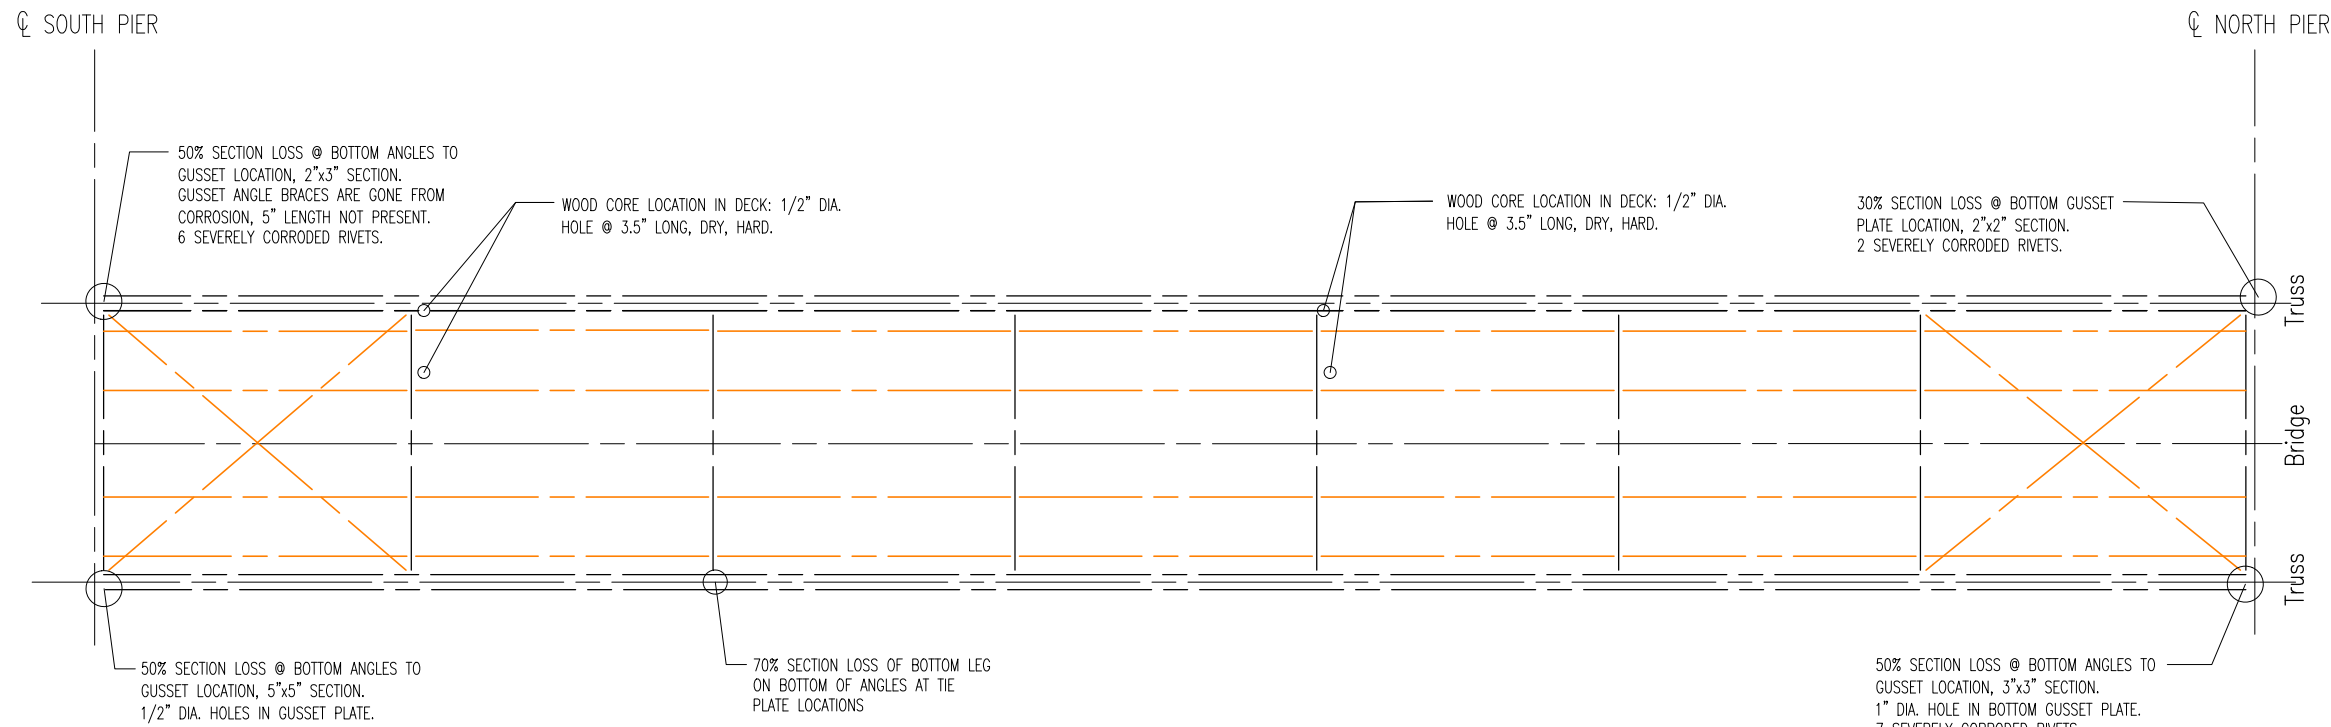
PARTIAL BRIDGE PLAN AT DECK ELEVATION – CENTER SPAN

NOTE: ALL TRANSOM BEAMS HAVE 5%-15% LOCALIZED SECTION LOSS ON TOP FLANGE DIRECTLY ABOVE DECK PANEL JOINTS.

NOTE: 15%-50% SECTION LOSS ON BOTTOM LEG OF ANGLES @ TIE PLATE LOCATIONS, TYP.

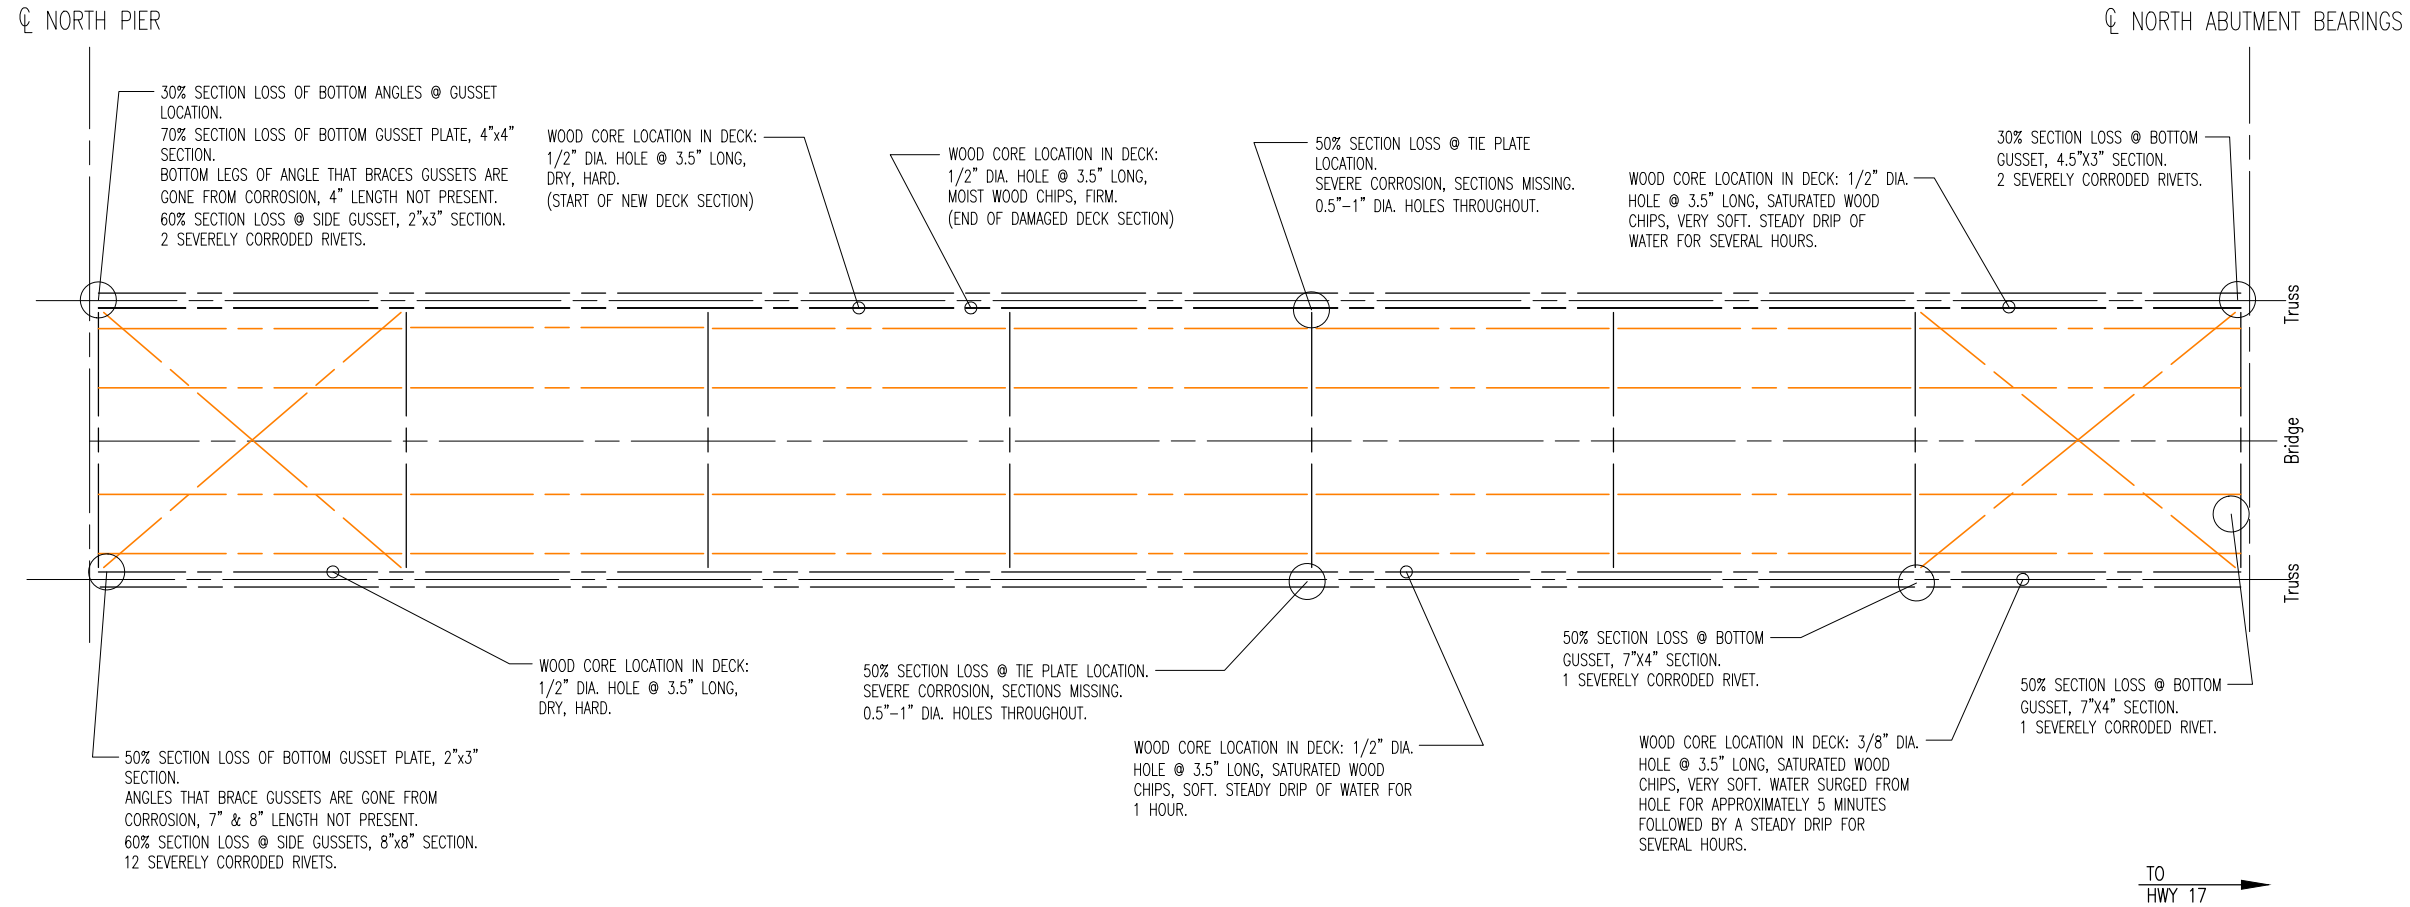
PARTIAL BRIDGE PLAN AT DECK ELEVATION - NORTH SPAN

NOTE: ALL TRANSOM BEAMS HAVE 5%-15% LOCALIZED SECTION LOSS ON TOP FLANGE DIRECTLY ABOVE DECK PANEL JOINTS.

NOTE: 15%-50% SECTION LOSS ON BOTTOM LEG OF ANGLES @ TIE PLATE LOCATIONS, TYP.
