Structure Name	<input type="text" value="#19 Dean Lake Bridge"/>		
Main Highway #	<input type="text" value="N/A"/>	On <input checked="" type="checkbox"/> or Under <input type="checkbox"/> Structure	Service on structure: <input checked="" type="checkbox"/> Navig. Water <input type="checkbox"/> Non-Navig. Water <input type="checkbox"/> Rail <input type="checkbox"/> Road <input checked="" type="checkbox"/> Ped. <input type="checkbox"/> Other
Location description	<input type="text" value="Dean Lake Road, 100m South of Highway 17"/>	Service under	<input type="checkbox"/> Navig. Water <input type="checkbox"/> Non-Navig. Water <input type="checkbox"/> Rail <input type="checkbox"/> Road <input type="checkbox"/> Ped. <input type="checkbox"/> Other
Owner/Custodian	<input type="text" value="Municipality of Huron Shores"/>	LHRS:	<input type="text"/> LHRS offset: <input type="text"/>
MTO Region	<input type="text" value="50 - Northern"/>	Latitude:	<input type="text" value="46 14.6'"/> Longitude: <input type="text" value="83 9'"/>

Field Inspection Information:			
Date of Inspection:	2023-07-21	Type of Inspection:	<input checked="" type="checkbox"/> Reg. OSIM <input type="checkbox"/> Enh. OSIM
In

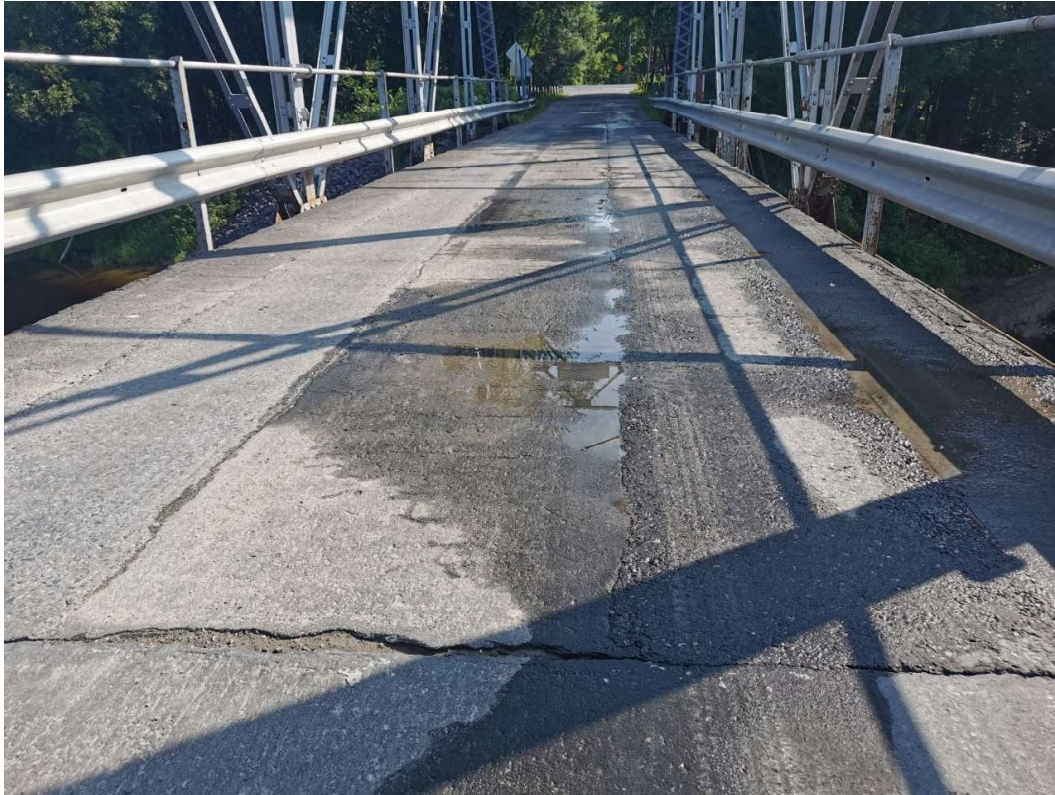
358.0	70.0	31.3	09
Comments: Light deck wear throughout, light to medium transverse cracking, localized delamination at deck joints, patches at intermediate deck joints, patches and wheel rutting at northern span, localized potholes.						
Recommended Work:			<input checked="" type="checkbox"/> Rehab <input type="checkbox"/> Replace <input checked="" type="checkbox"/> 1-5 years <input type="checkbox"/> 6-10 years		Maintenance Needs: 01. N/A	
Repair deck slab wearing surface					<input type="checkbox"/> Urgent <input type="checkbox"/> 1 year <input type="checkbox"/> 2 year

Patches, Wheel Rutting and Ponding Water on North Span

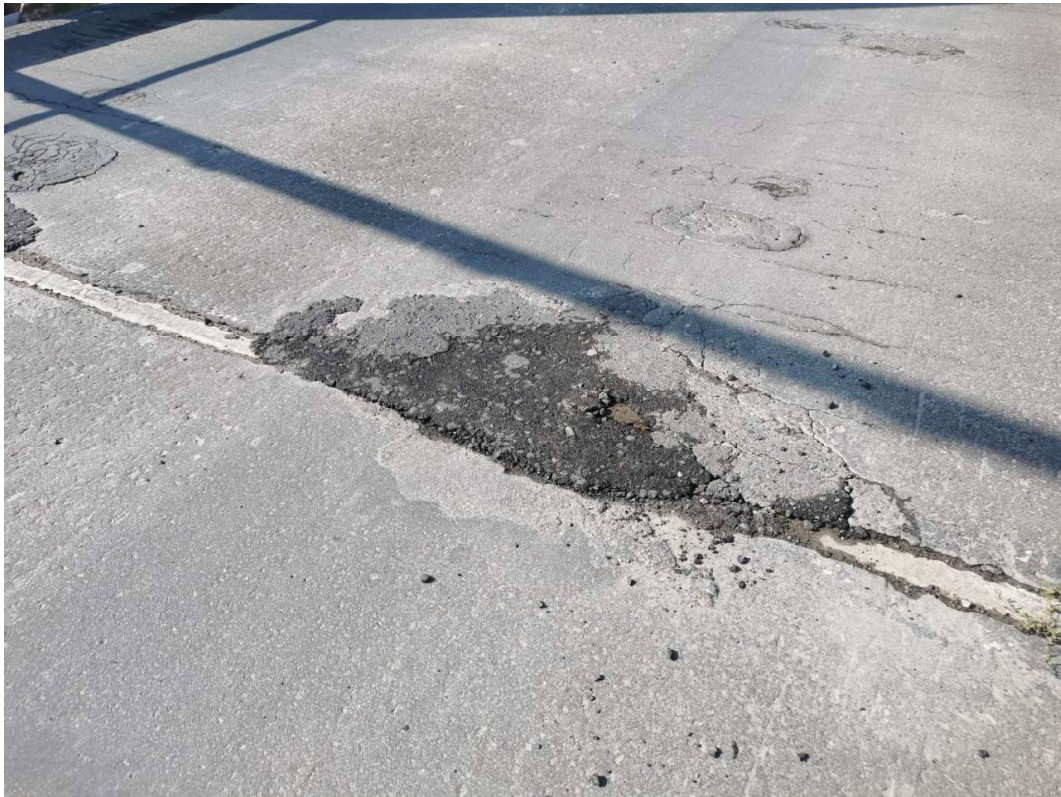
Large Potholes, De-bonding and Transverse Cracking in Overlay

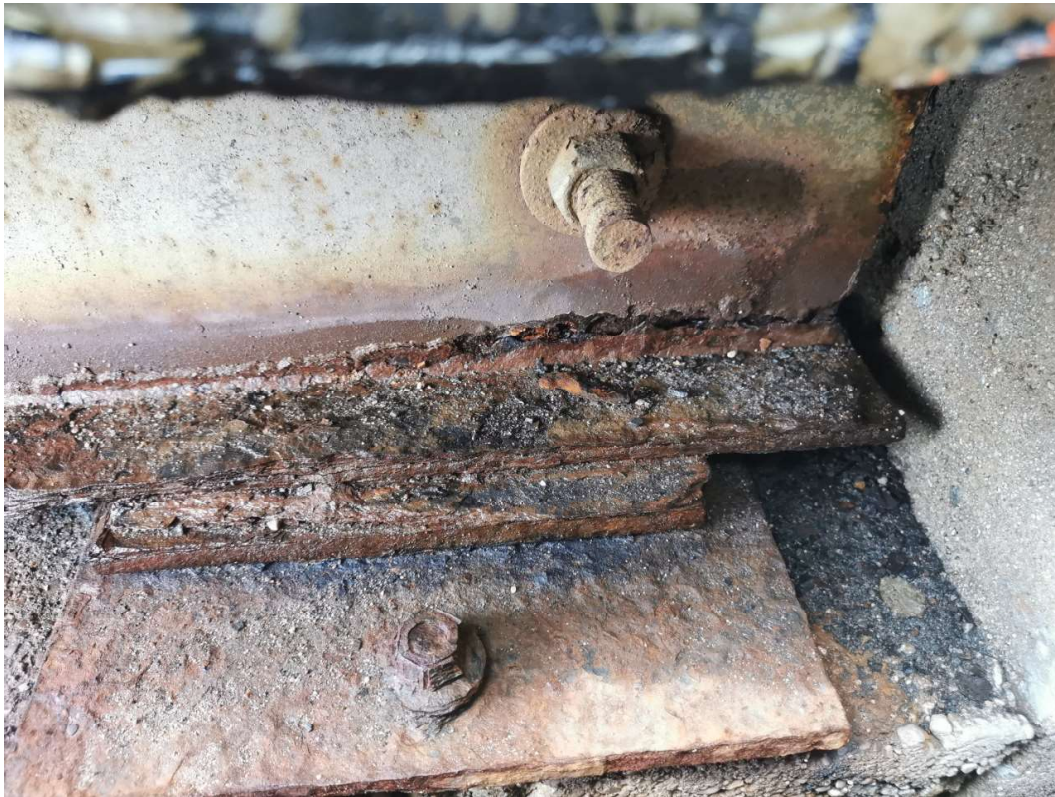
Localized Severe Corrosion and Cracking in Web of Exterior Stringer at North Abutment

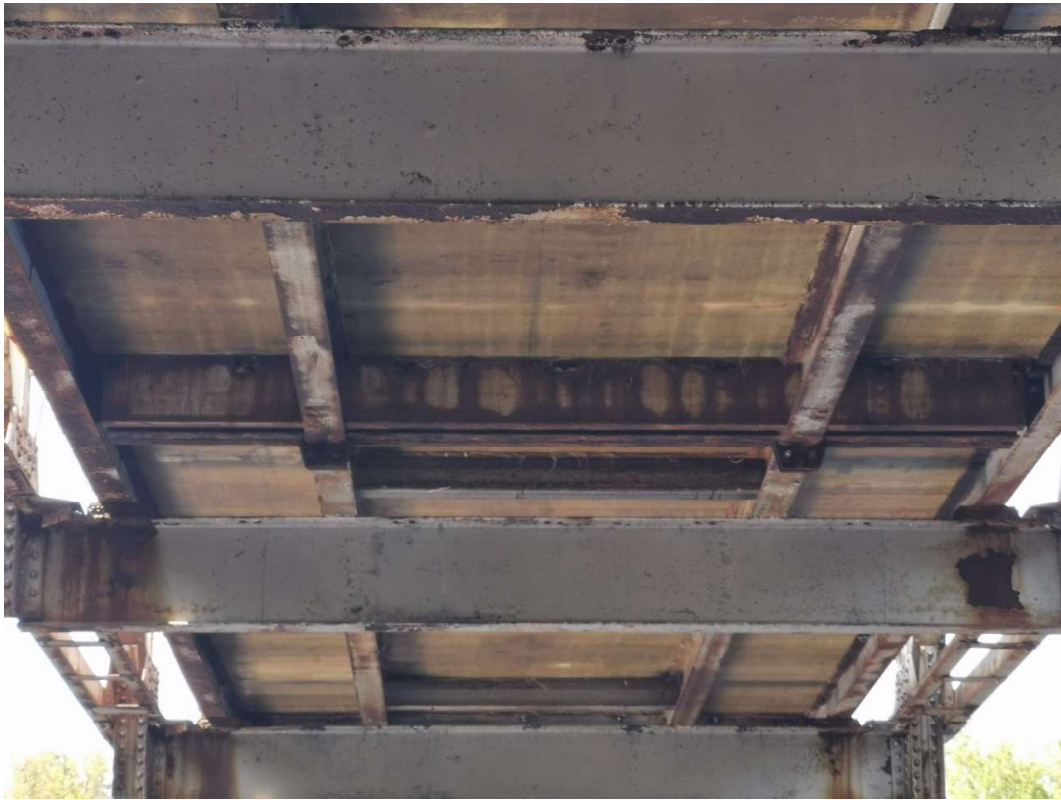
19.2	2.6	00. None
Comments: Light to medium corrosion, localized rust jacking at floor beam to truss vertical connection(s), Top flange has severe localized corrosion, pitting and staining.						
Recommended Work:			Maintenance Needs:			
None			01. N/A			
			<input type="checkbox"/> Rehab <input type="checkbox"/> Replace <input type="checkbox"/> 1-5 years <input type="checkbox"/> 6-10 years <input type="checkbox"/> Urgent <input type="checkbox"/> 1 year <input type="checkbox"/> 2 year

Typical Floor Beam - Pitting and Flaking Present on End Sections

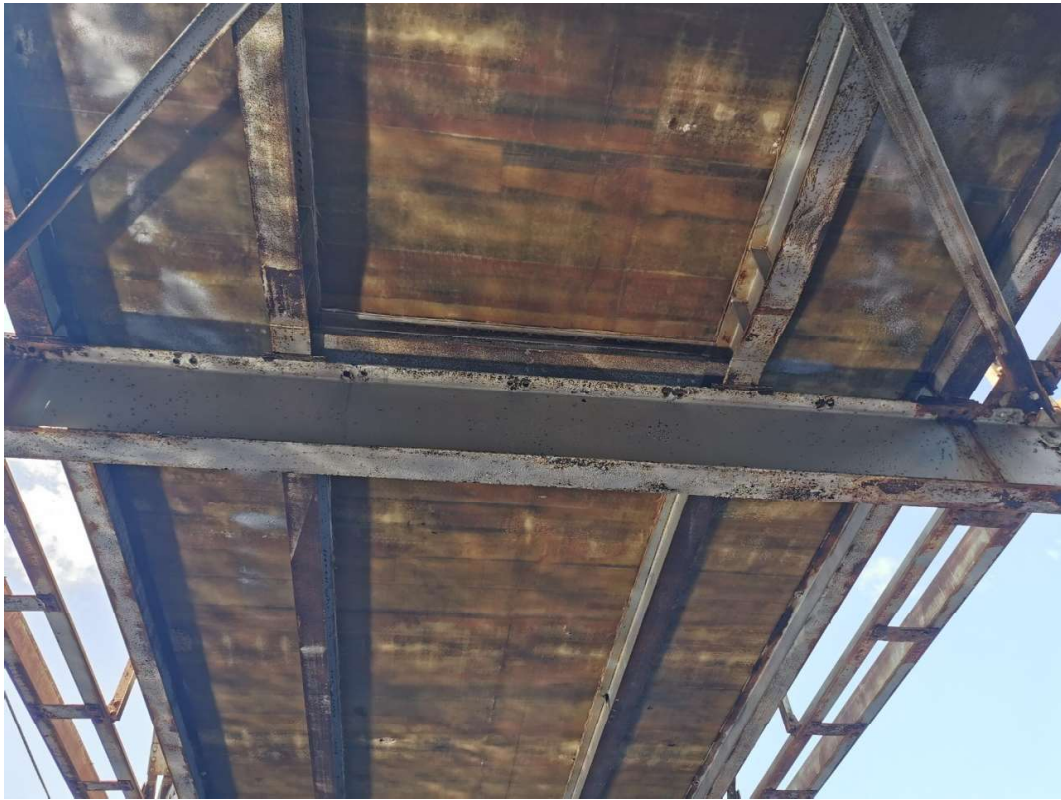
81.3	2.1	00. None
Comments: Light to medium corrosion throughout, Top flange has moderate to severe localized corrosion and pitting.						
Recommended Work:			Maintenance Needs:			
<input type="checkbox"/> Rehab <input type="checkbox"/> Replace <input type="checkbox"/> 1-5 years <input type="checkbox"/> 6-10 years			<input type="checkbox"/> Urgent <input type="checkbox"/> 1 year <input type="checkbox"/> 2 year			
None.			01. N/A

Staining of Floor Beams at Edges of Deck (staining below shim plates under exterior stringers)

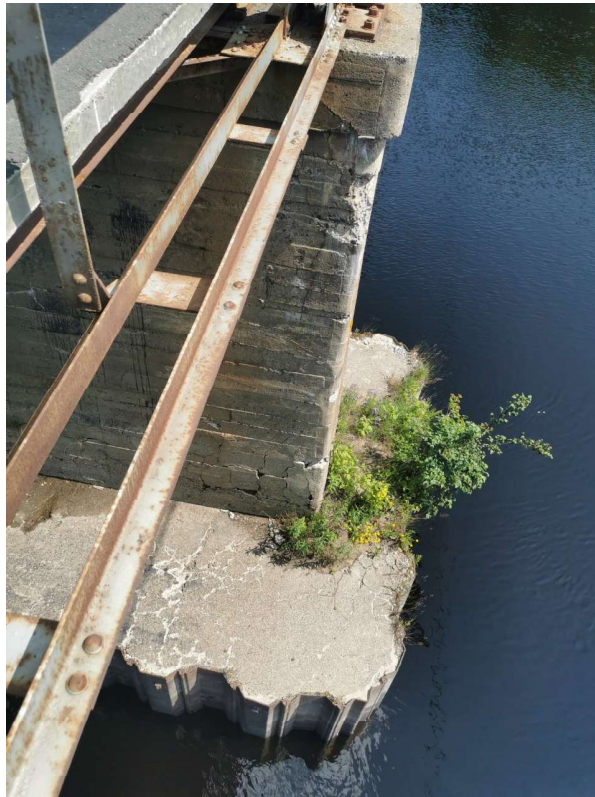
Typical Pier With Localized Spalling and Medium to Wide Cracking Throughout

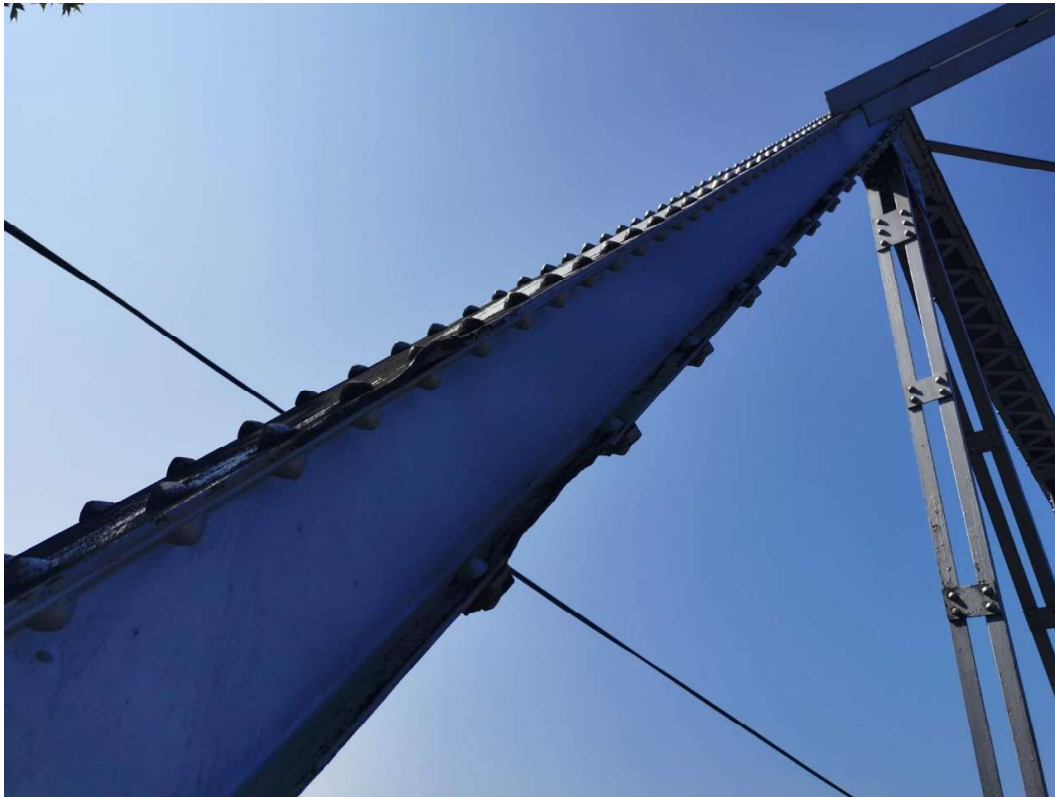
Top Chord - Built up Box Section. Various locations with impact damage to the interior edges.

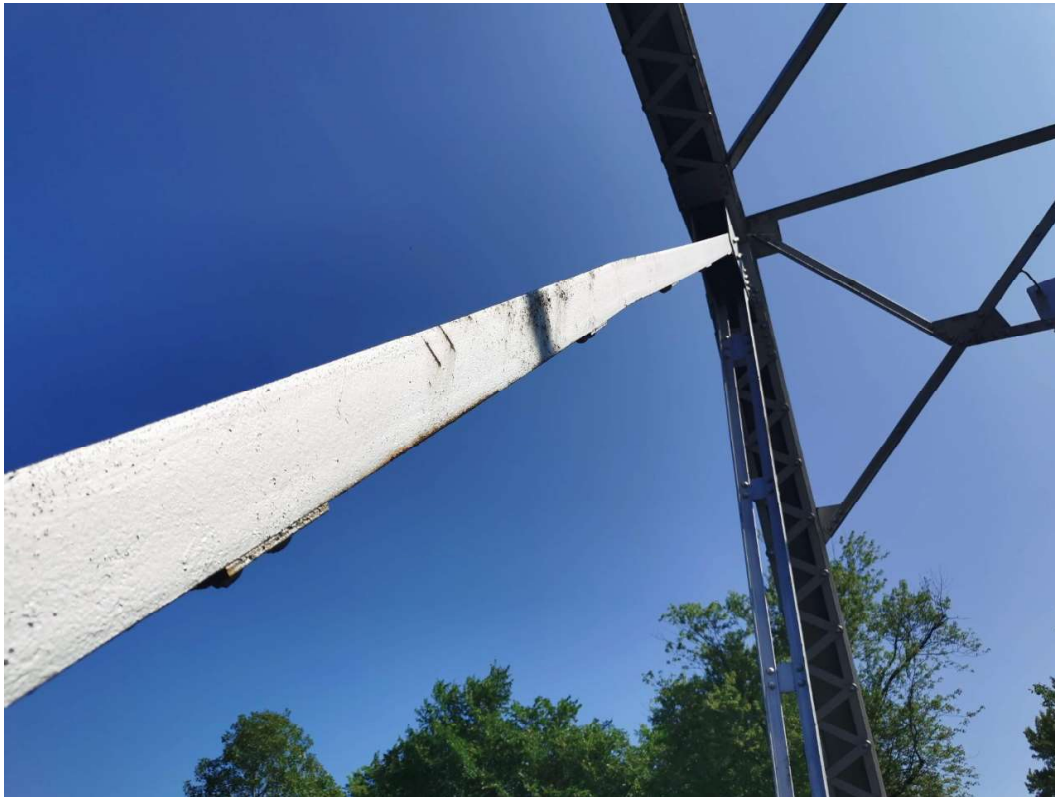
Localized distortion of diagonal (inner) on the West Truss at North Abutment

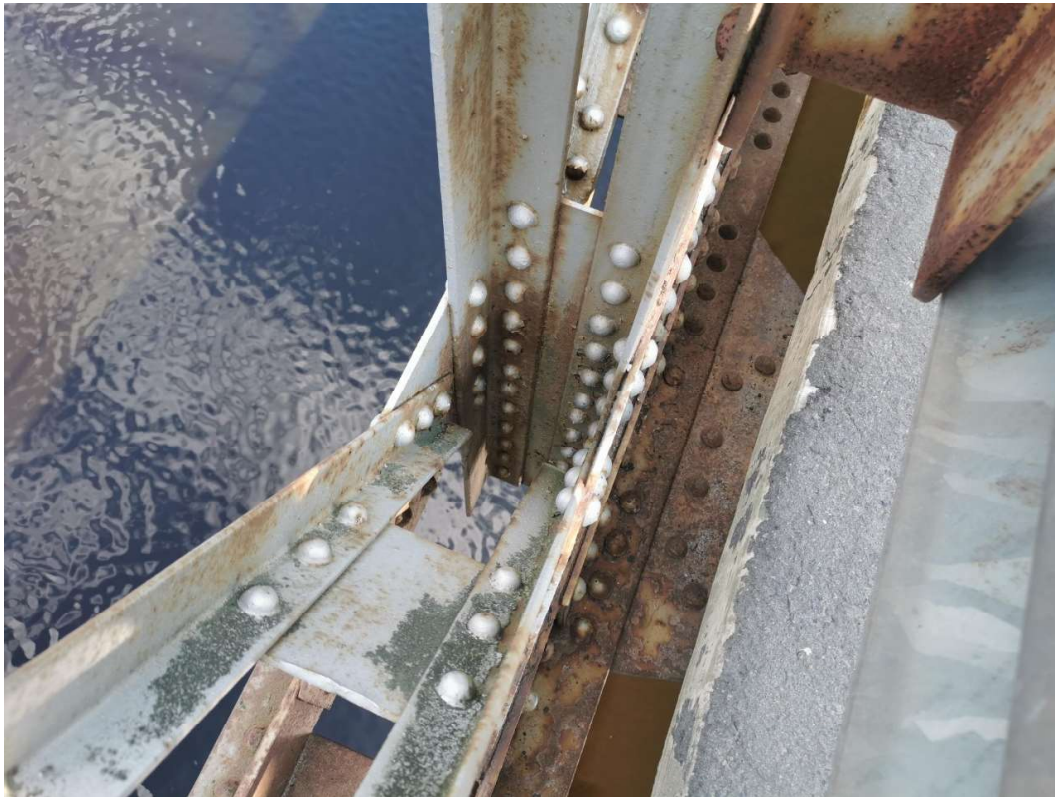
Moderate to Severe Corrosion of Rivets and Gusset plates.

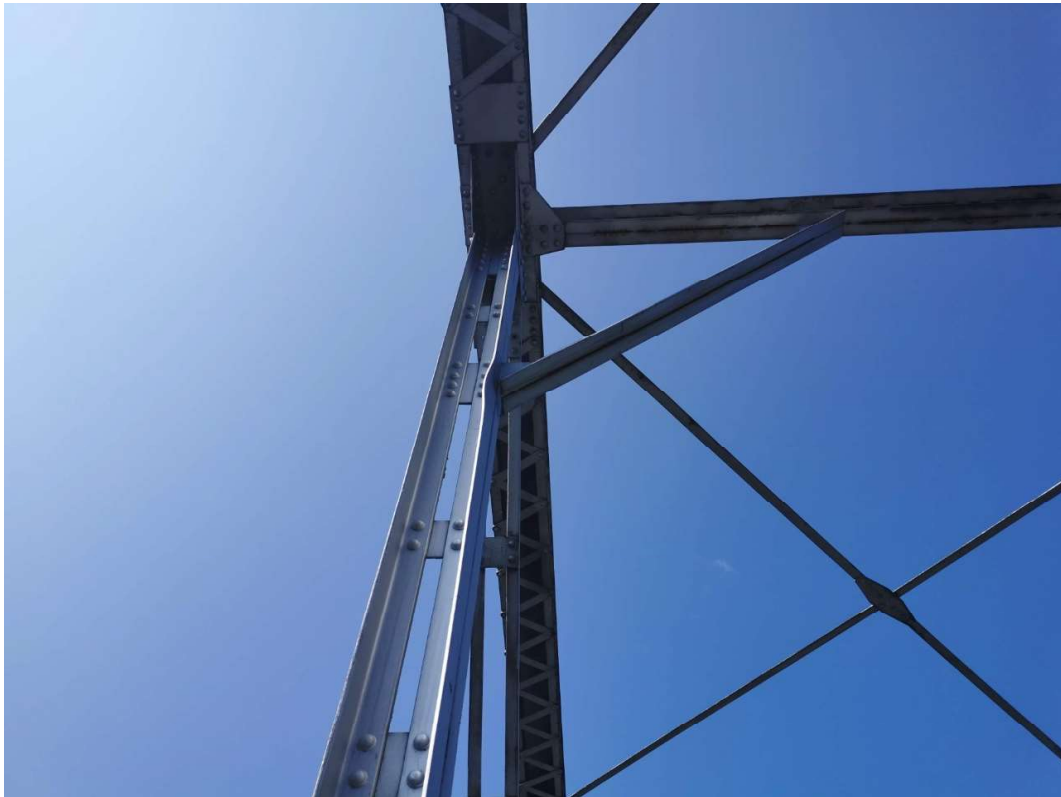
Warping of Vertical near connection to 'K' bracing

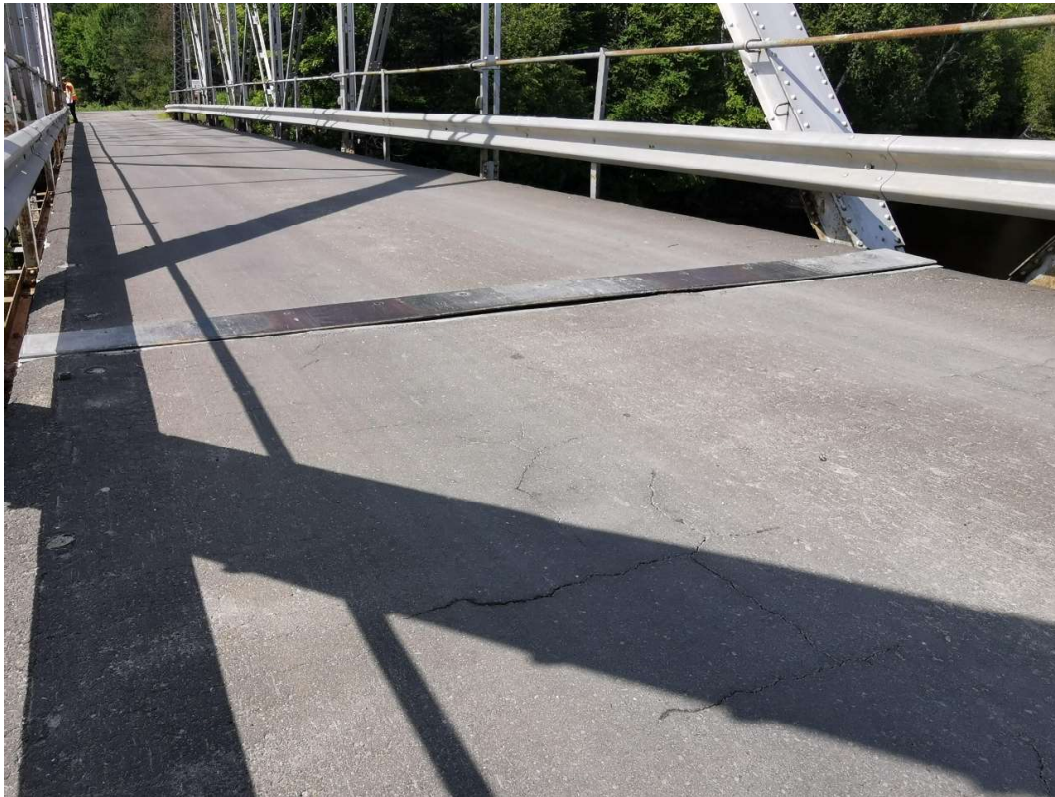
12.0	4.1		00. None
Comments: Light to moderate wear with localized light corrosion. The second armouring plate from the South pier has lifted slightly, allowing gravel and debris underneath the plate.						
Recommended Work:			<input checked="" type="checkbox"/> Rehab <input type="checkbox"/> Replace <input checked="" type="checkbox"/> 1-5 years <input type="checkbox"/> 6-10 years		Maintenance Needs: 02. Bridge Cleaning	
Rehab/reconnect armouring steel					<input type="checkbox"/> Urgent <input checked="" type="checkbox"/> 1 year <input type="checkbox"/> 2 year Cleaning of gravel debris from connections.

Lifted Armouring Plate at Centerline, Rotated at West side of Bridge

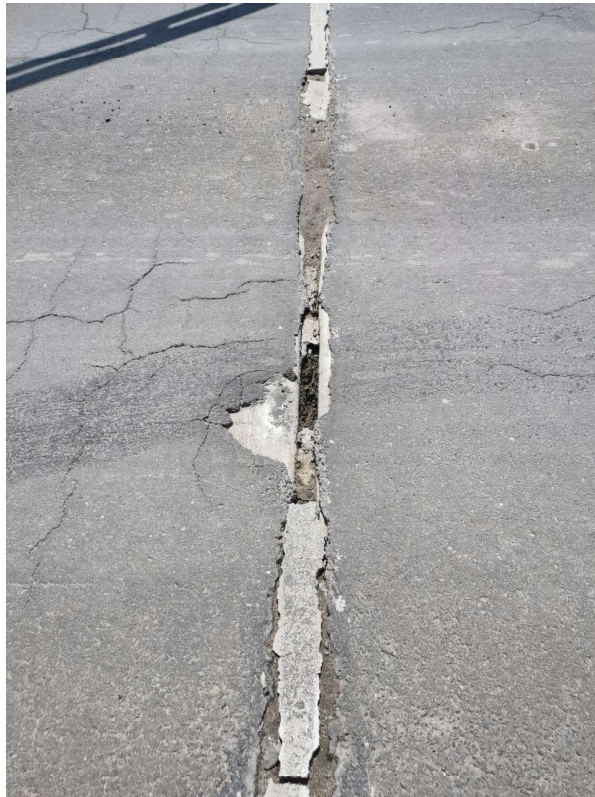
Joint Seal Severely Deteriorated with Sections Missing

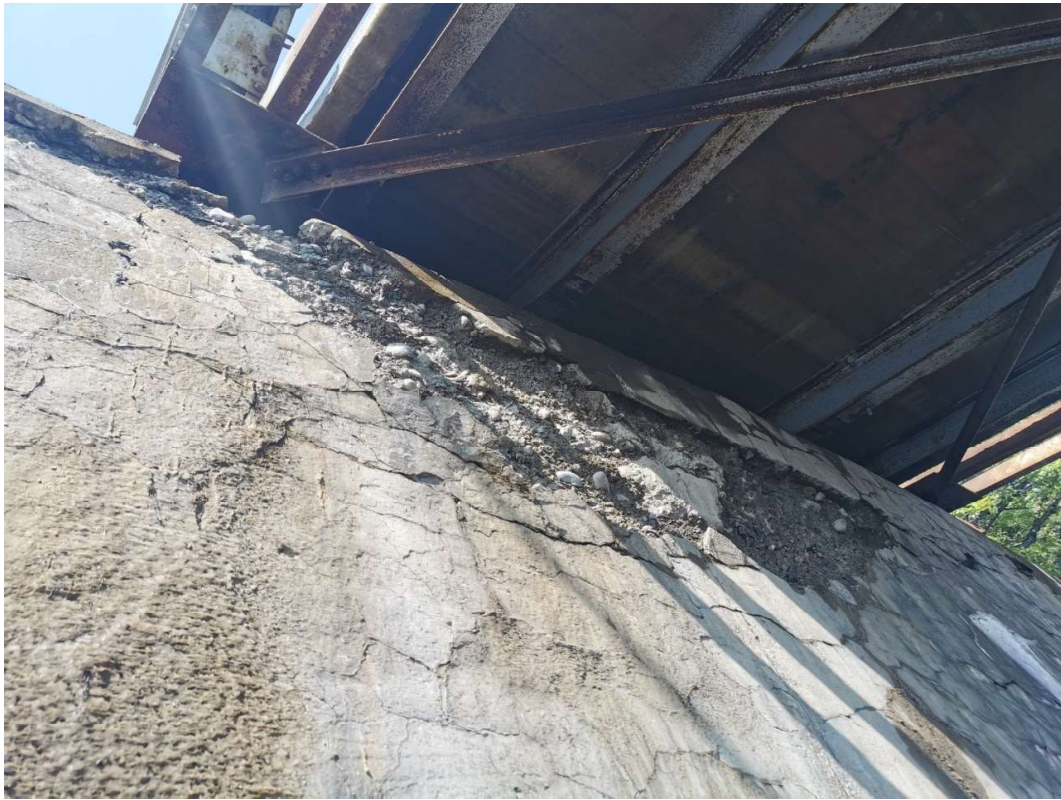
71.7	00. None
Comments: Stained narrow to wide map cracking with efflorescence, delamination, light to severe scaling, gravel/debris buildup and spalls.						
Recommended Work:			<input checked="" type="checkbox"/> Rehab <input type="checkbox"/> Replace <input checked="" type="checkbox"/> 1-5 years <input type="checkbox"/> 6-10 years		Maintenance Needs: 01. N/A	
Partial depth concrete repairs to abutment walls					<input type="checkbox"/> Urgent <input type="checkbox"/> 1 year <input type="checkbox"/> 2 year

Severe Spalling, Delamination and Efflorescence Throughout Abutment Walls

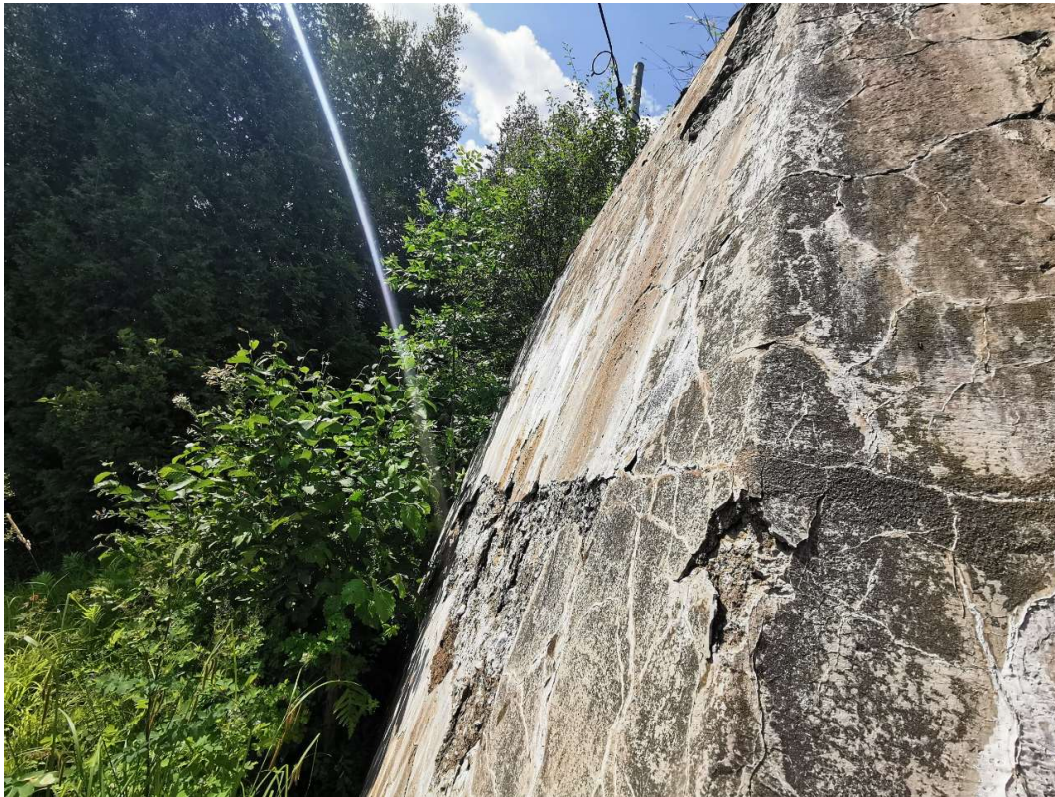
86.2	00. None
Comments: Stained narrow to wide map cracking with efflorescence, delamination, light to severe scaling and spalls.						
Recommended Work:			Maintenance Needs:			
<input checked="" type="checkbox"/> Rehab <input type="checkbox"/> Replace <input checked="" type="checkbox"/> 1-5 years <input type="checkbox"/> 6-10 years Partial depth concrete repairs to abutment wingwalls.			01. N/A <input type="checkbox"/> Urgent <input type="checkbox"/> 1 year <input type="checkbox"/> 2 year

Delaminations and Efflorescence Throughout Wingwalls

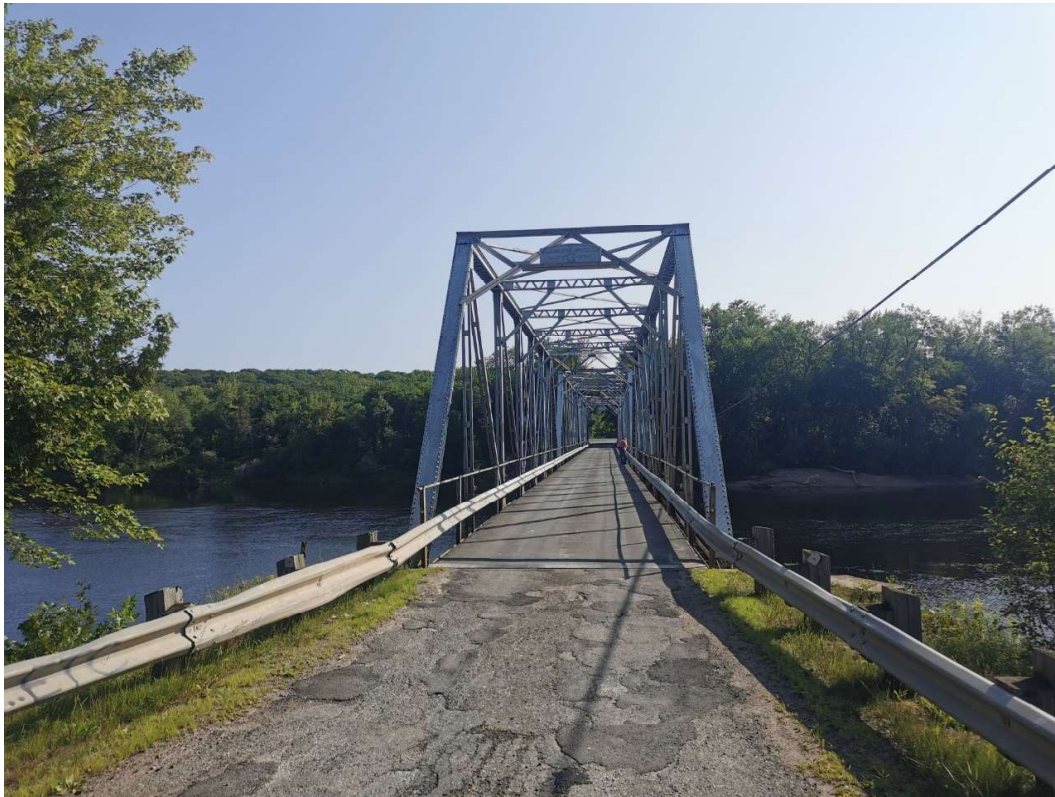
6.0	18.0	01.
Comments: Vehicular damage to barrier at SW quadrant, missing guiderail bolts, moderate to severe decay of wood posts, wide splits and checks with severe end decay, buried end treatments at approach guiderails on the south approach.						
Recommended Work:			<input checked="" type="checkbox"/> Rehab <input type="checkbox"/> Replace <input checked="" type="checkbox"/> 1-5 years <input type="checkbox"/> 6-10 years		Maintenance Needs: 17. Scaling	
Replace guiderails and upgrade end treatments.					<input type="checkbox"/> Urgent <input checked="" type="checkbox"/> 1 year <input type="checkbox"/> 2 year Replace missing and/or tighten loose bolts in approach guiderails, replace decayed posts.

Wooden Posts with Moderate to Severe End Decay.

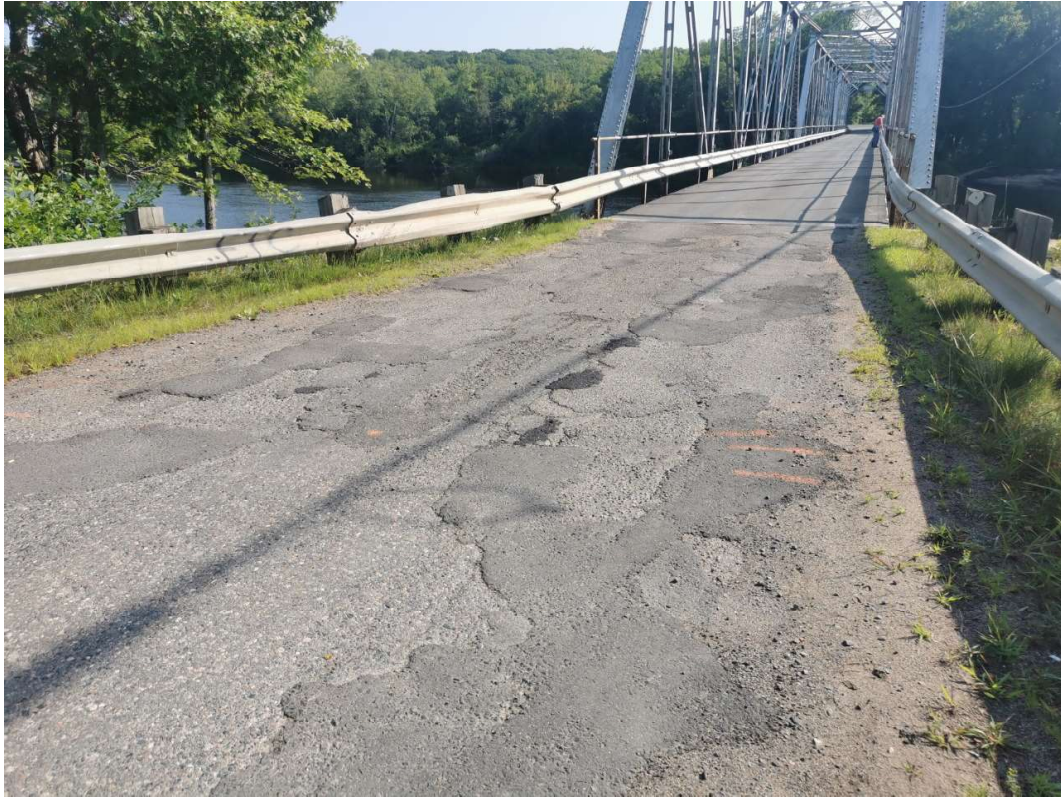
Patches and Potholes in South Approach

Element Group:	Approaches		Length:	6.0 m		
Element Name:	Wearing Surface		Width:	3.70 m		
Location:	North and South Approaches		Height:	-		
Material:	Surface Treatment		Count:	2		
Element Type:			Total Quantity:	44.4 sq.m		
Environment:	Benign / Moderate / Severe		Inspected:	Yes <input checked="" type="checkbox"/> No <input type="checkbox"/> Limited <input type="checkbox"/>		
Protection System:						Perform. Deficiencies
Condition Data:	Units	Exc.	Good	Fair	Poor*	
	m² m / each / % / all			34	10.4	08, 09
Comments: Medium to severe raveling at centerline, medium wheel rutting, light to moderate potholes with patching noted throughout the South approach.						
Recommended Work:			Maintenance Needs: 12. Bridge Surface Repair			
<input type="checkbox"/> Rehab <input checked="" type="checkbox"/> Replace <input checked="" type="checkbox"/> 1-5 years <input type="checkbox"/> 6-10 years Regrade South approach and replace wearing surface			<input type="checkbox"/> Urgent <input checked="" type="checkbox"/> 1 year <input type="checkbox"/> 2 year Surface repairs and patching to smooth out approaches. (South Approach worse)

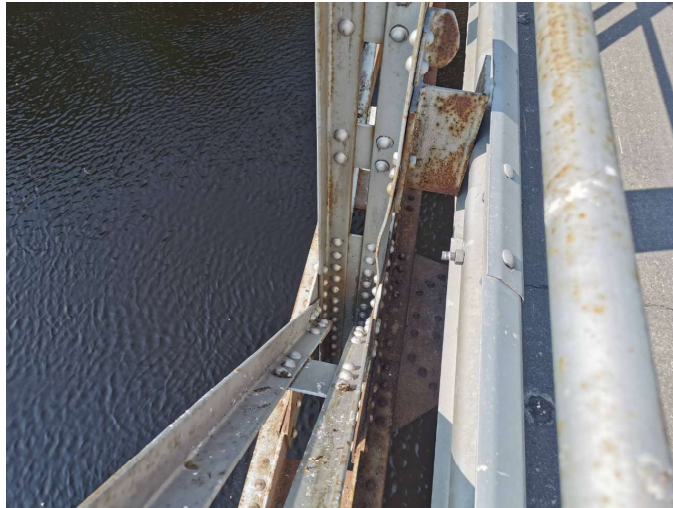
Hand railing with breakdown of protective coating

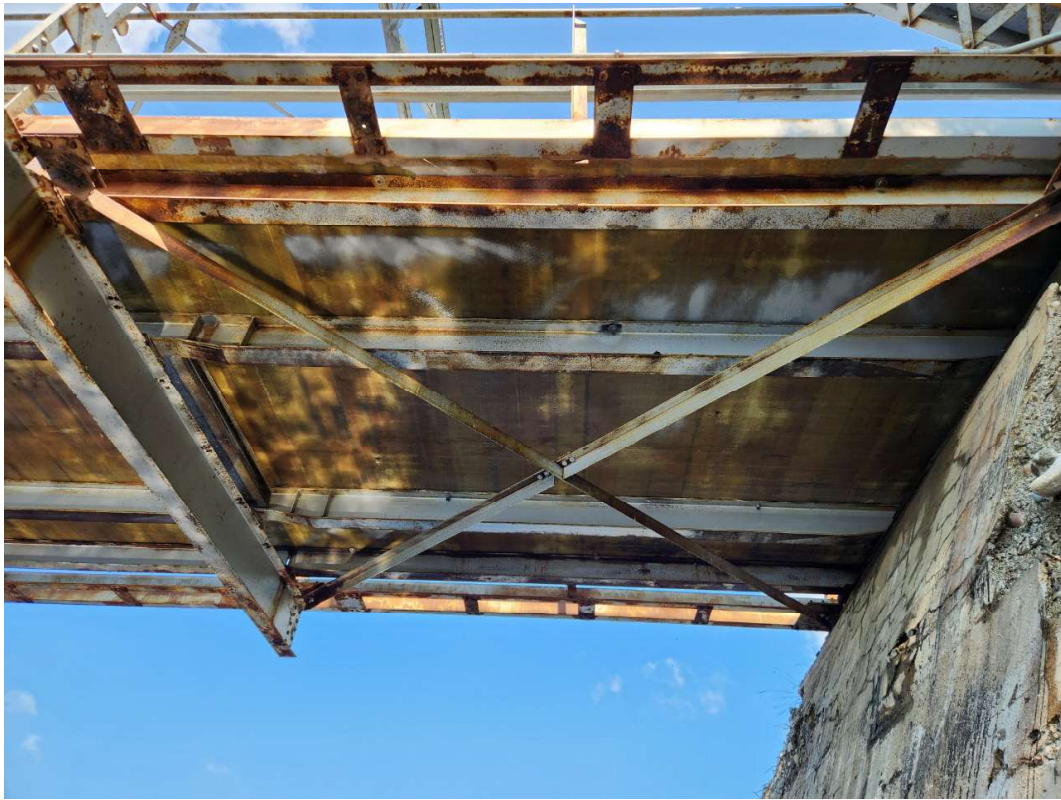
305.0	916.0	305.0	00. None
Comments: Localized breakdown and loss of protective coating throughout						
Recommended Work:			<input checked="" type="checkbox"/> Rehab <input type="checkbox"/> Replace <input type="checkbox"/> 1-5 years <input checked="" type="checkbox"/> 6-10 years		Maintenance Needs: 01. N/A	
Re-coat structural steel					<input type="checkbox"/> Urgent <input type="checkbox"/> 1 year <input type="checkbox"/> 2 year

Typical Protective Coating Condition

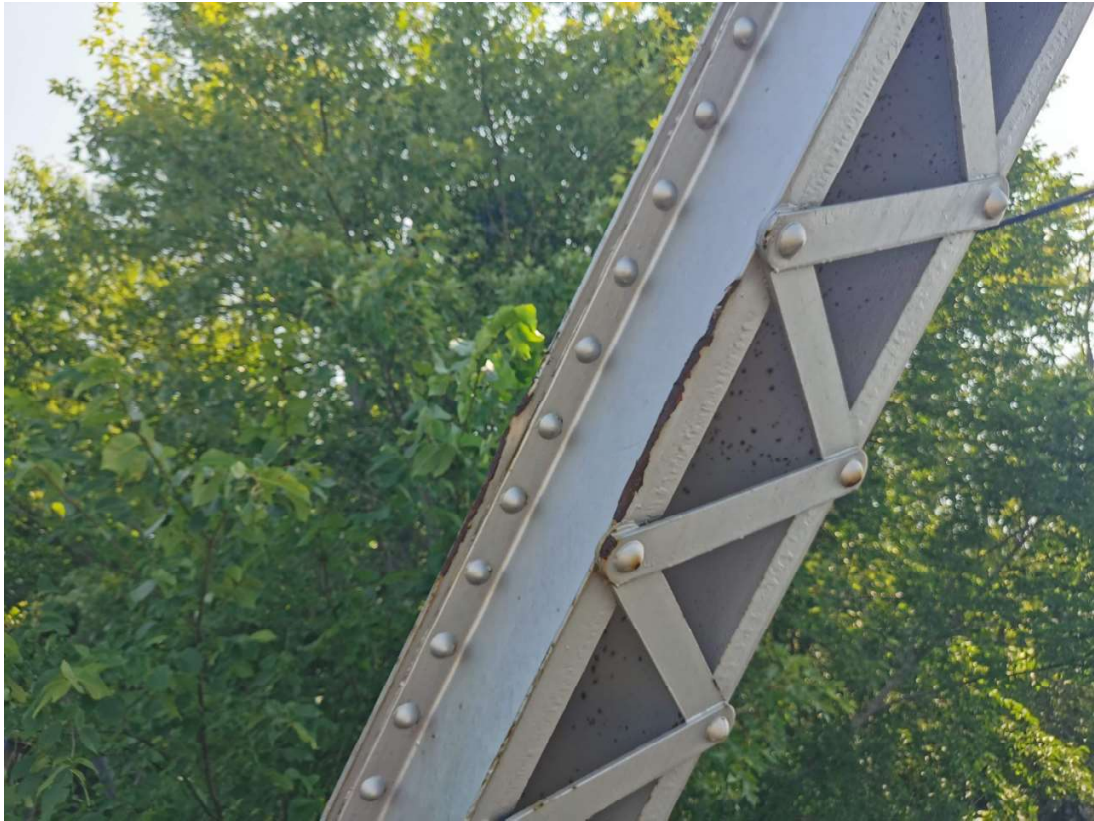
Impact damage to inner surface of the top chord (~3.5m above bridge deck)

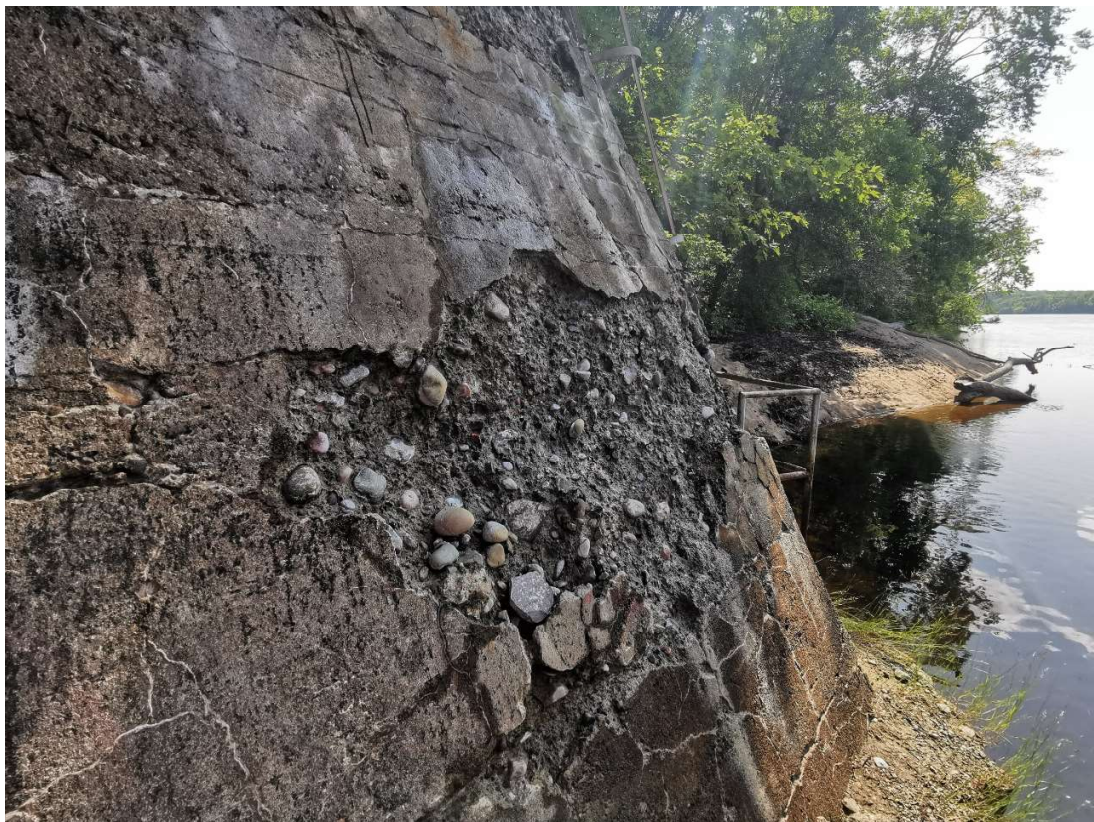
Severe spalling, delamination and map cracking with efflorescence (north abutment worse)
