Project No.: **25-1019**

## STRUCTURE INSPECTION REPORT

**Structure Name:** Dean Lake Road Culvert **Date:** June 5<sup>th</sup>, 2025

**Owner's Name:** The Municipality of Huron Shores

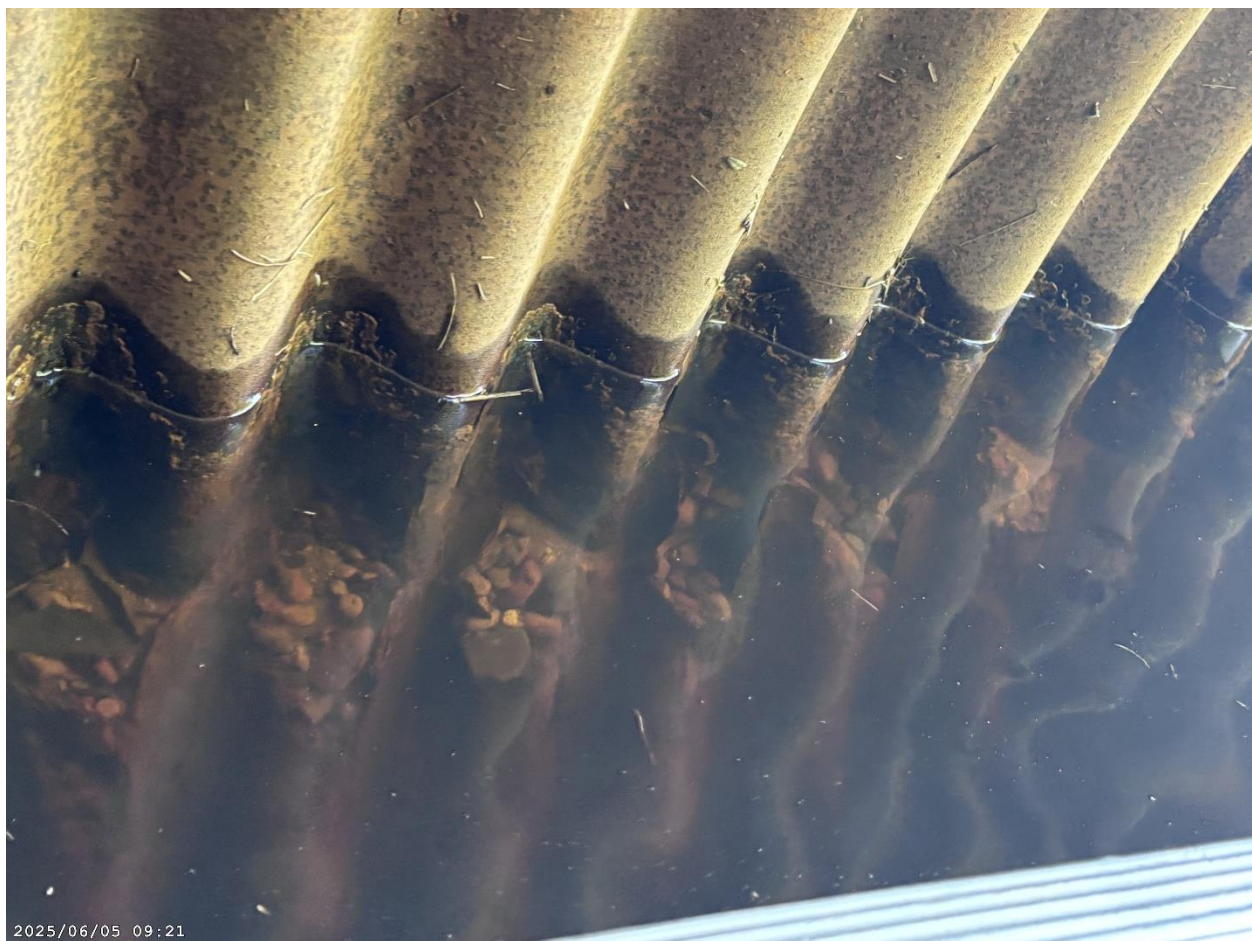
**Figure #1:** Separation of top and bottom portions of culvert barrel exposing gravel

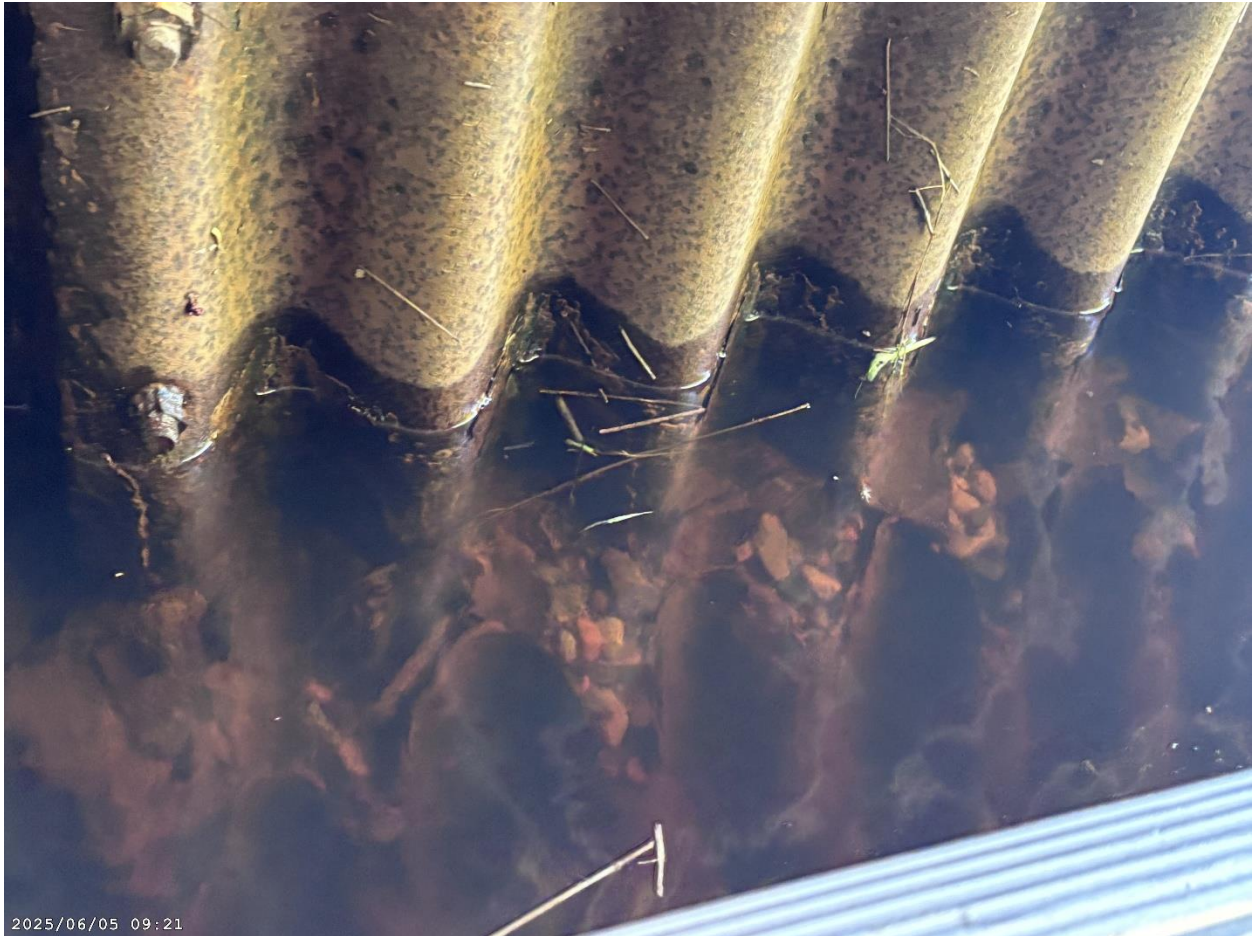
**Figure #2:** Close-up view of separation between top and bottom portions of culvert barrel

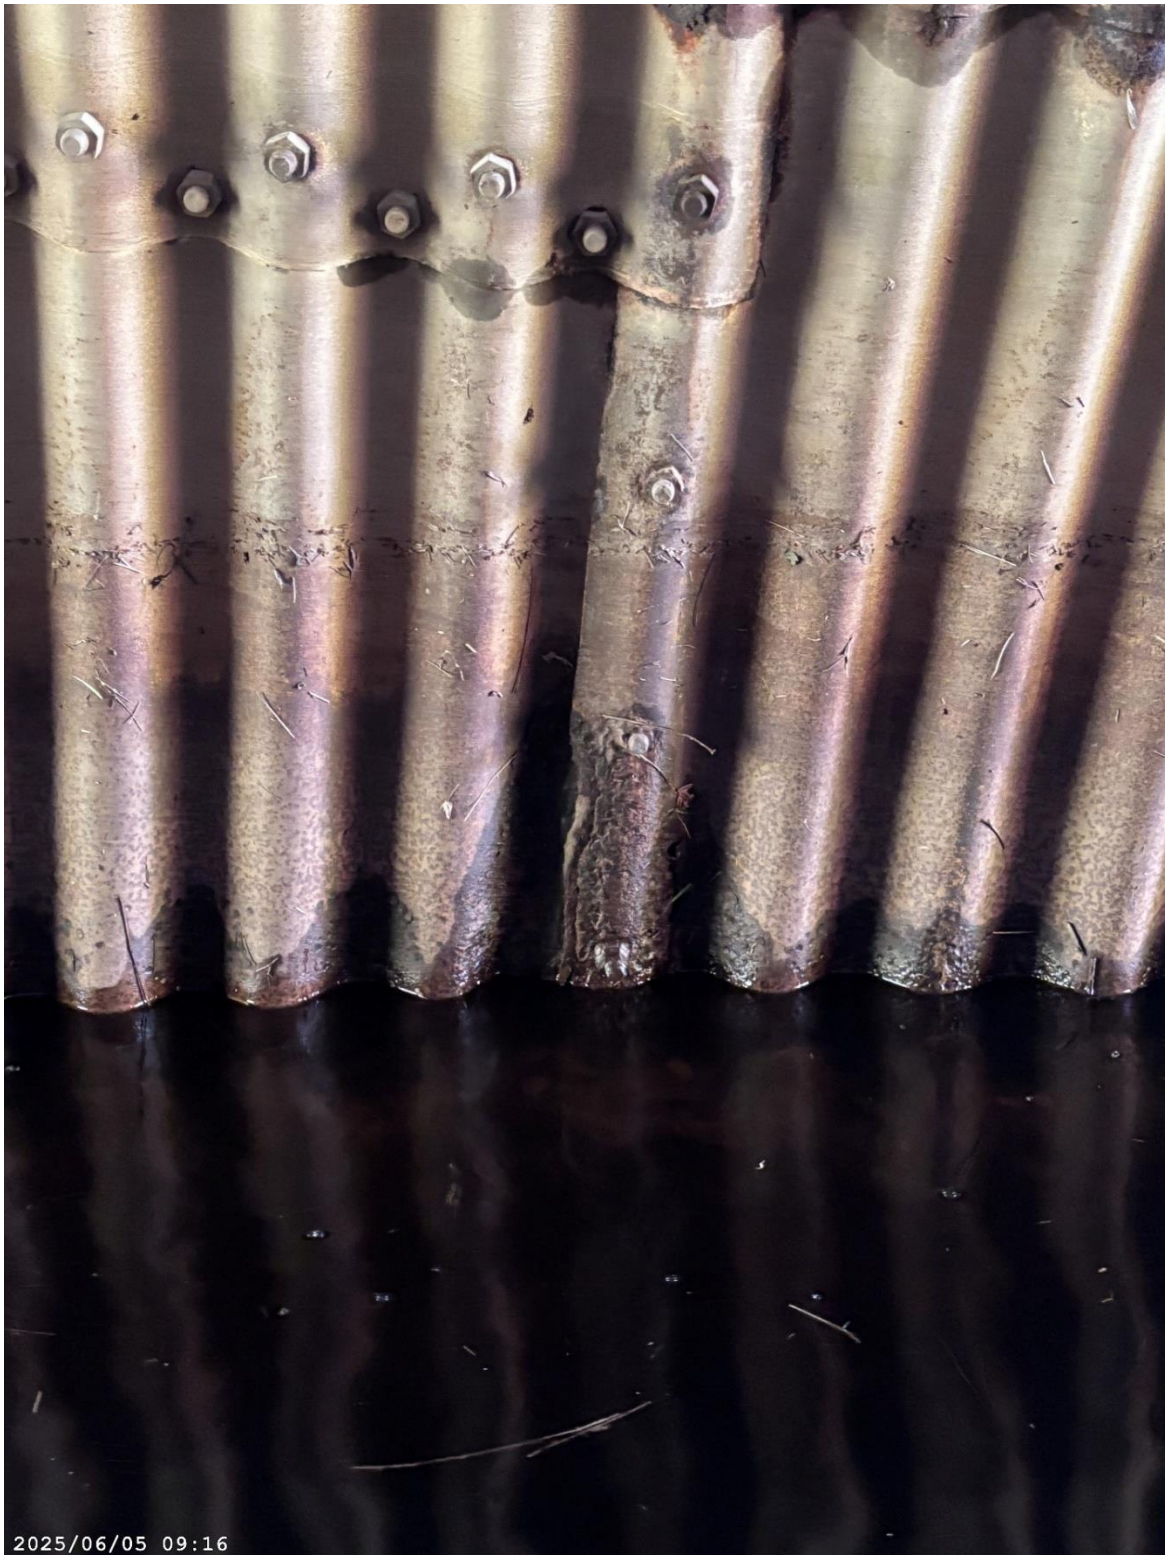
**Figure #3:** Localized severe flaking of culvert barrel

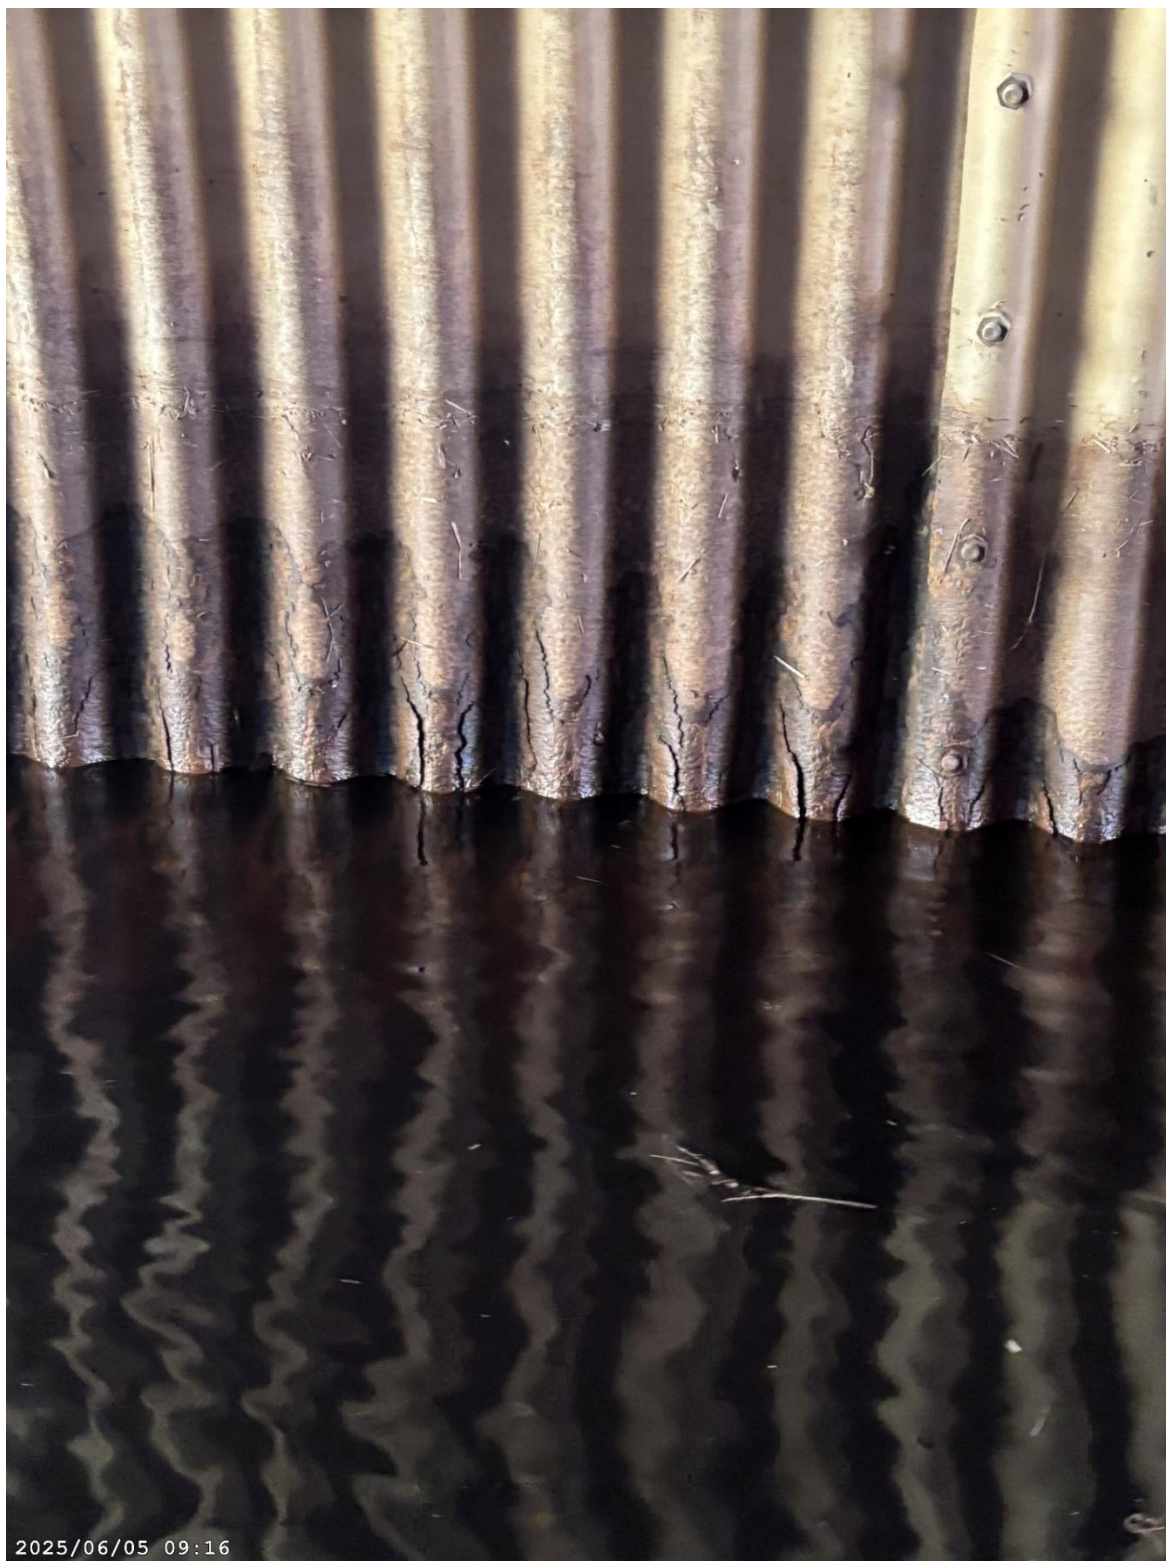
**Figure #4:** Flaking of culvert barrel at water line

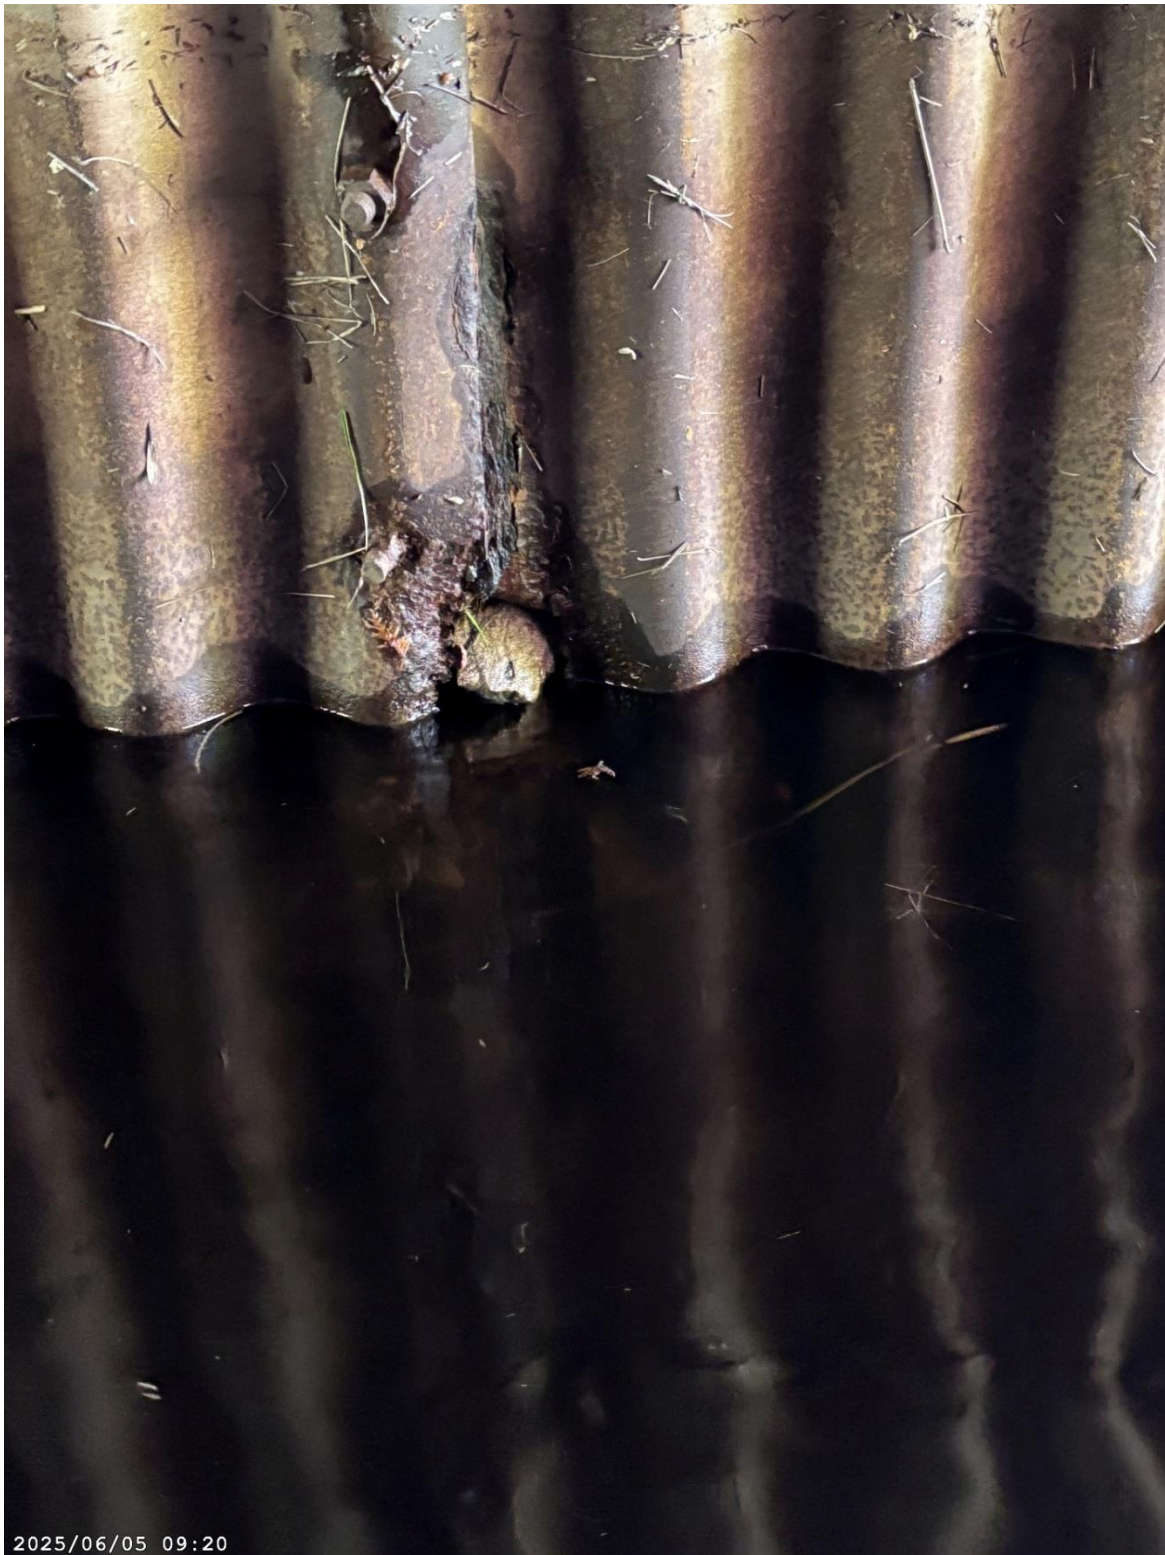
**Figure #5:** Hole in culvert barrel at water line

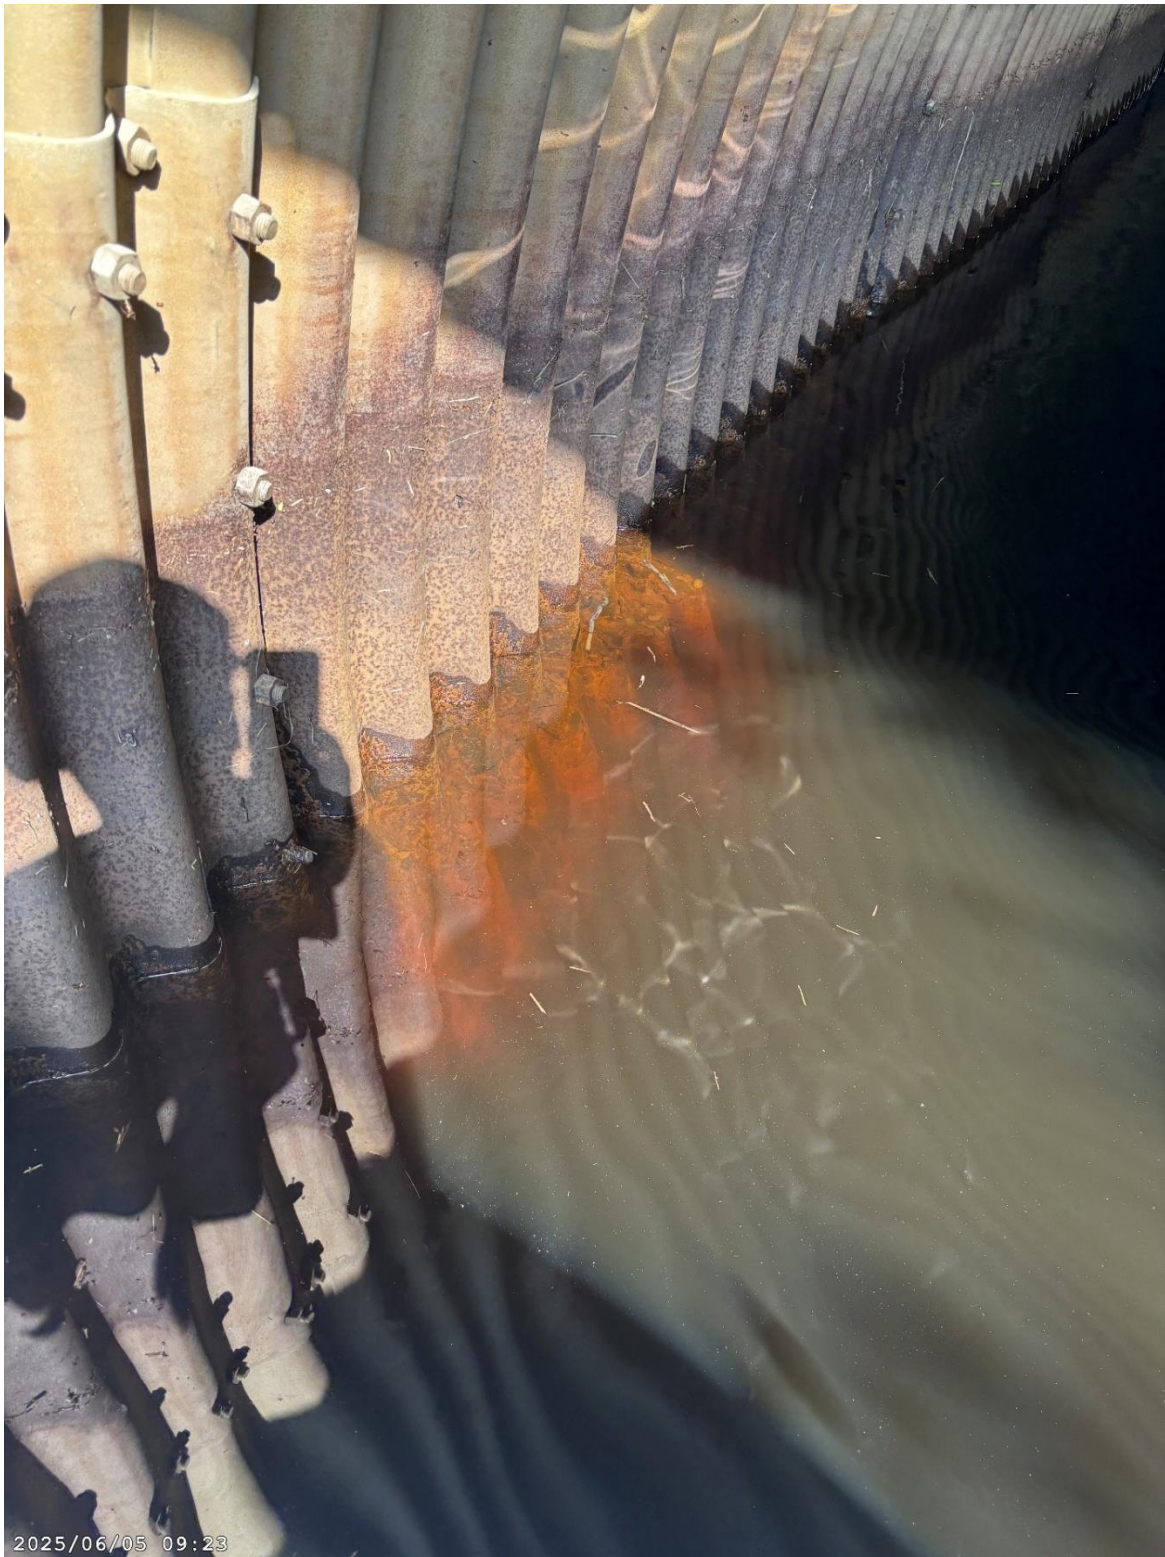
**Figure #6:** Corrosion of culvert barrel above/below water line

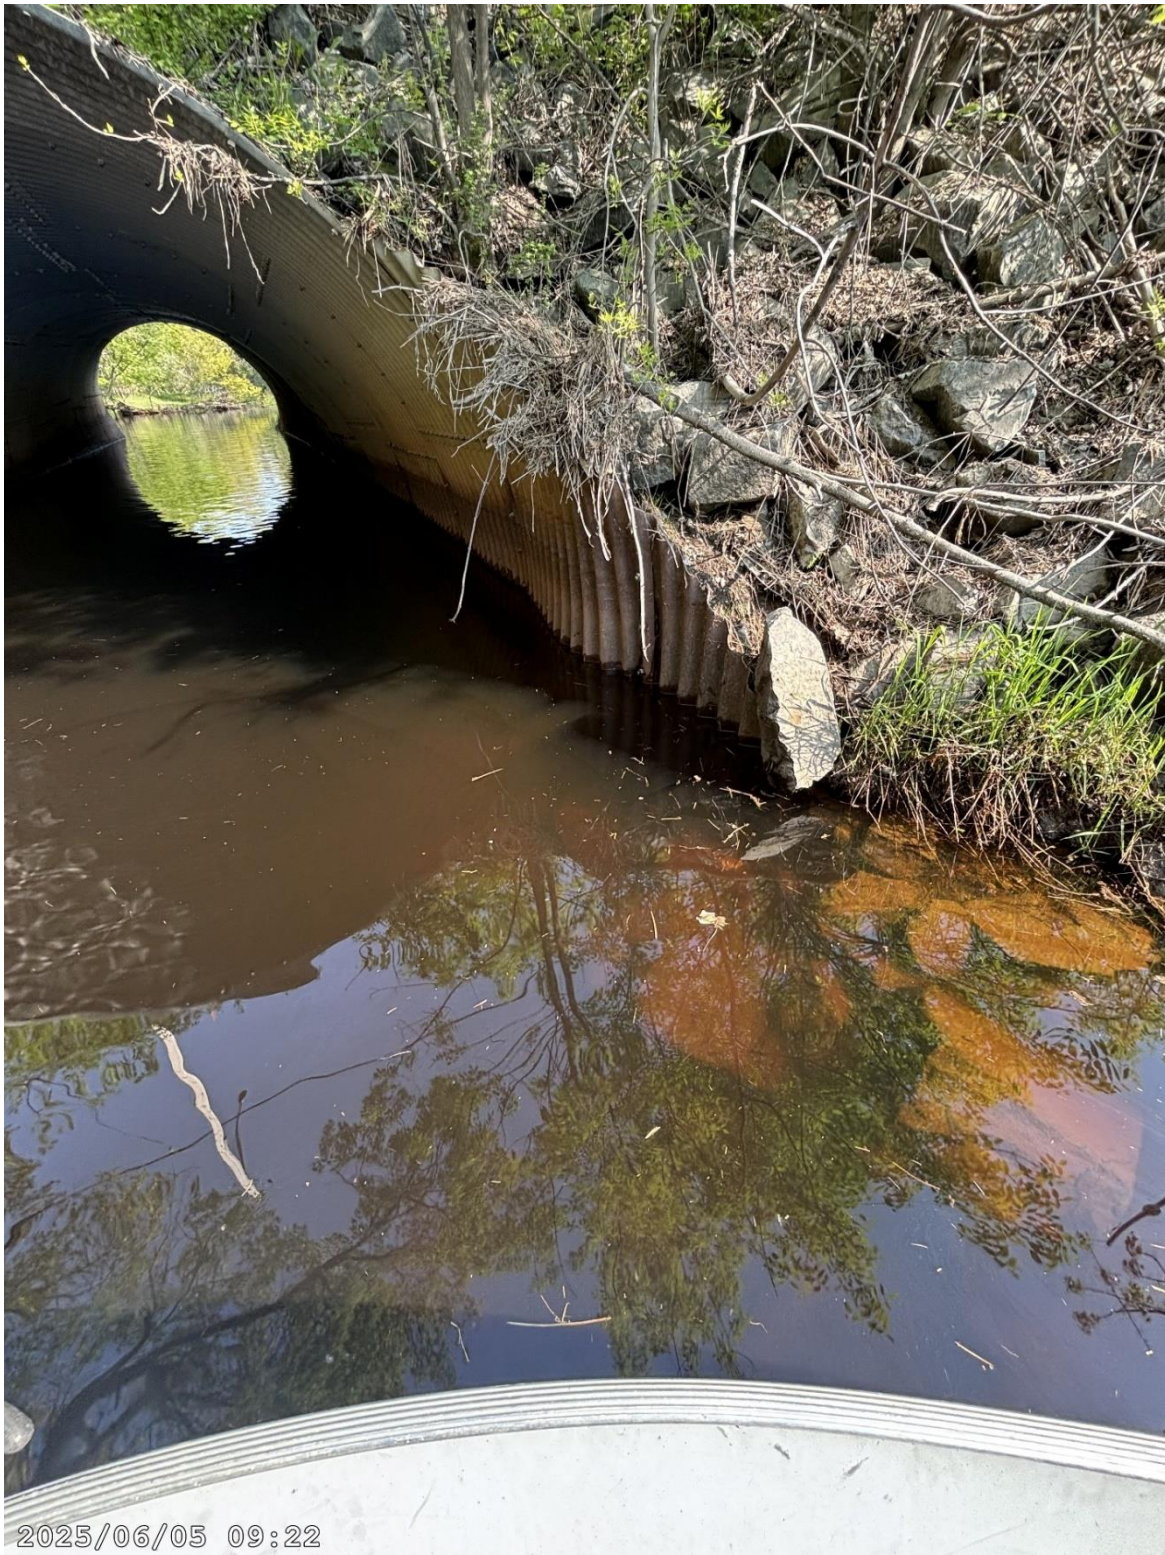
**Figure #8:** Bulge in Northeast corner of culvert barrel

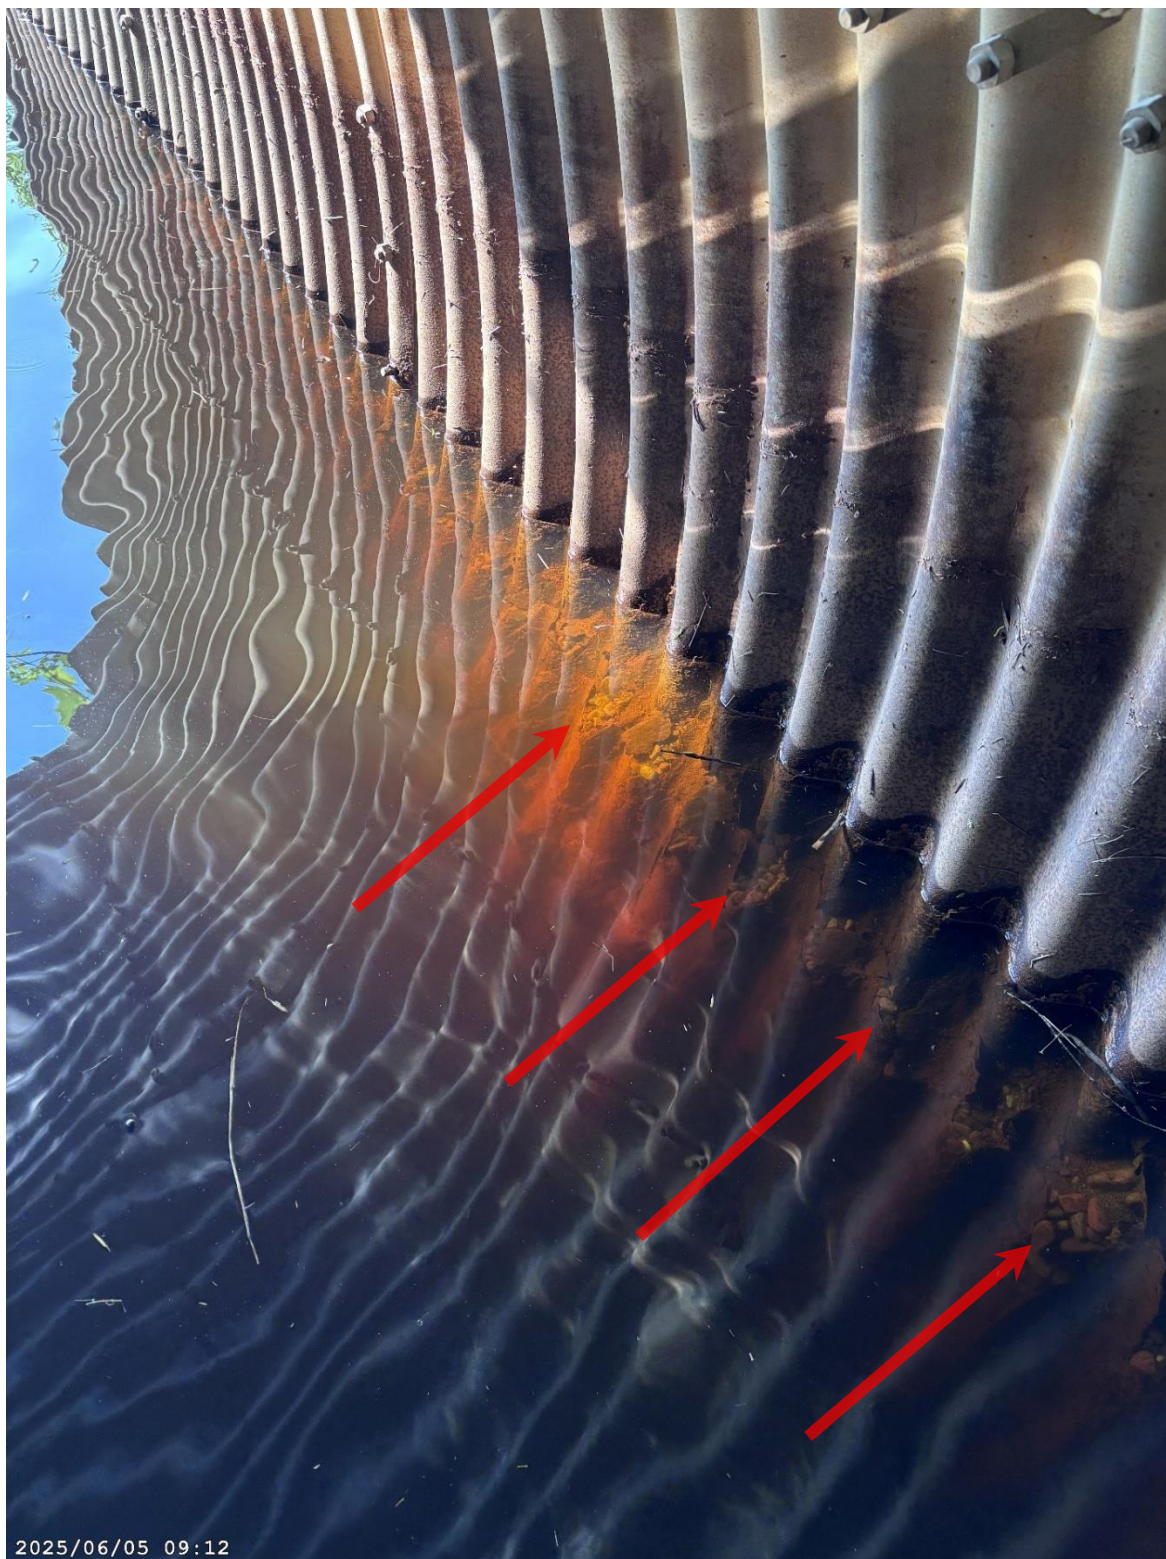
**Figure #9:** Shear failure line on South wall of culvert barrel with exposed gravel throughout
