PUBLIC HEALTH

Bright Lake Sanitary Survey

Date: May 23, 2012

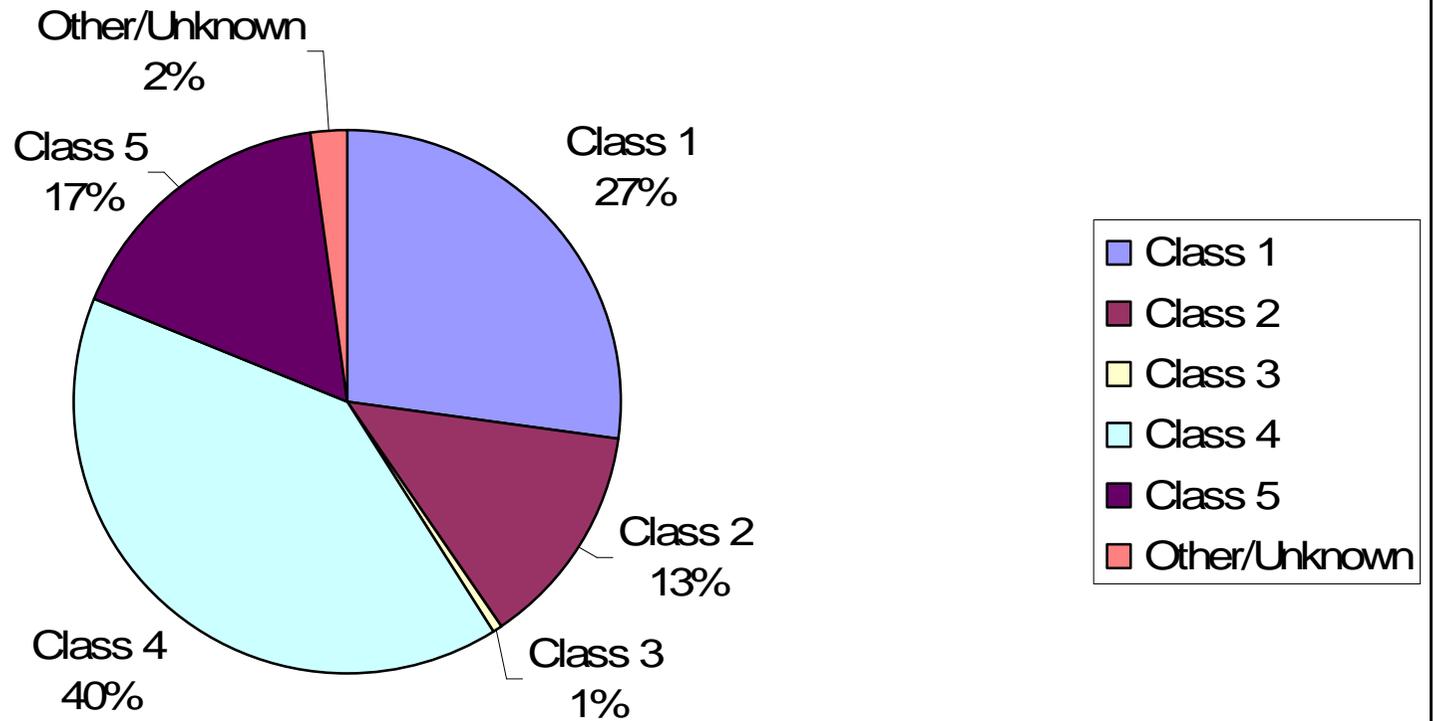
Systems On The Lake

- Class 1 – Privy and composting toilets
- Class 2 – Leaching pits for grey water waste
- Class 3 – Cesspools
- Class 4 – Septic tank and field bed systems
- Class 5 – Holding tank

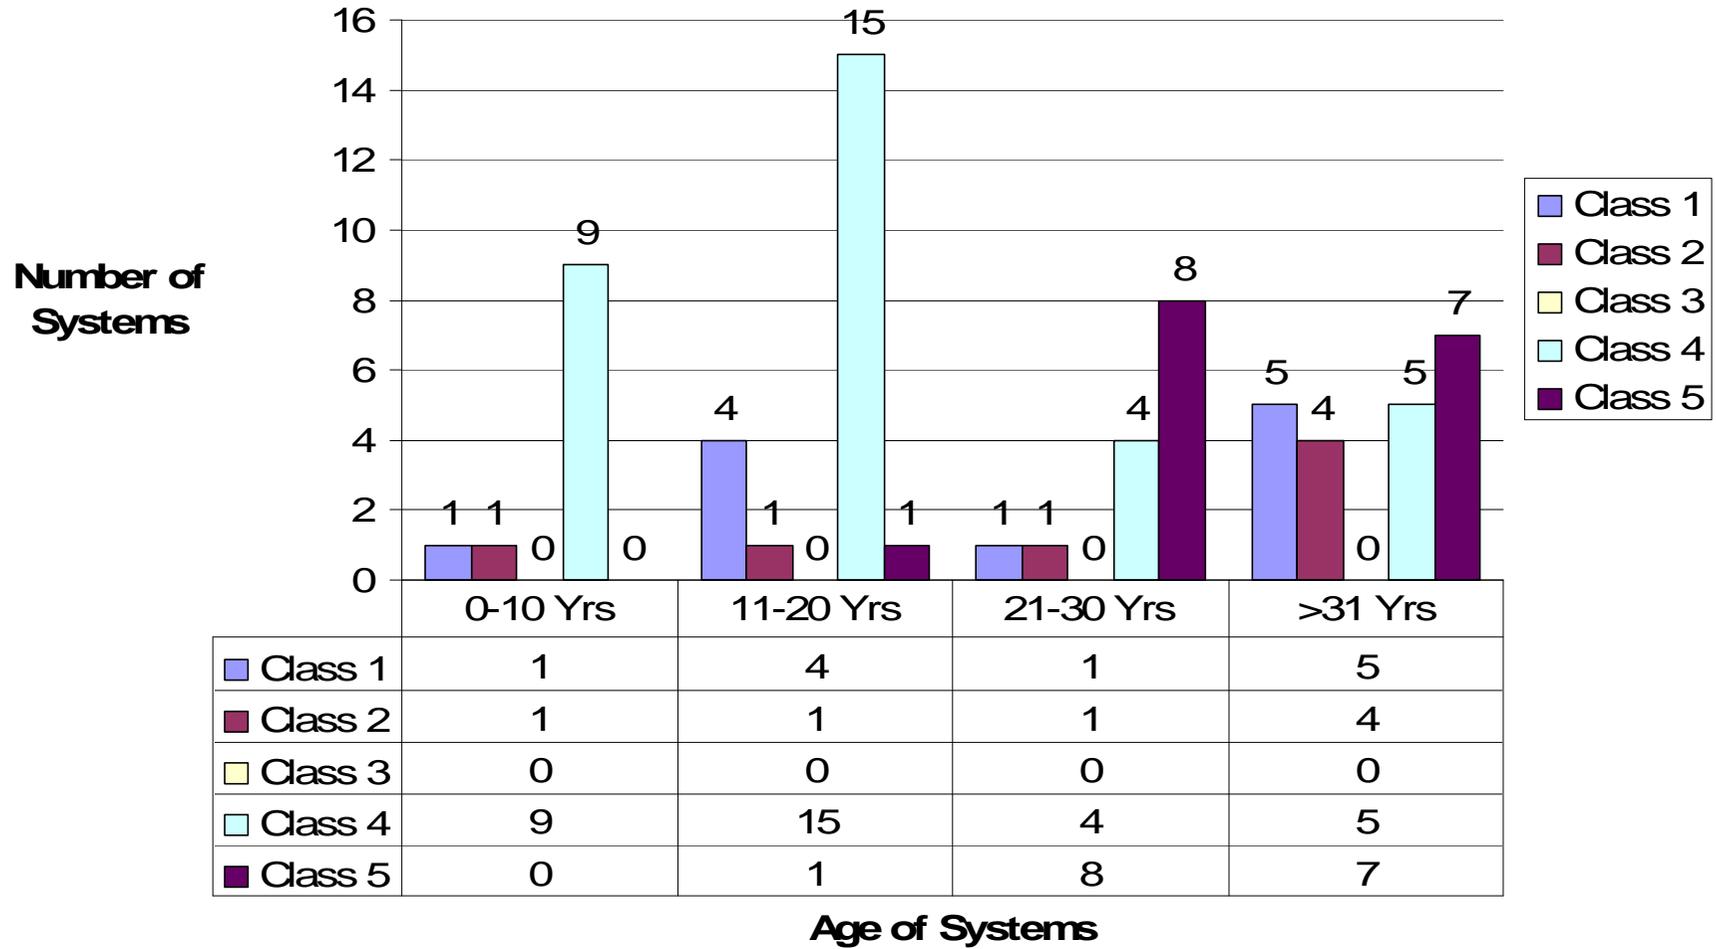
The Known Age of Systems

- The average life span is generally 20 to 30 years.
- Most sewage disposal systems on Bright Lake are close to that age, if not exceeding it.
- From the limited data collected the bulk of SDS were installed between 1980 and 2000.
- Many of the sewage systems pre-date Algoma Public Health Records (1978).

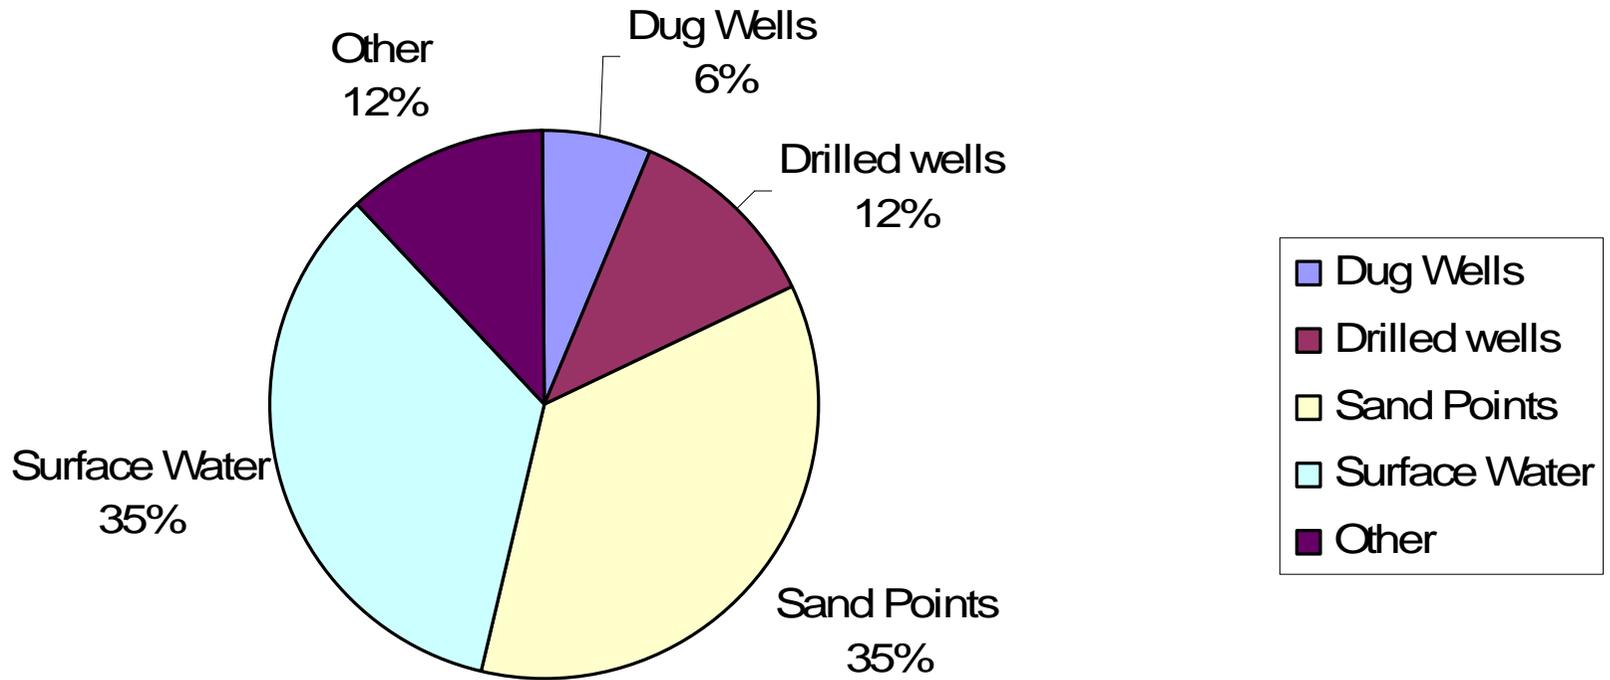
Cottage Source Water

- Eight drinking water samples were taken between Myers Road, Pioneer Road and Sunset Beach Road.
- All samples were tested for bacteriological indicators (Total Coliform and E.coli)
- All results were satisfactory.
