# GEOTECHNICAL REPORT

Potomac Bridge Replacement

Municipality of Huron Shores, Ontario

TULLOCH Project # 22-0887

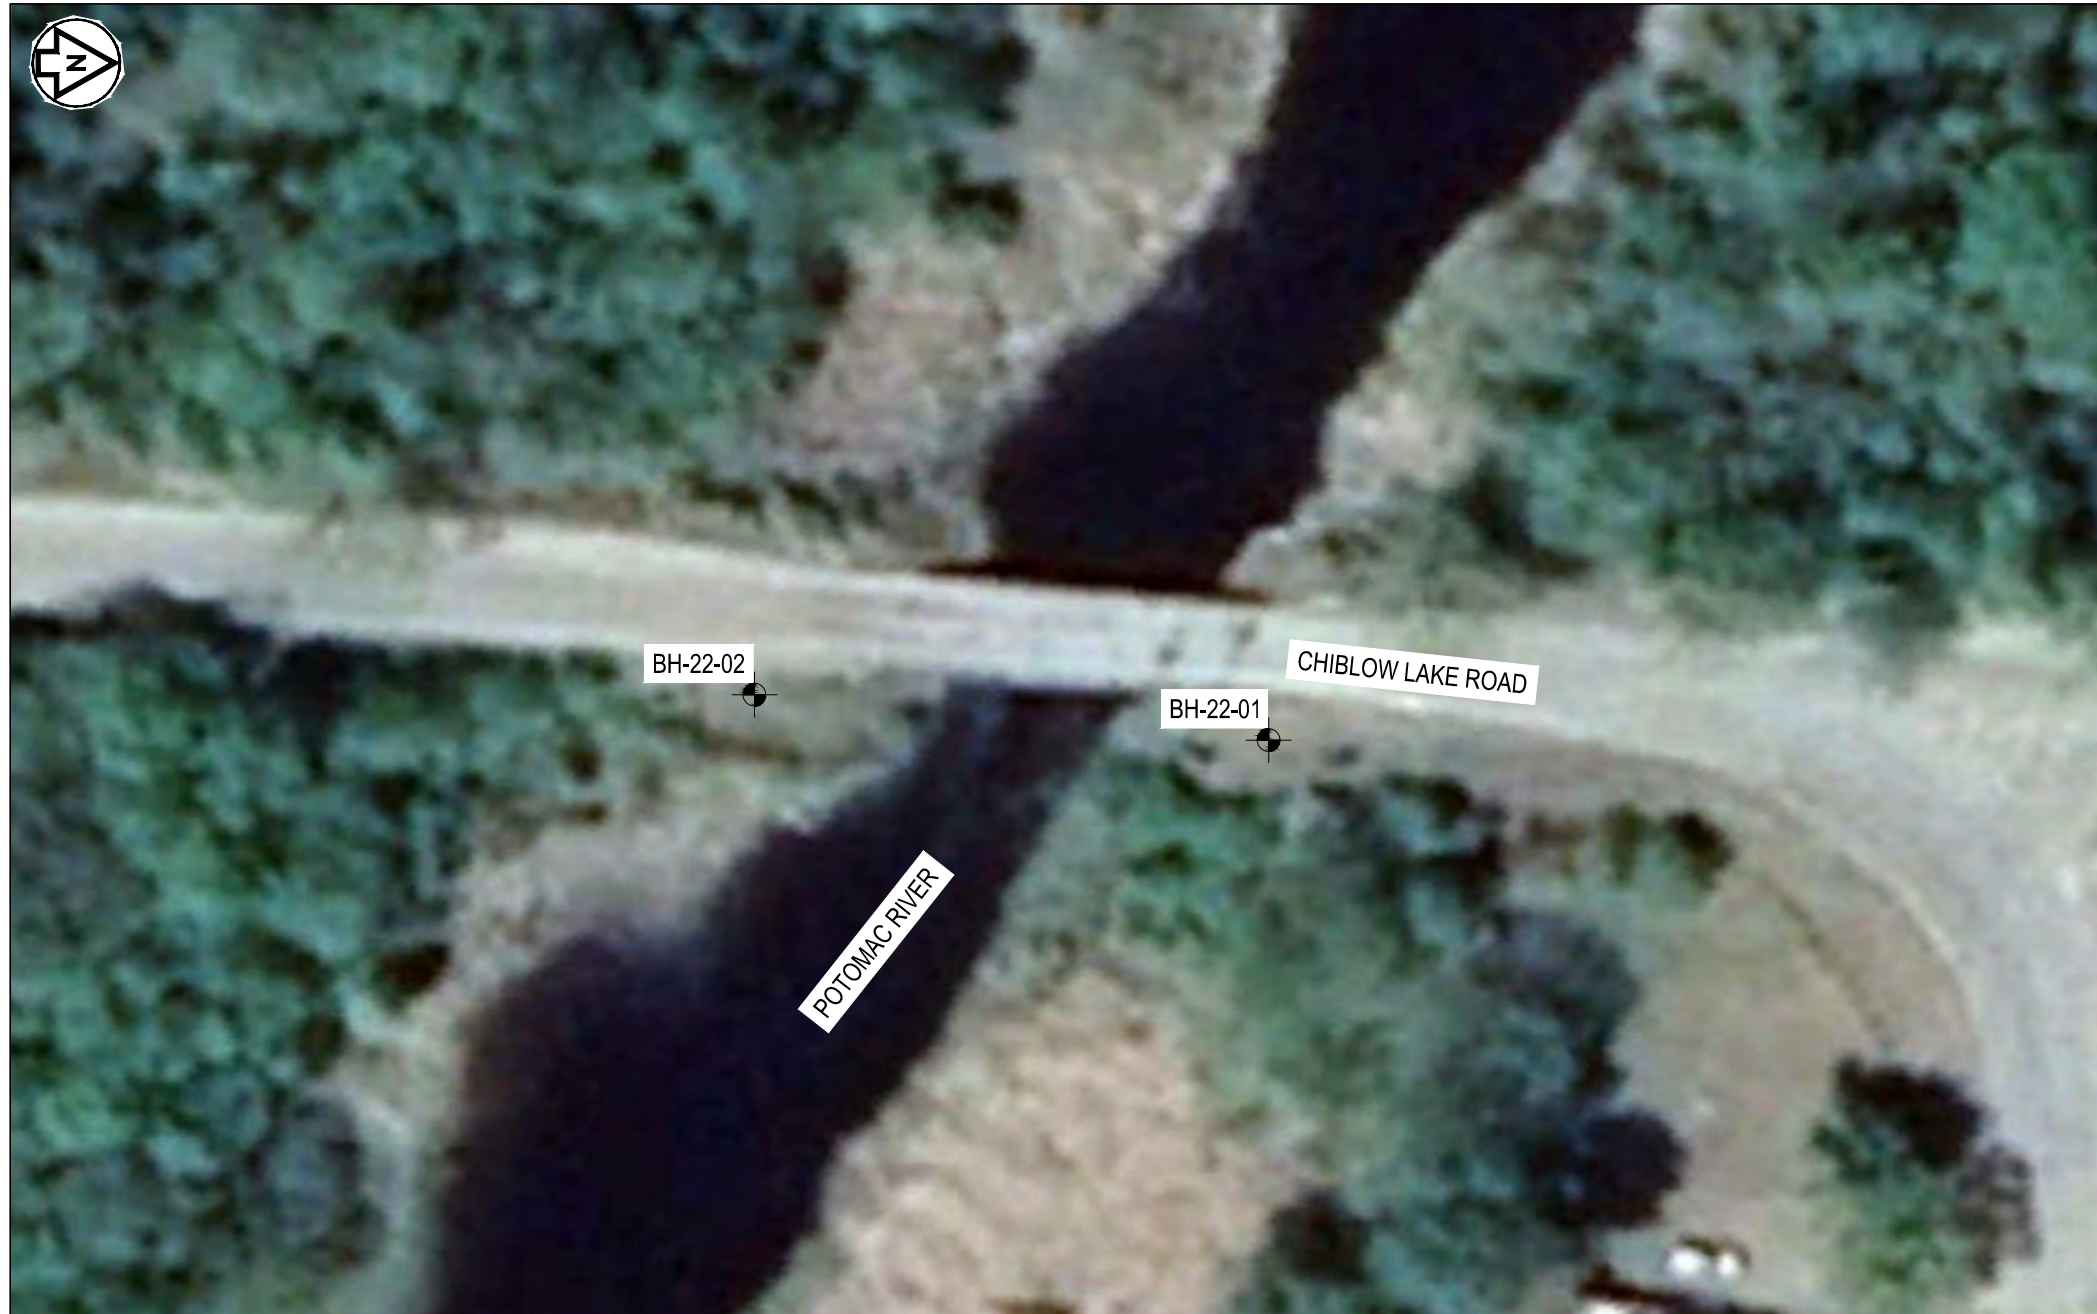
**PLAN**

### **KEY LOCATION PLAN & SITE PLAN LOCATION**

Table 3-1 below shows a summary of the investigation. The locations of the boreholes are shown in the site plan in Appendix A. Please note that refusal depths do not necessarily indicate bedrock locations, while the bedrock surface may be inferred via auger or cone refusal during drilling operations, bedrock was not confirmed via coring due to a very dense soil layer at depth. For more details, borehole logs can be found in Appendix D.

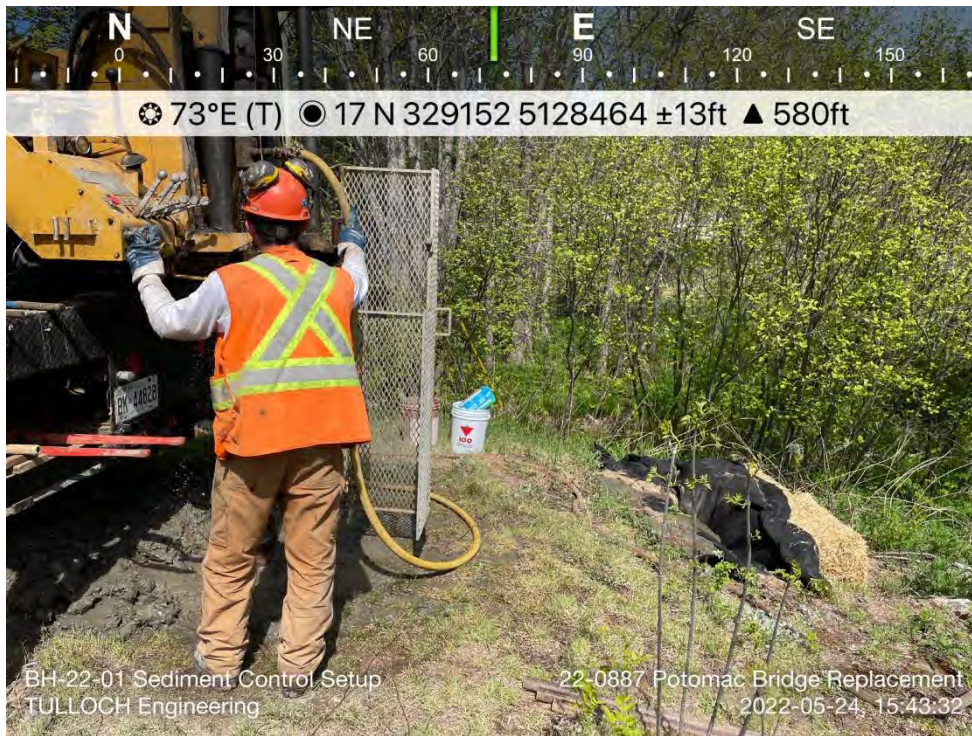
Photo 1: Drill rig setup at BH-22-01

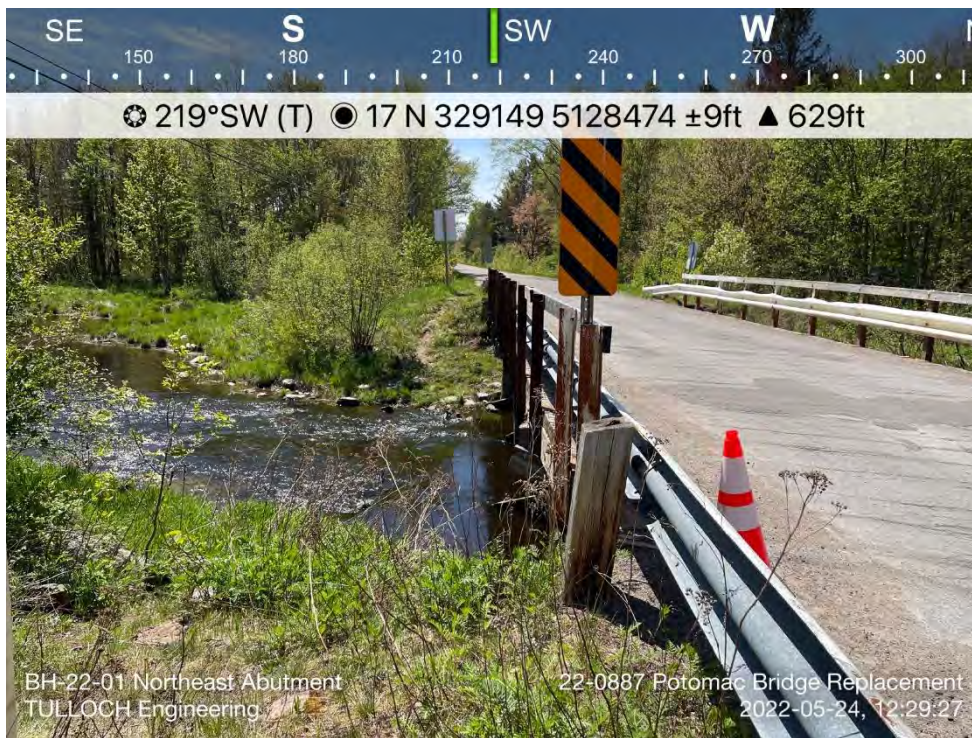
Photo 2: View from Drill Rig set up at BH-22-01 and view of the east side of the existing bridge

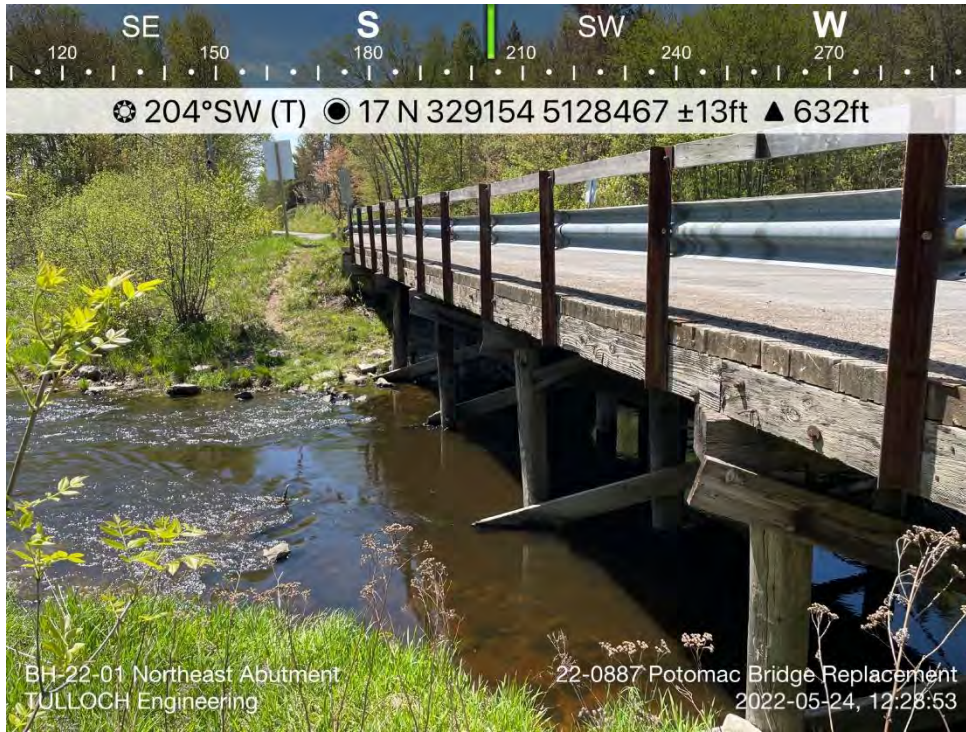
Photo 5: View of existing bridge deck and foundation from north abutment

The existing Potomac Bridge structure consists of a timber deck that has been paved. The deck of the bridge is supported on historic wood timber piles over five even spans (5) spans across the Potomac River. Each span is supported by a row of five (5) timber piles with wooden cross supports. The piles are capped by large wooden square cut beams that support the wooden deck. Based on visual inspection, the abutments of the bridge consist of wooden cribbing with granular backfill supported laterally by timber piles set in a similar fashion to the in-water spans. Lateral movement was noted on some of the wooden piles, indicating movement or possible failure over time. The bridge spans approximately 23 m across the river south of the intersection of Chiblow Lake Road and Allen Road. The founding elevations of the existing piles are unknown.

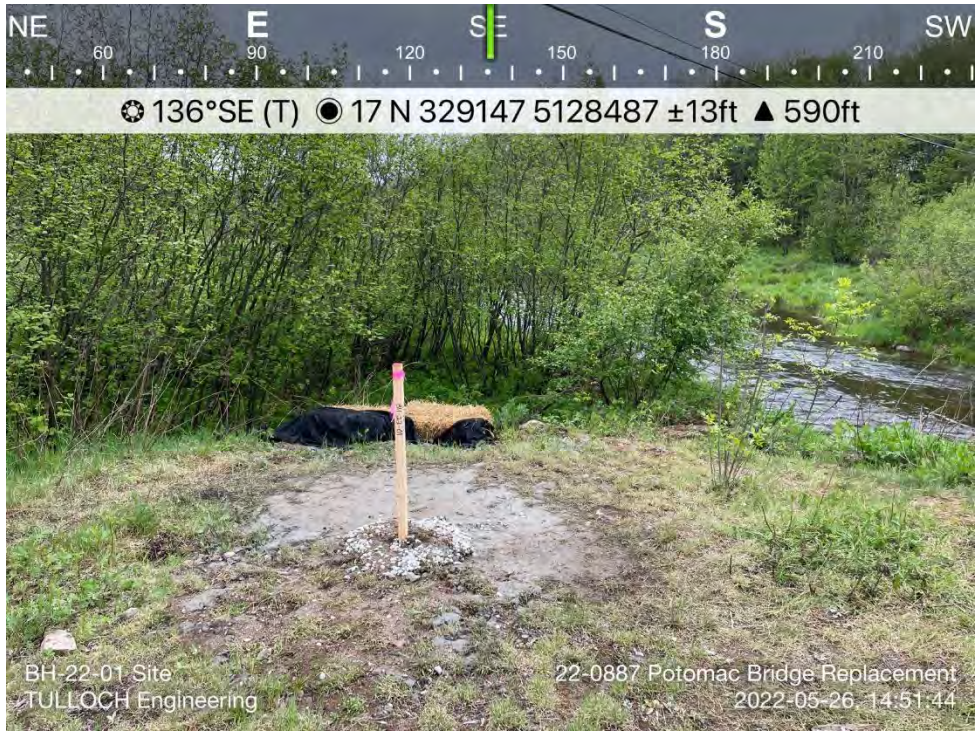
Photo 7: BH-22-01 location borehole backfilled

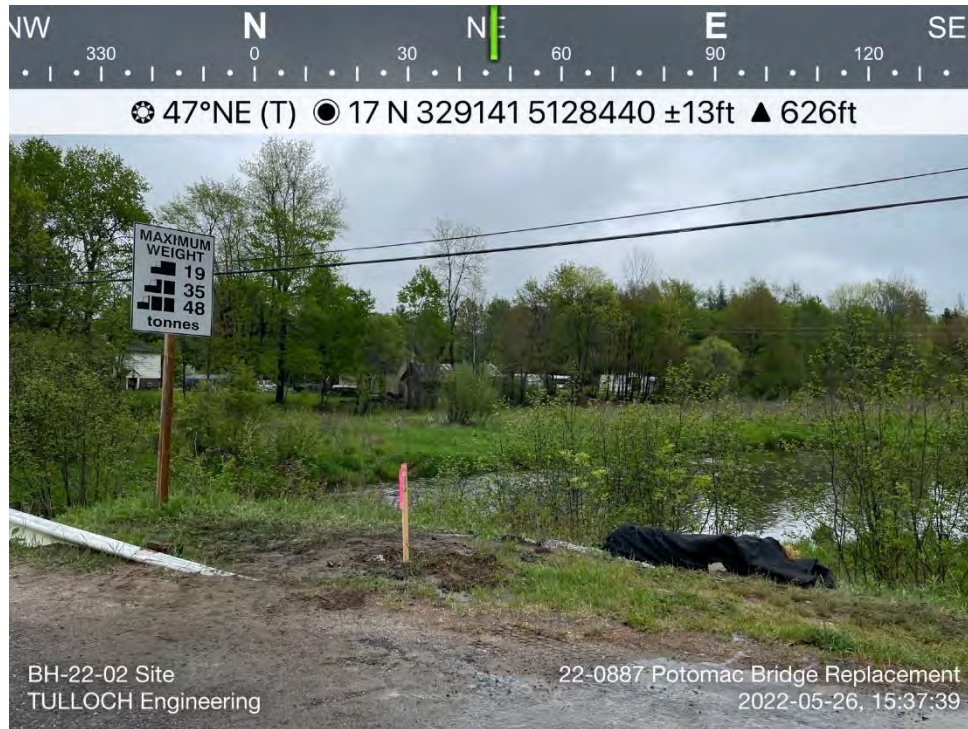
Photo 8: Completed BH-22-02 and backfilled
