**Municipality of
Huron Shores**

DEAN LAKE BRIDGE

**Load Evaluation and
Condition Assessment**

**19-1414
October 2020**

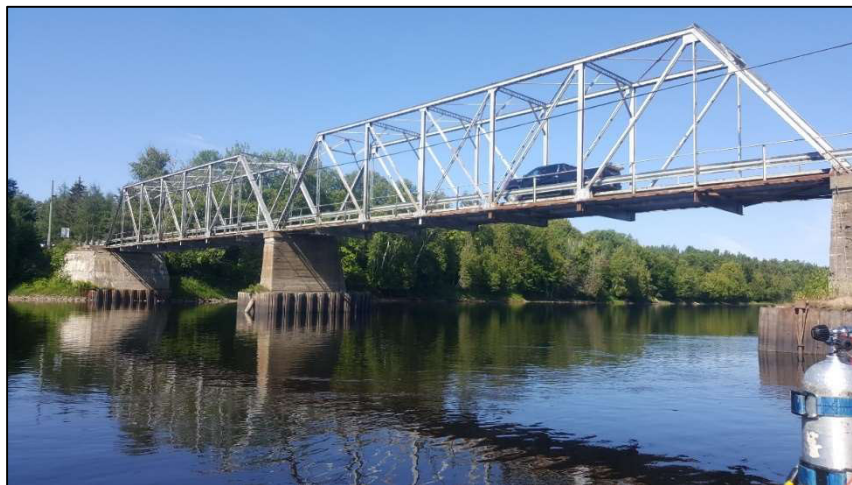
Figure 1 - Elevation of Middle and South Spans

As shown in Figure 1 below, the bridge consists of a triple span through truss bridge measuring approximately 111.0m in total length (37.0m each span). The concrete abutments and piers are severely weathered and will require extensive concrete rehabilitation in order to maintain the function of the bridge.

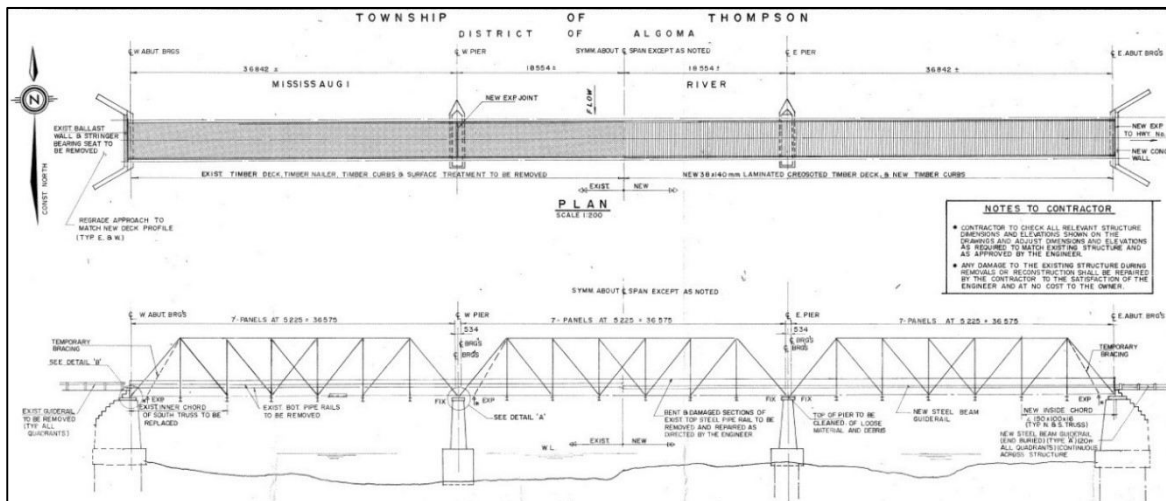
Figure 4 - Dean Lake Bridge Rehabilitation Drawing circa 1988

A drawing set provided by “Kresin Engineering & Planning” dated 1988 show the bridge had undergone a significant rehabilitation involving the replacement of; the old 3” timber creosote deck with a new 5.5” thick laminated creosote timber deck, elastomeric bearing pads, new concrete ballast walls, flex beam guiderail on wooden posts on the approaches and new flex beam guiderail on the structure, replacement/modifications to existing stringer beams and reinforcing/modifications to the gusset plates at the base of the connection nodes of specified panel points.

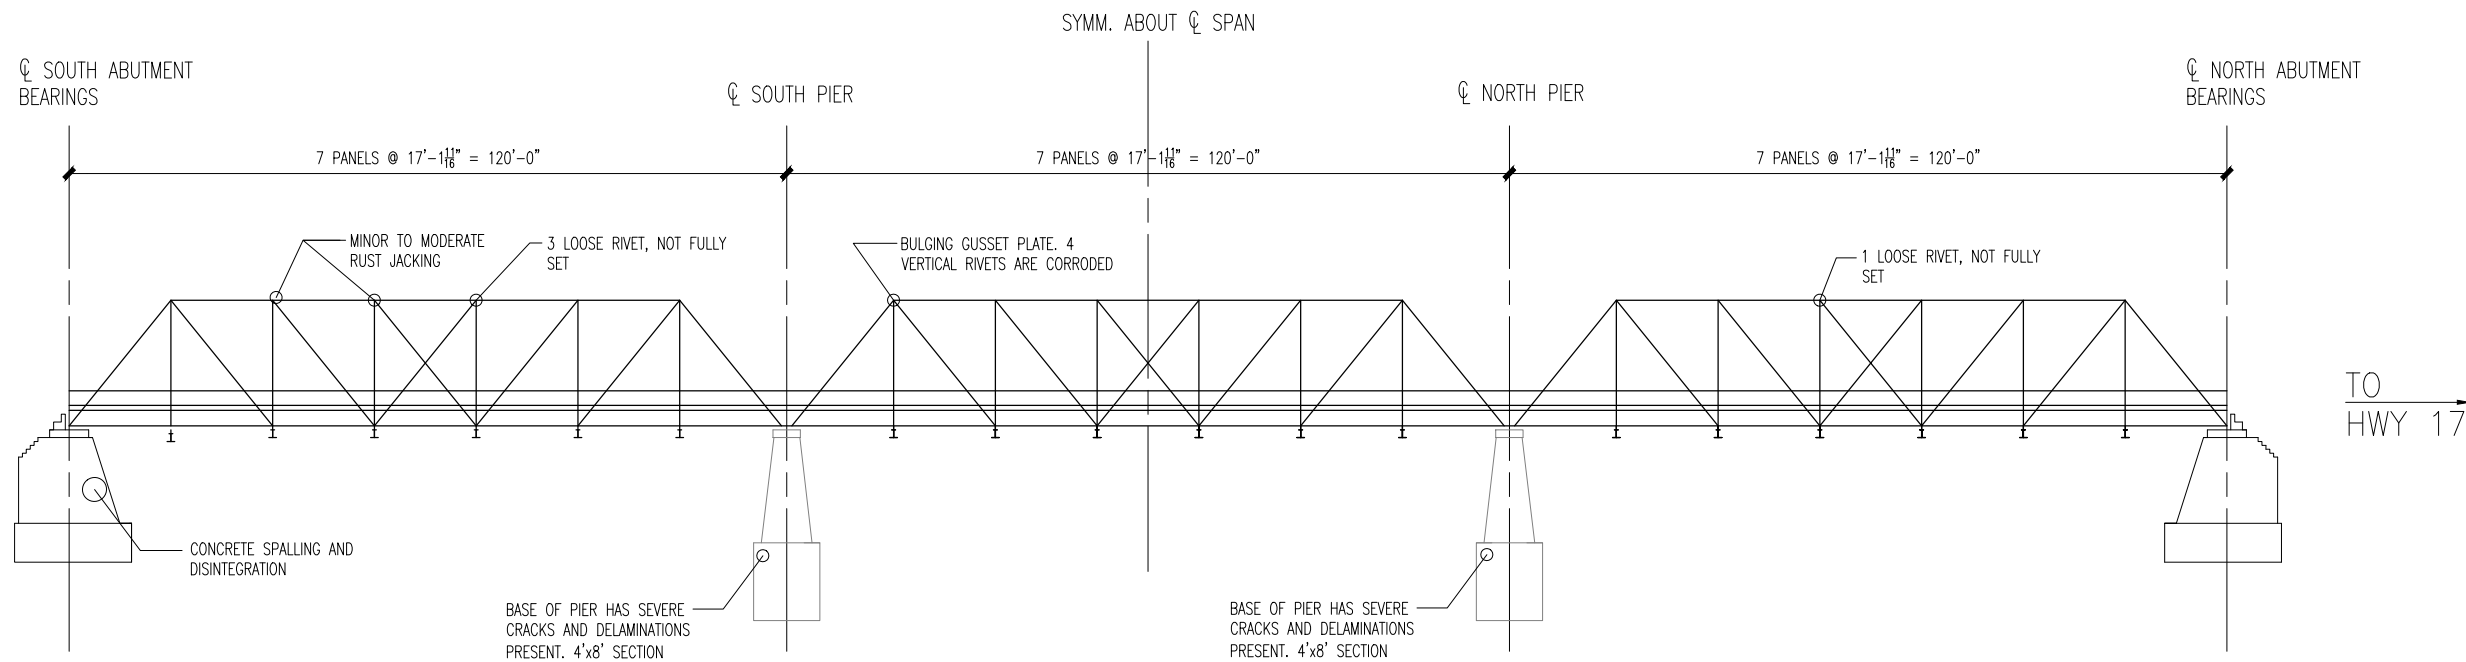
EAST ELEVATION/EAST TRUSS
SCALE 1/32"=1'-0"

NOTE: THE NORTH & SOUTH ABUTMENTS HAVE SEVERE SCALING, SPALLING, CRACKING, POP-OUTS AND EROSION PRESENT ON ALL SURFACES.

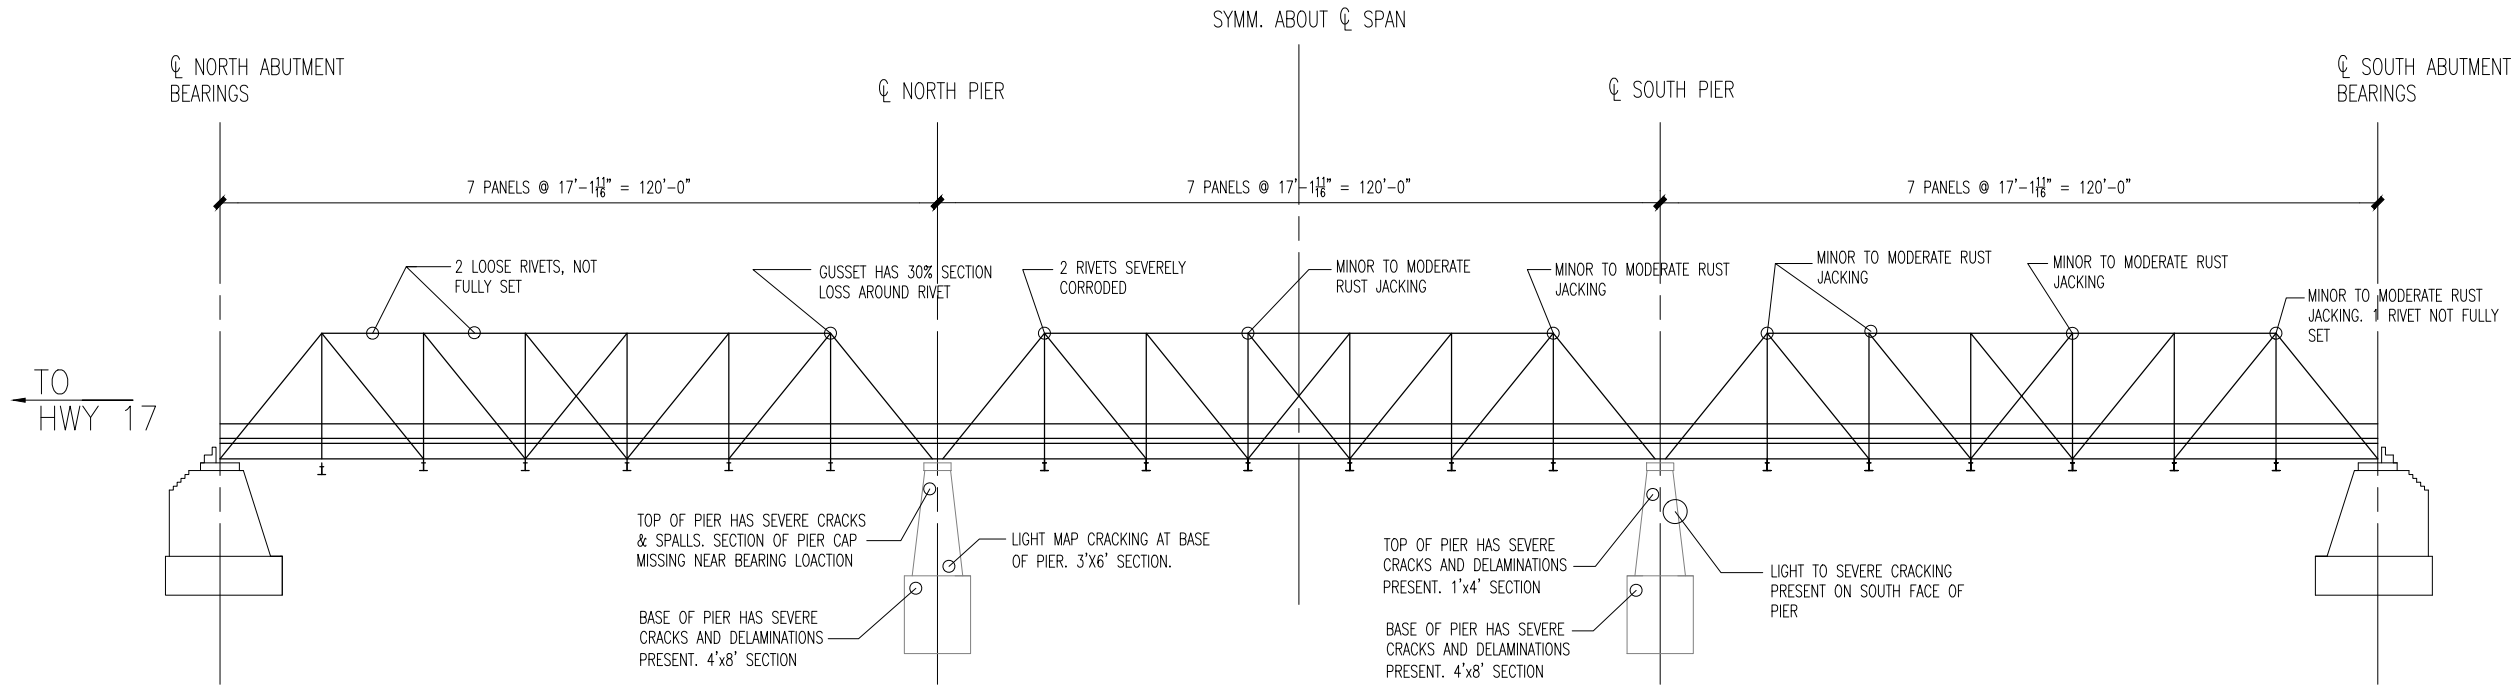
NOTE: THE NORTH & SOUTH ABUTMENTS HAVE SEVERE SCALING, SPALLING, CRACKING, POP-OUTS AND EROSION PRESENT ON ALL SURFACES.
