Structure Name	<input type="text" value="#19 Dean Lake Bridge"/>		
Main Highway #	<input type="text" value="N/A"/>	On <input checked="" type="checkbox"/> or Under <input type="checkbox"/> Structure	Service on structure: <input checked="" type="checkbox"/> Navig. Water <input type="checkbox"/> Non-Navig. Water <input type="checkbox"/> Rail <input type="checkbox"/> Road <input checked="" type="checkbox"/> Ped. <input type="checkbox"/> Other
Location description	<input type="text" value="Dean Lake Road, 100m South of Highway 17"/>	Service under	<input type="checkbox"/> Navig. Water <input type="checkbox"/> Non-Navig. Water <input type="checkbox"/> Rail <input type="checkbox"/> Road <input type="checkbox"/> Ped. <input type="checkbox"/> Other
Owner/Custodian	<input type="text" value="Municipality of Huron Shores"/>	LHRS:	<input type="text"/> LHRS offset: <input type="text"/>
MTO Region	<input type="text" value="50 - Northern"/>	Latitude:	<input type="text" value="46 14.6'"/> Longitude: <input type="text" value="83 9'"/>

Field Inspection Information:			
Date of Inspection:	2023-07-21	Type of Inspection:	<input checked="" type="checkbox"/> Reg. OSIM <input type="checkbox"/> Enh. OSIM
In

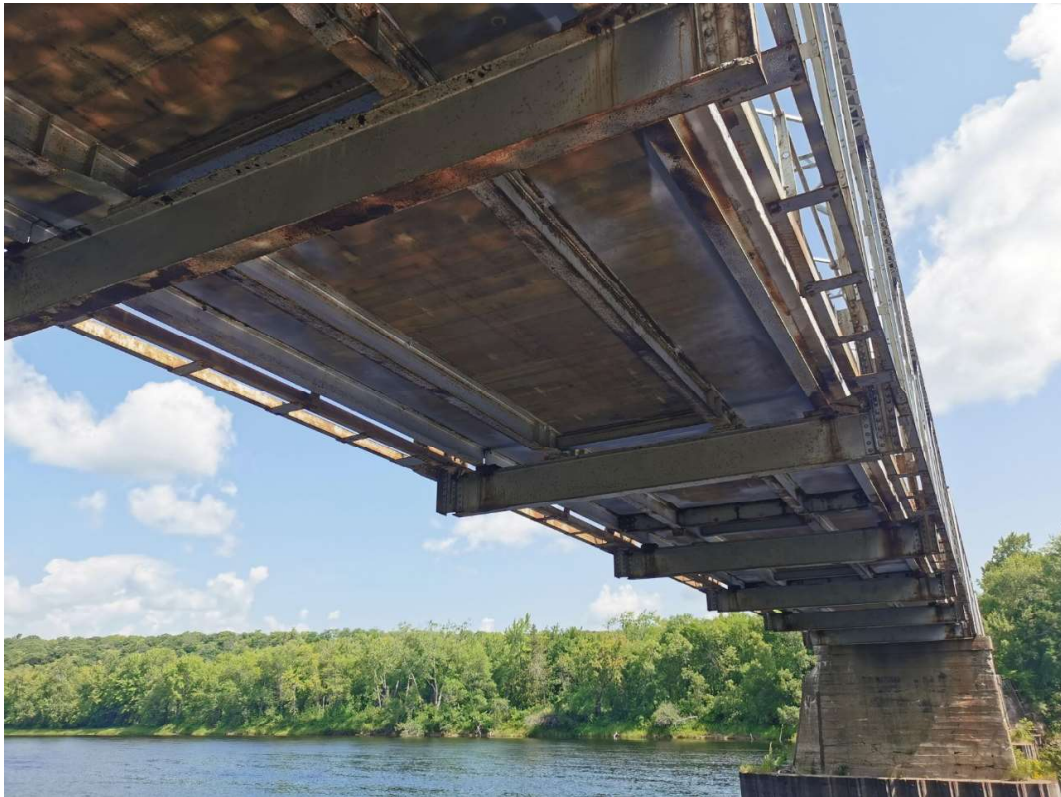
Deck Soffit General Arrangement (looking north)

36.4	36.4	36.4	00. None
Comments:						
Two most northern deck panels were found to have water residing within the panels (2019). All other panels had no traces of moisture.						
Recommended Work:			Maintenance Needs:			
<input type="checkbox"/> Rehab <input type="checkbox"/> Replace <input type="checkbox"/> 1-5 years <input type="checkbox"/> 6-10 years			01. N/A <input type="checkbox"/> Urgent <input type="checkbox"/> 1 year <input type="checkbox"/> 2 year			
None
