## Dean Lake Bridge

# Steel Coupon and Concrete Core Testing Results For Rehabilitation Planning

Municipality of Huron Shore

Dean Lake Bridge, Iron Bridge, ON

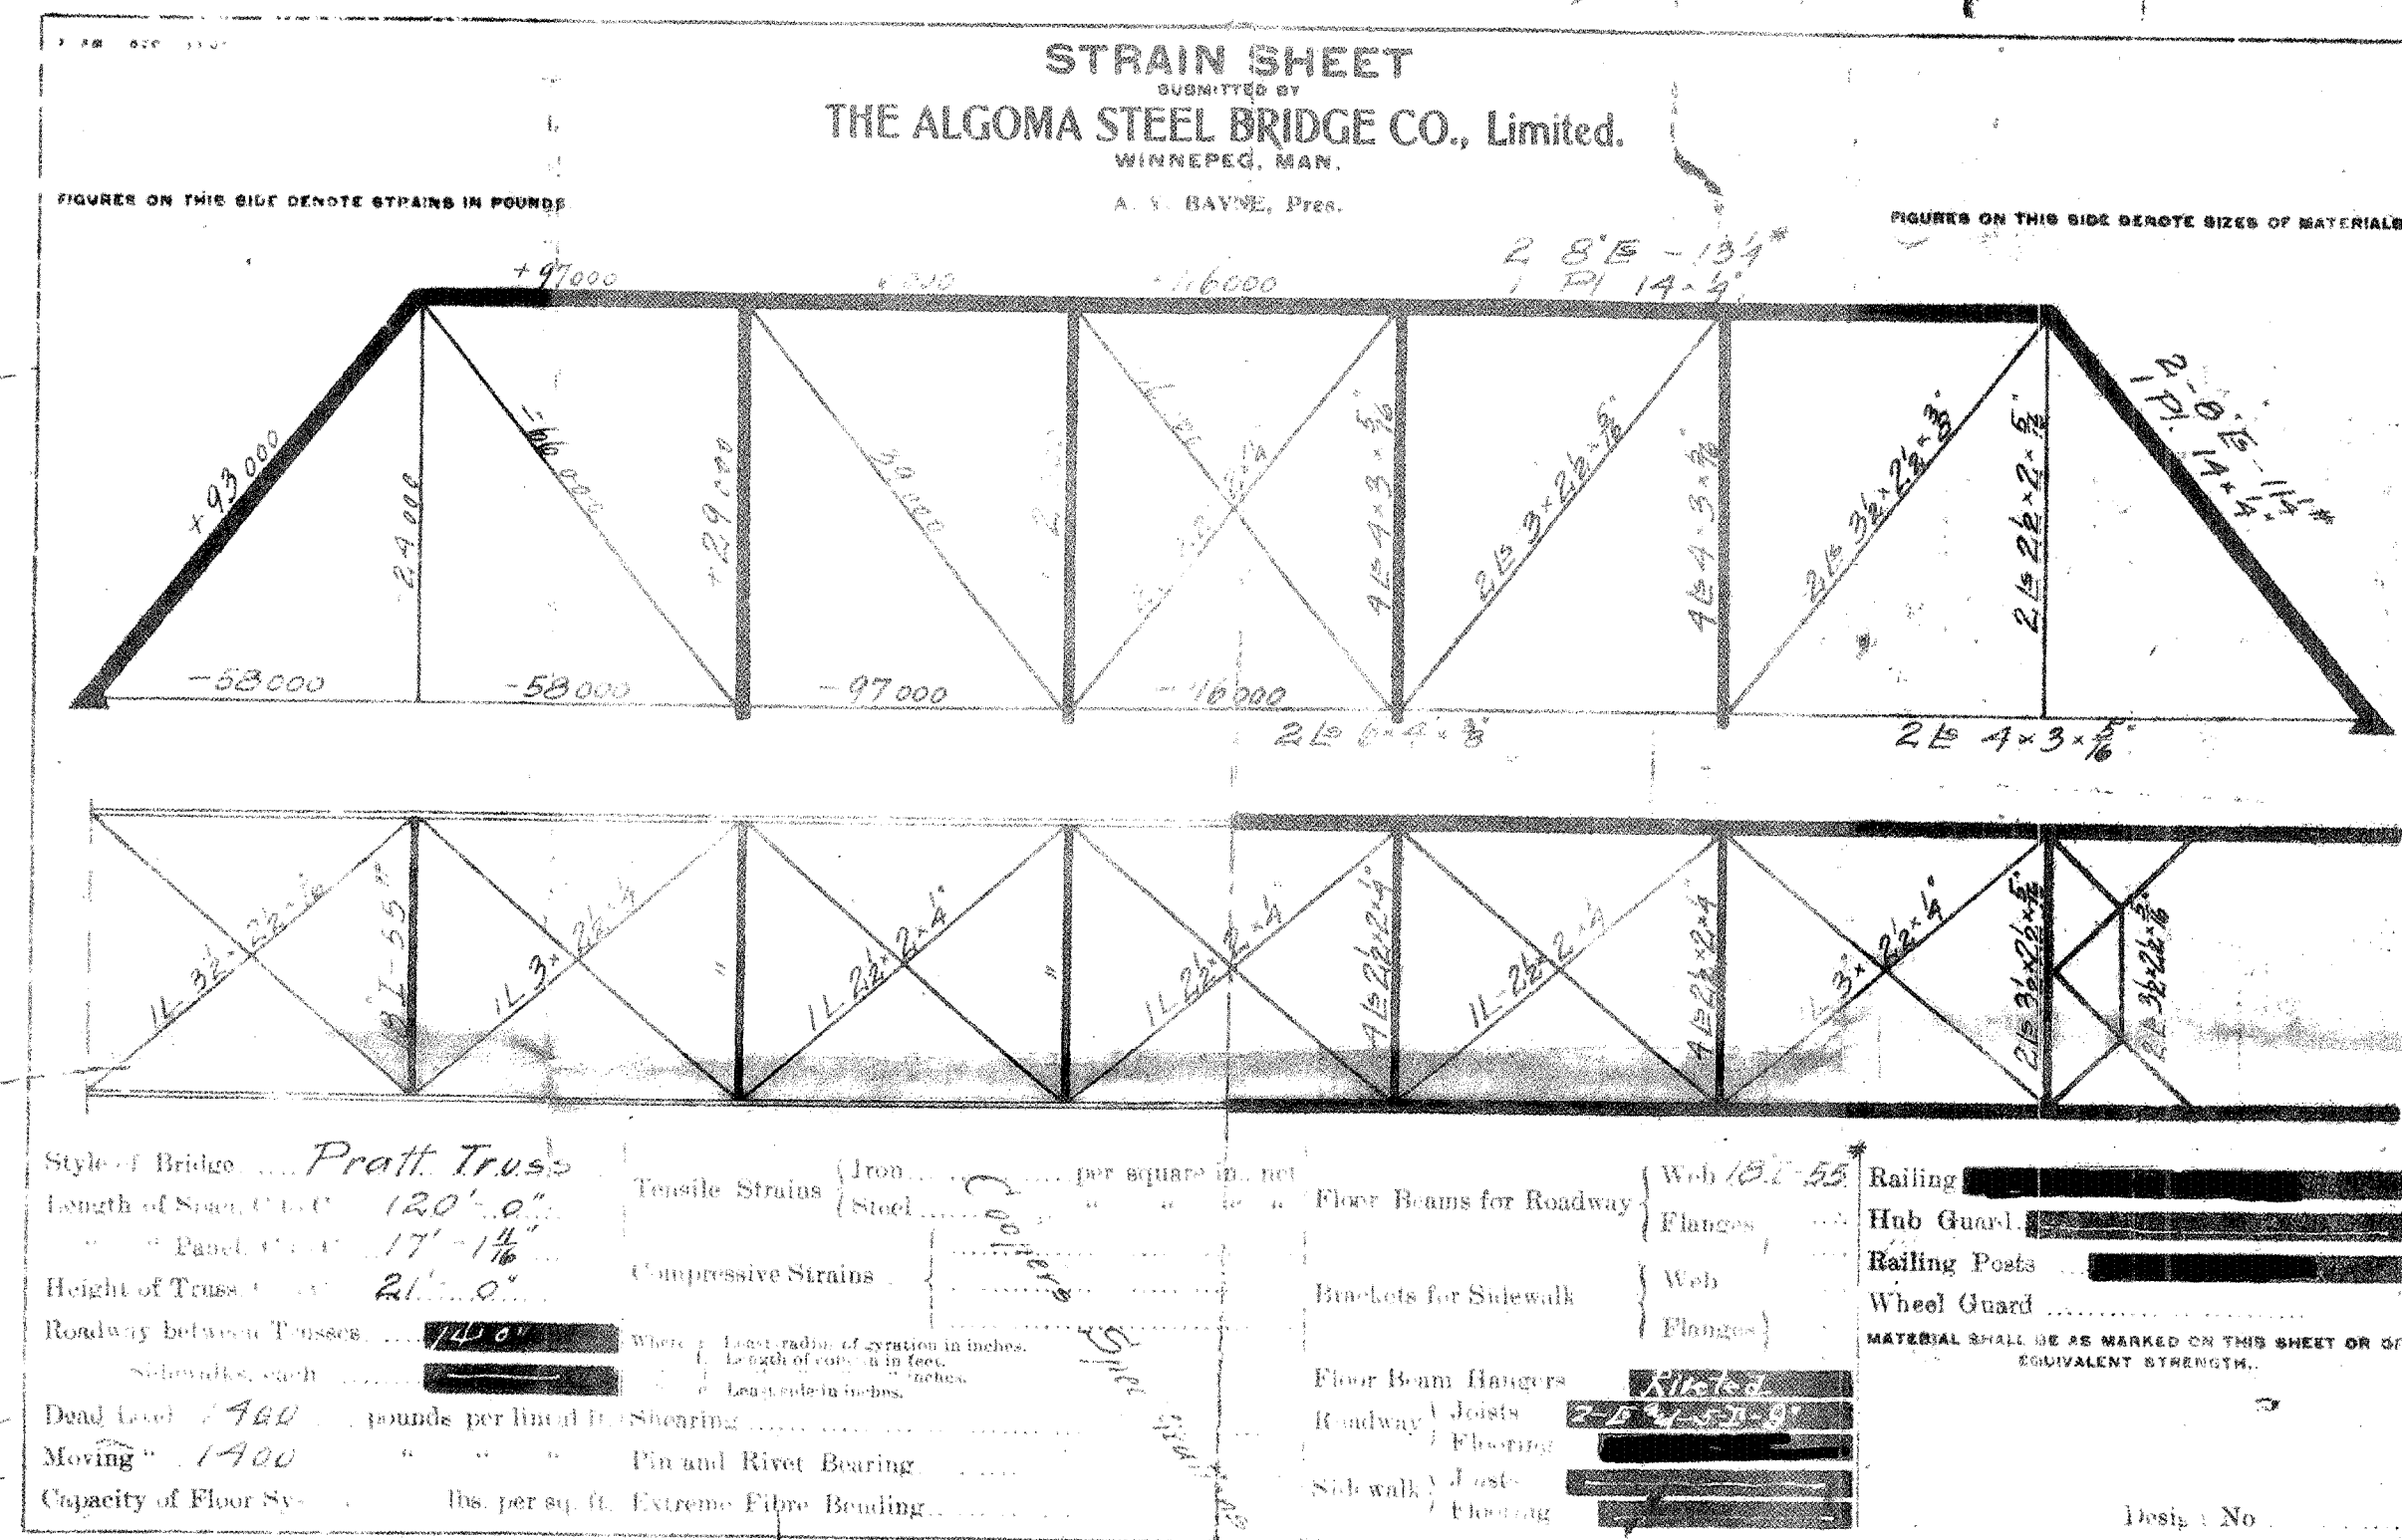
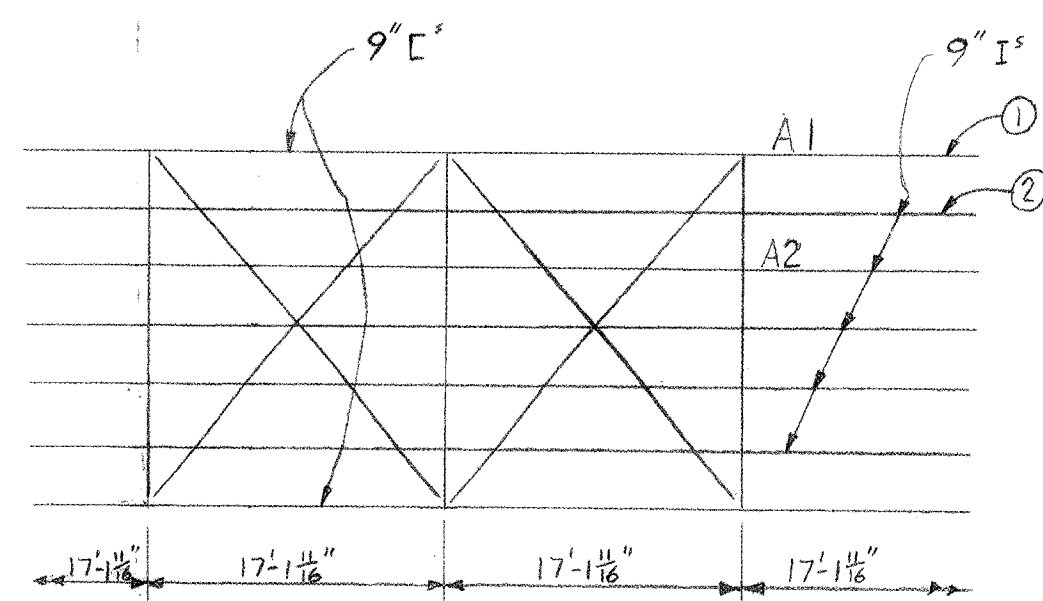
ELEVATION AND PLAN OF ONE TRUSS N.T.S.

- 1/ THE PLANS ARE FOR GUIDANCE ONLY AND DO NOT NECESSARILY REPRESENT EXISTING CONDITIONS AND DIMENSIONS.
- 2/ THE STRUCTURE CONSISTS OF 3 EQUAL SPANS, OF WHICH ONE IS SHOWN ON THIS PLAN.
- 3/ REMOVE EXISTING TIMBER DECK AND REPLACE WITH NEW 3" CREOSOTED TIMBER DECK.
- 4/ SANDBLAST AND REPAINT ALL STRUCTURAL STEEL.
- 5/ REPAIRS TO CONCRETE NOT SHOWN. REPAIRS TO CONCRETE SHOULD BE CARRIED OUT AS DIRECTED BY THE ENGINEER.

- ① REPLACE 'A1' WITH NEW 8" C'S WHERE NECESSARY, EQUIVALENT OR BETTER THAN THE EXISTING 9" C'S, AS DIRECTED BY THE ENGINEER. NEW C'S HAVE TO BE BROUGHT UP TO THE TOP ELEVATION OF THE EXISTING C'S WITH SHIM PLATES ETC.
- ② REPLACE 'A2' WITH NEW 8" I'S OR 8" W'S WHERE NECESSARY, EQUIVALENT OR BETTER THAN THE EXISTING 9" I'S, AS DIRECTED BY THE ENGINEER. NEW I'S (OR W'S) HAVE TO BE BROUGHT UP TO THE TOP ELEVATION OF THE EXISTING I'S WITH SHIM PLATES ETC.

- Circa 1963: there was a drawing package which outlined that the 9" deep I-beam interior stringers and the 9" deep channel external stringers were replaced with 8" W-beams and 8" channels respectively. There was to be a new 75mm (3") creosote coated timber deck installed with new wooden curb. This outlines that there were some minor dimensional (height) changes completed to the floor framing/stringers but the elevation makeup would be eliminated with steel shim plates as required. All bridge steel was to be sandblasted and re-painted.

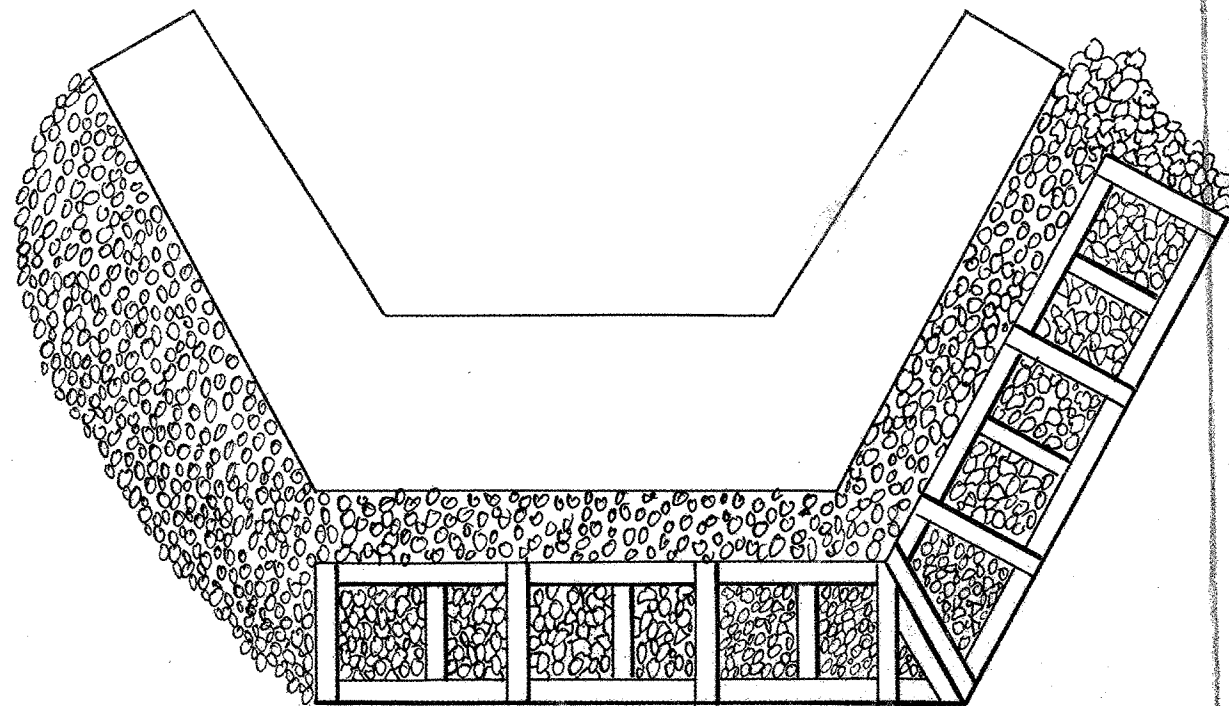
PLAN OF PIER SHEWING CRIB & RIP RAP

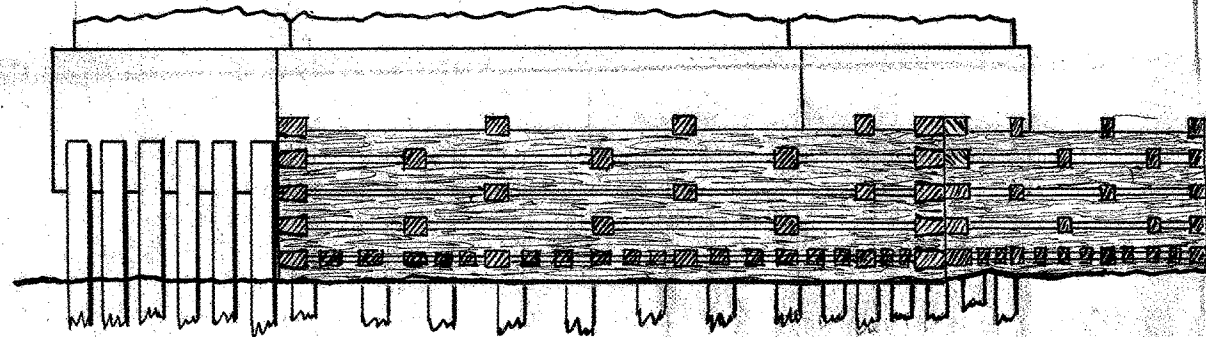
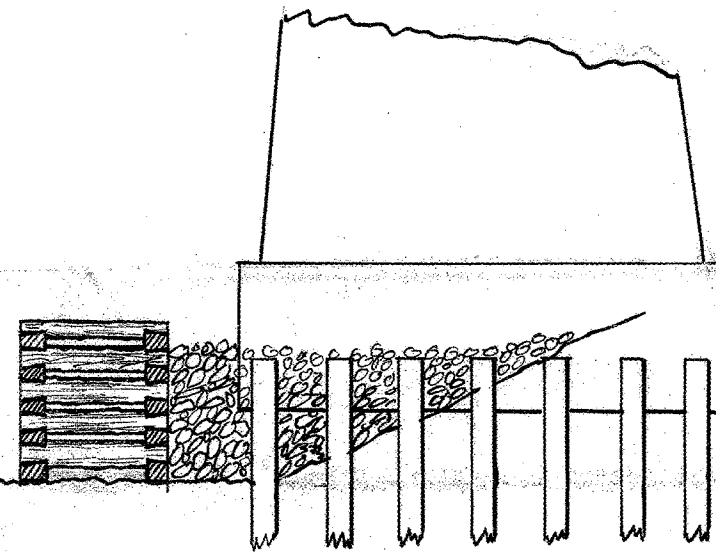
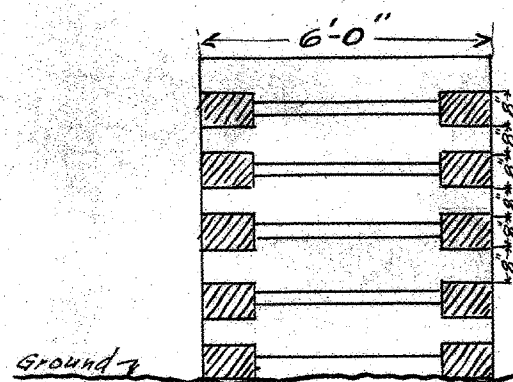
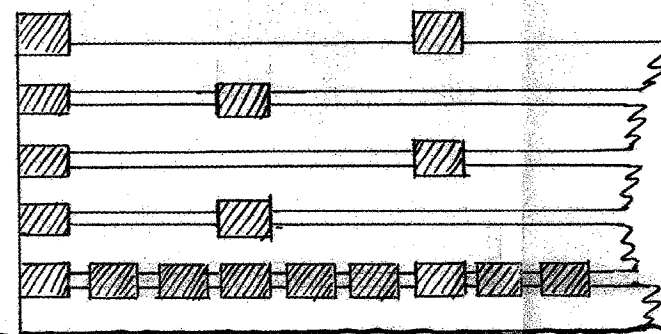
DETAIL OF CRIB WORK  
1/4 IN. SCALE

ELEVATION

END VIEW

FRONT ELEVATION

- Circa 1915: there is some undermining issues on the north abutment. A drawing by the Ontario Public Works at the time illustrated the repair. This drawing outlined a false cribbing work to be installed outboard of the existing abutment face. The purpose was to protect the foundation from scour and undermining, and to protect and in-fill the undermining that had already occurred since the bridge opened.

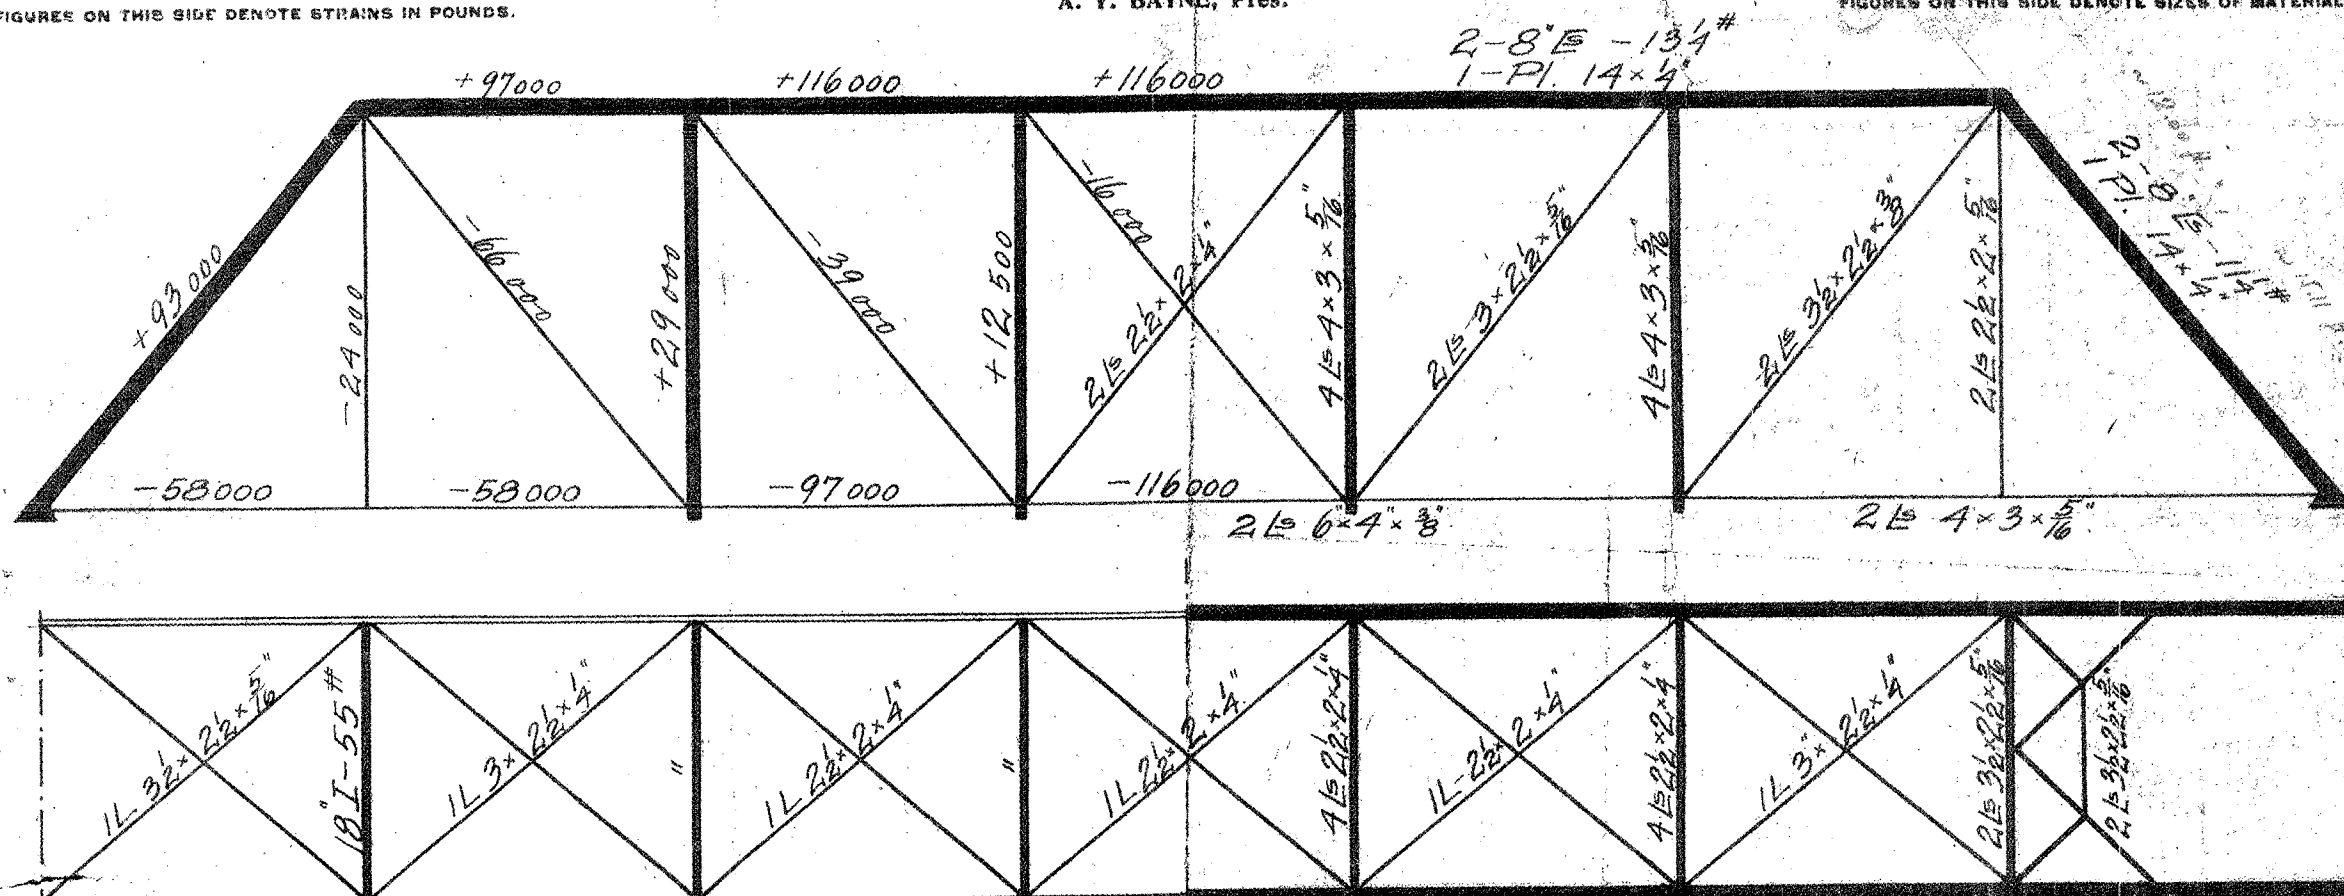
Style of Bridge..... *Pratt Truss*  
 Length of Span, C to C..... *120'-0"*  
 " " Panel, C to C..... *17'-1 1/16"*  
 Height of Truss, C to C..... *21'-0"*  
 Roadway between Trusses..... *14'-0"*  
 Sidewalks, each.....  
 Dead Load..... *1,400* pounds per lineal ft.  
 Moving "..... *1,400* " " "  
 Capacity of Floor System..... lbs. per sq. ft.

Railing..... *3 Lines 1 1/2" x 1/2" x 1/2" pipe*  
 Hub Guard.....  
 Railing Posts..... *3 1/2 x 3 1/2 x 9/16" L*  
 Wheel Guard.....  
 MATERIAL SHALL BE AS MARKED ON THIS SHEET OR OF  
 EQUIVALENT STRENGTH.

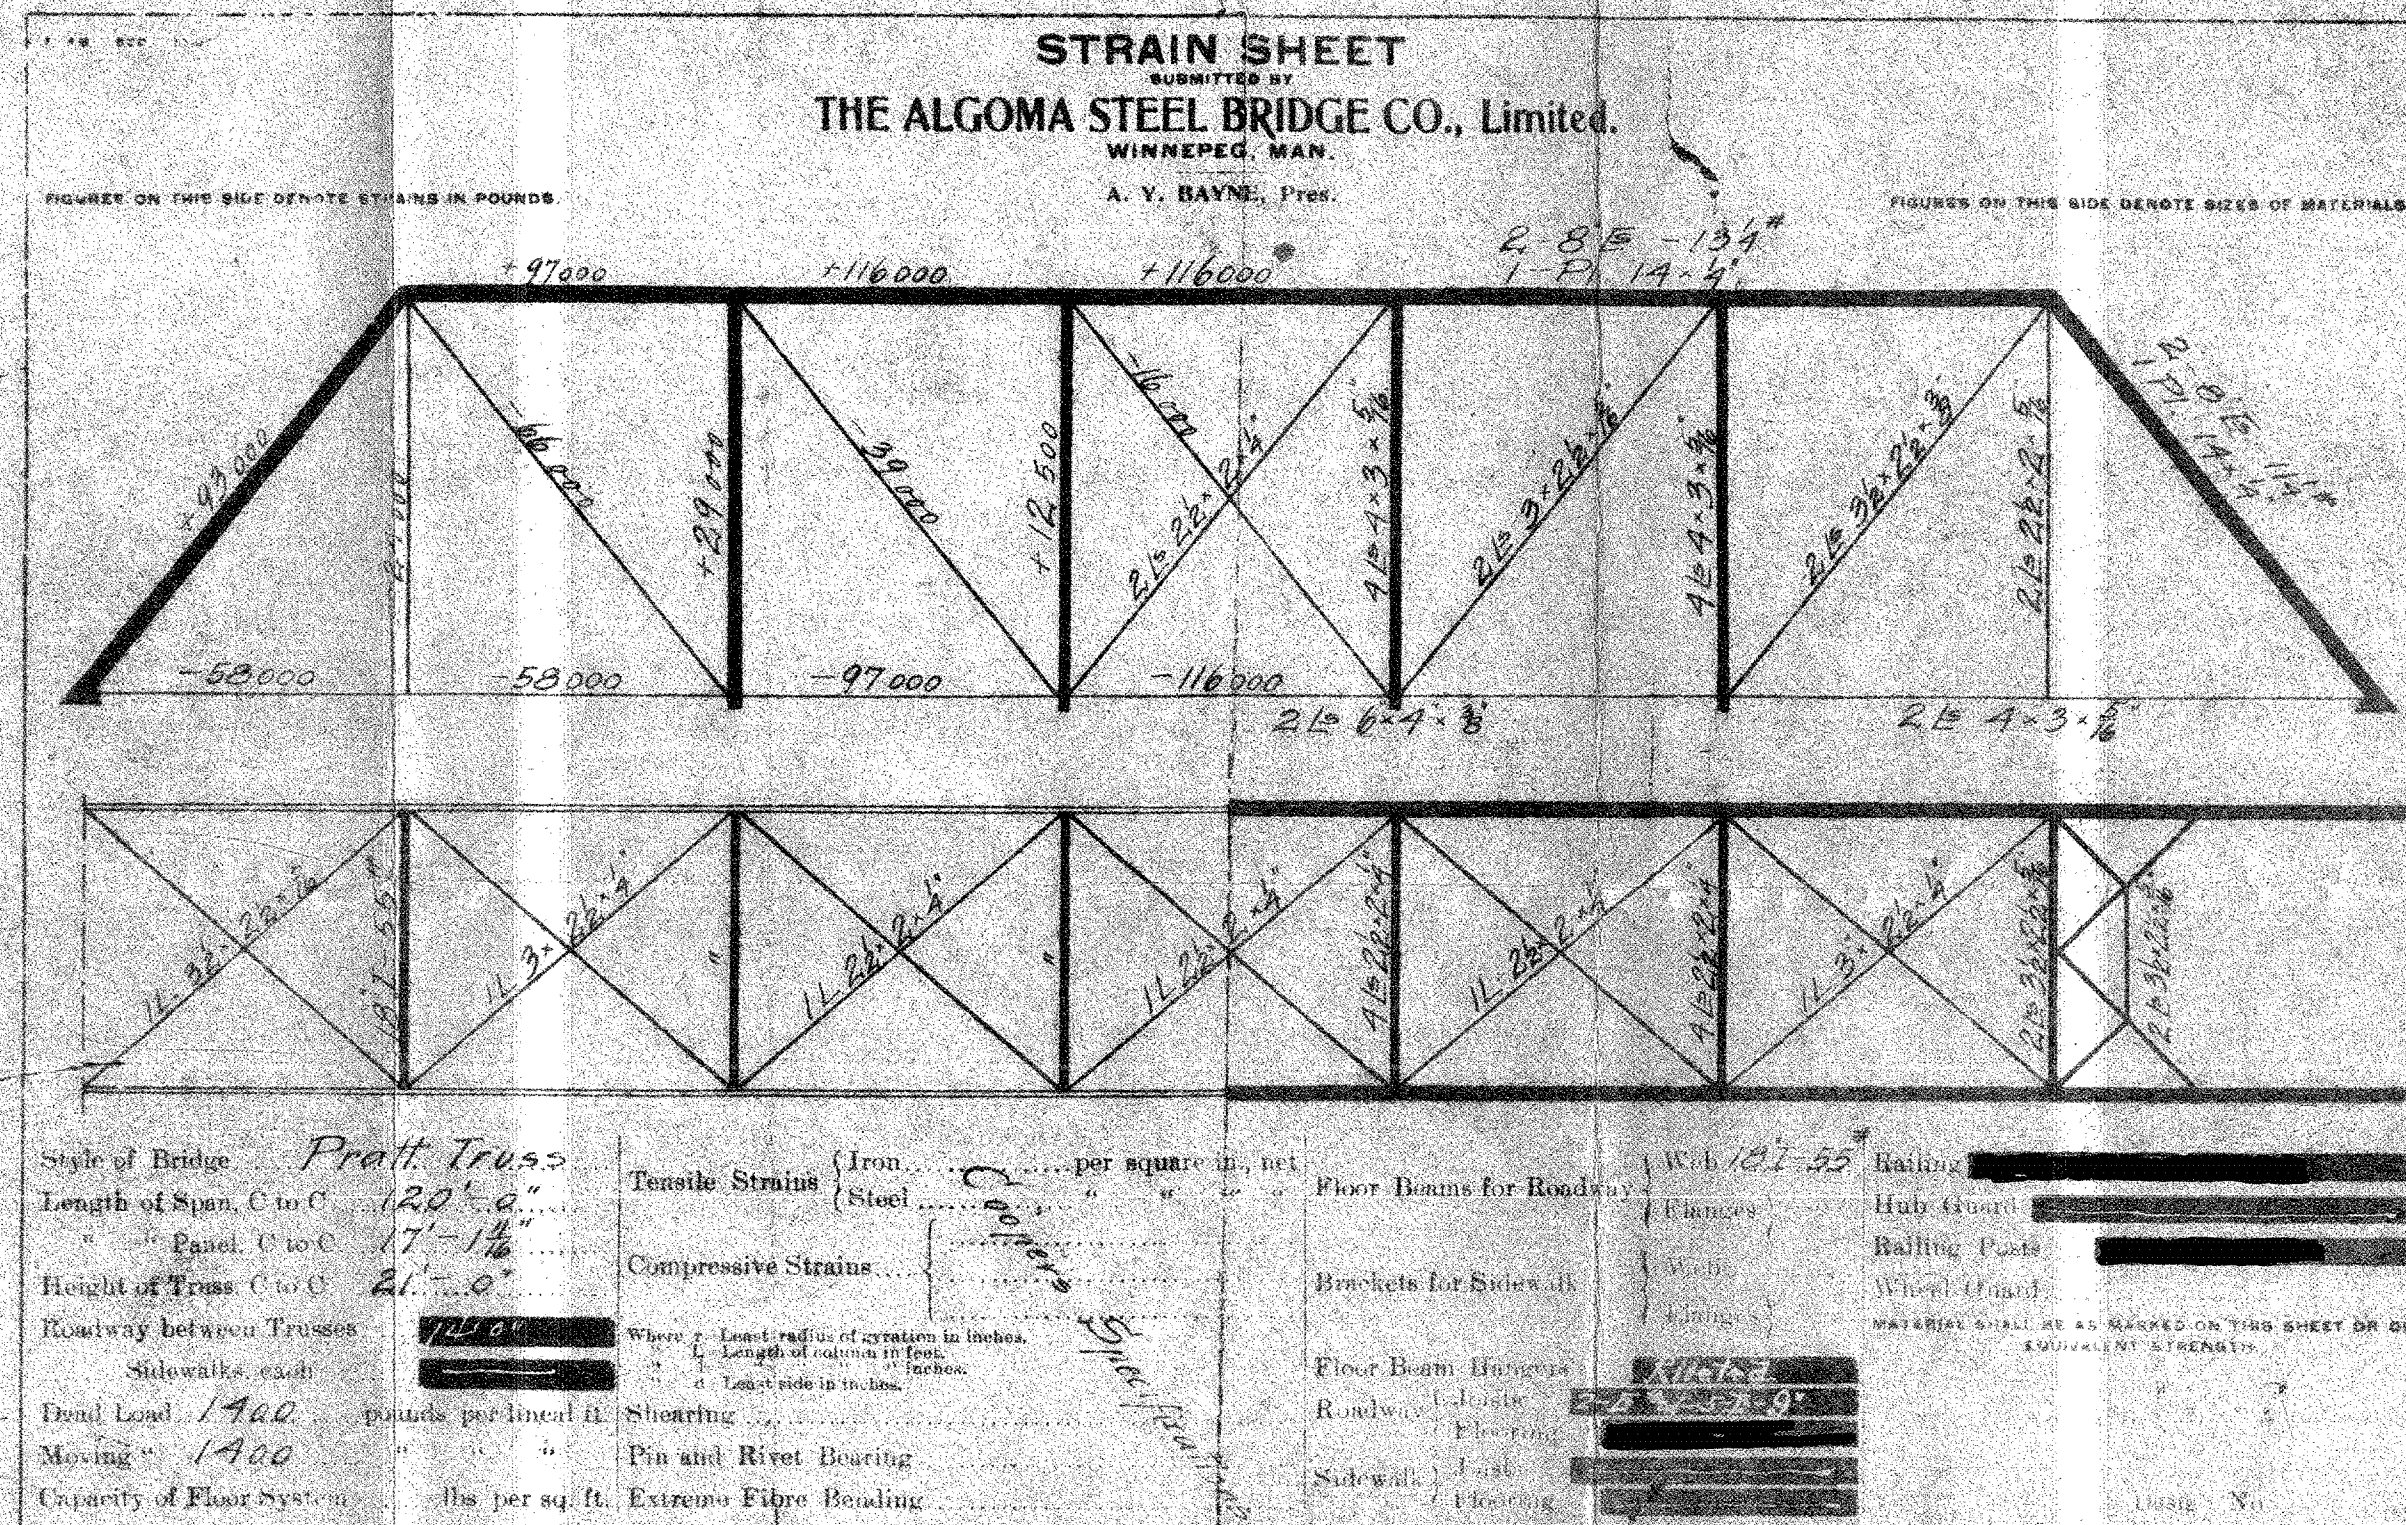
ELEVATION AND PLAN OF ONE TRUSS N.T.S.

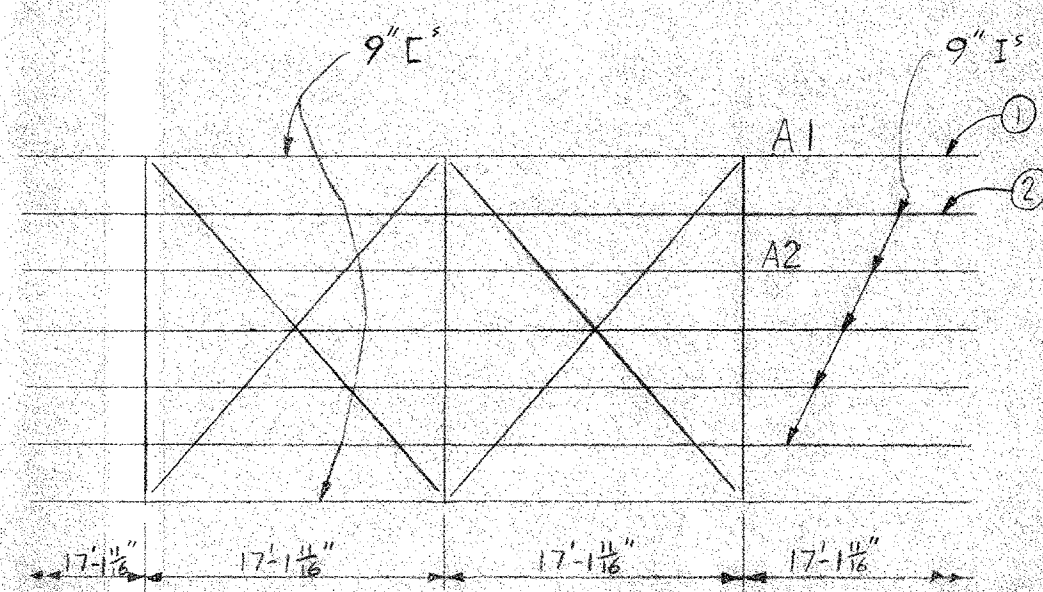
DETAIL OF FLOOR SYSTEM N.T.S.

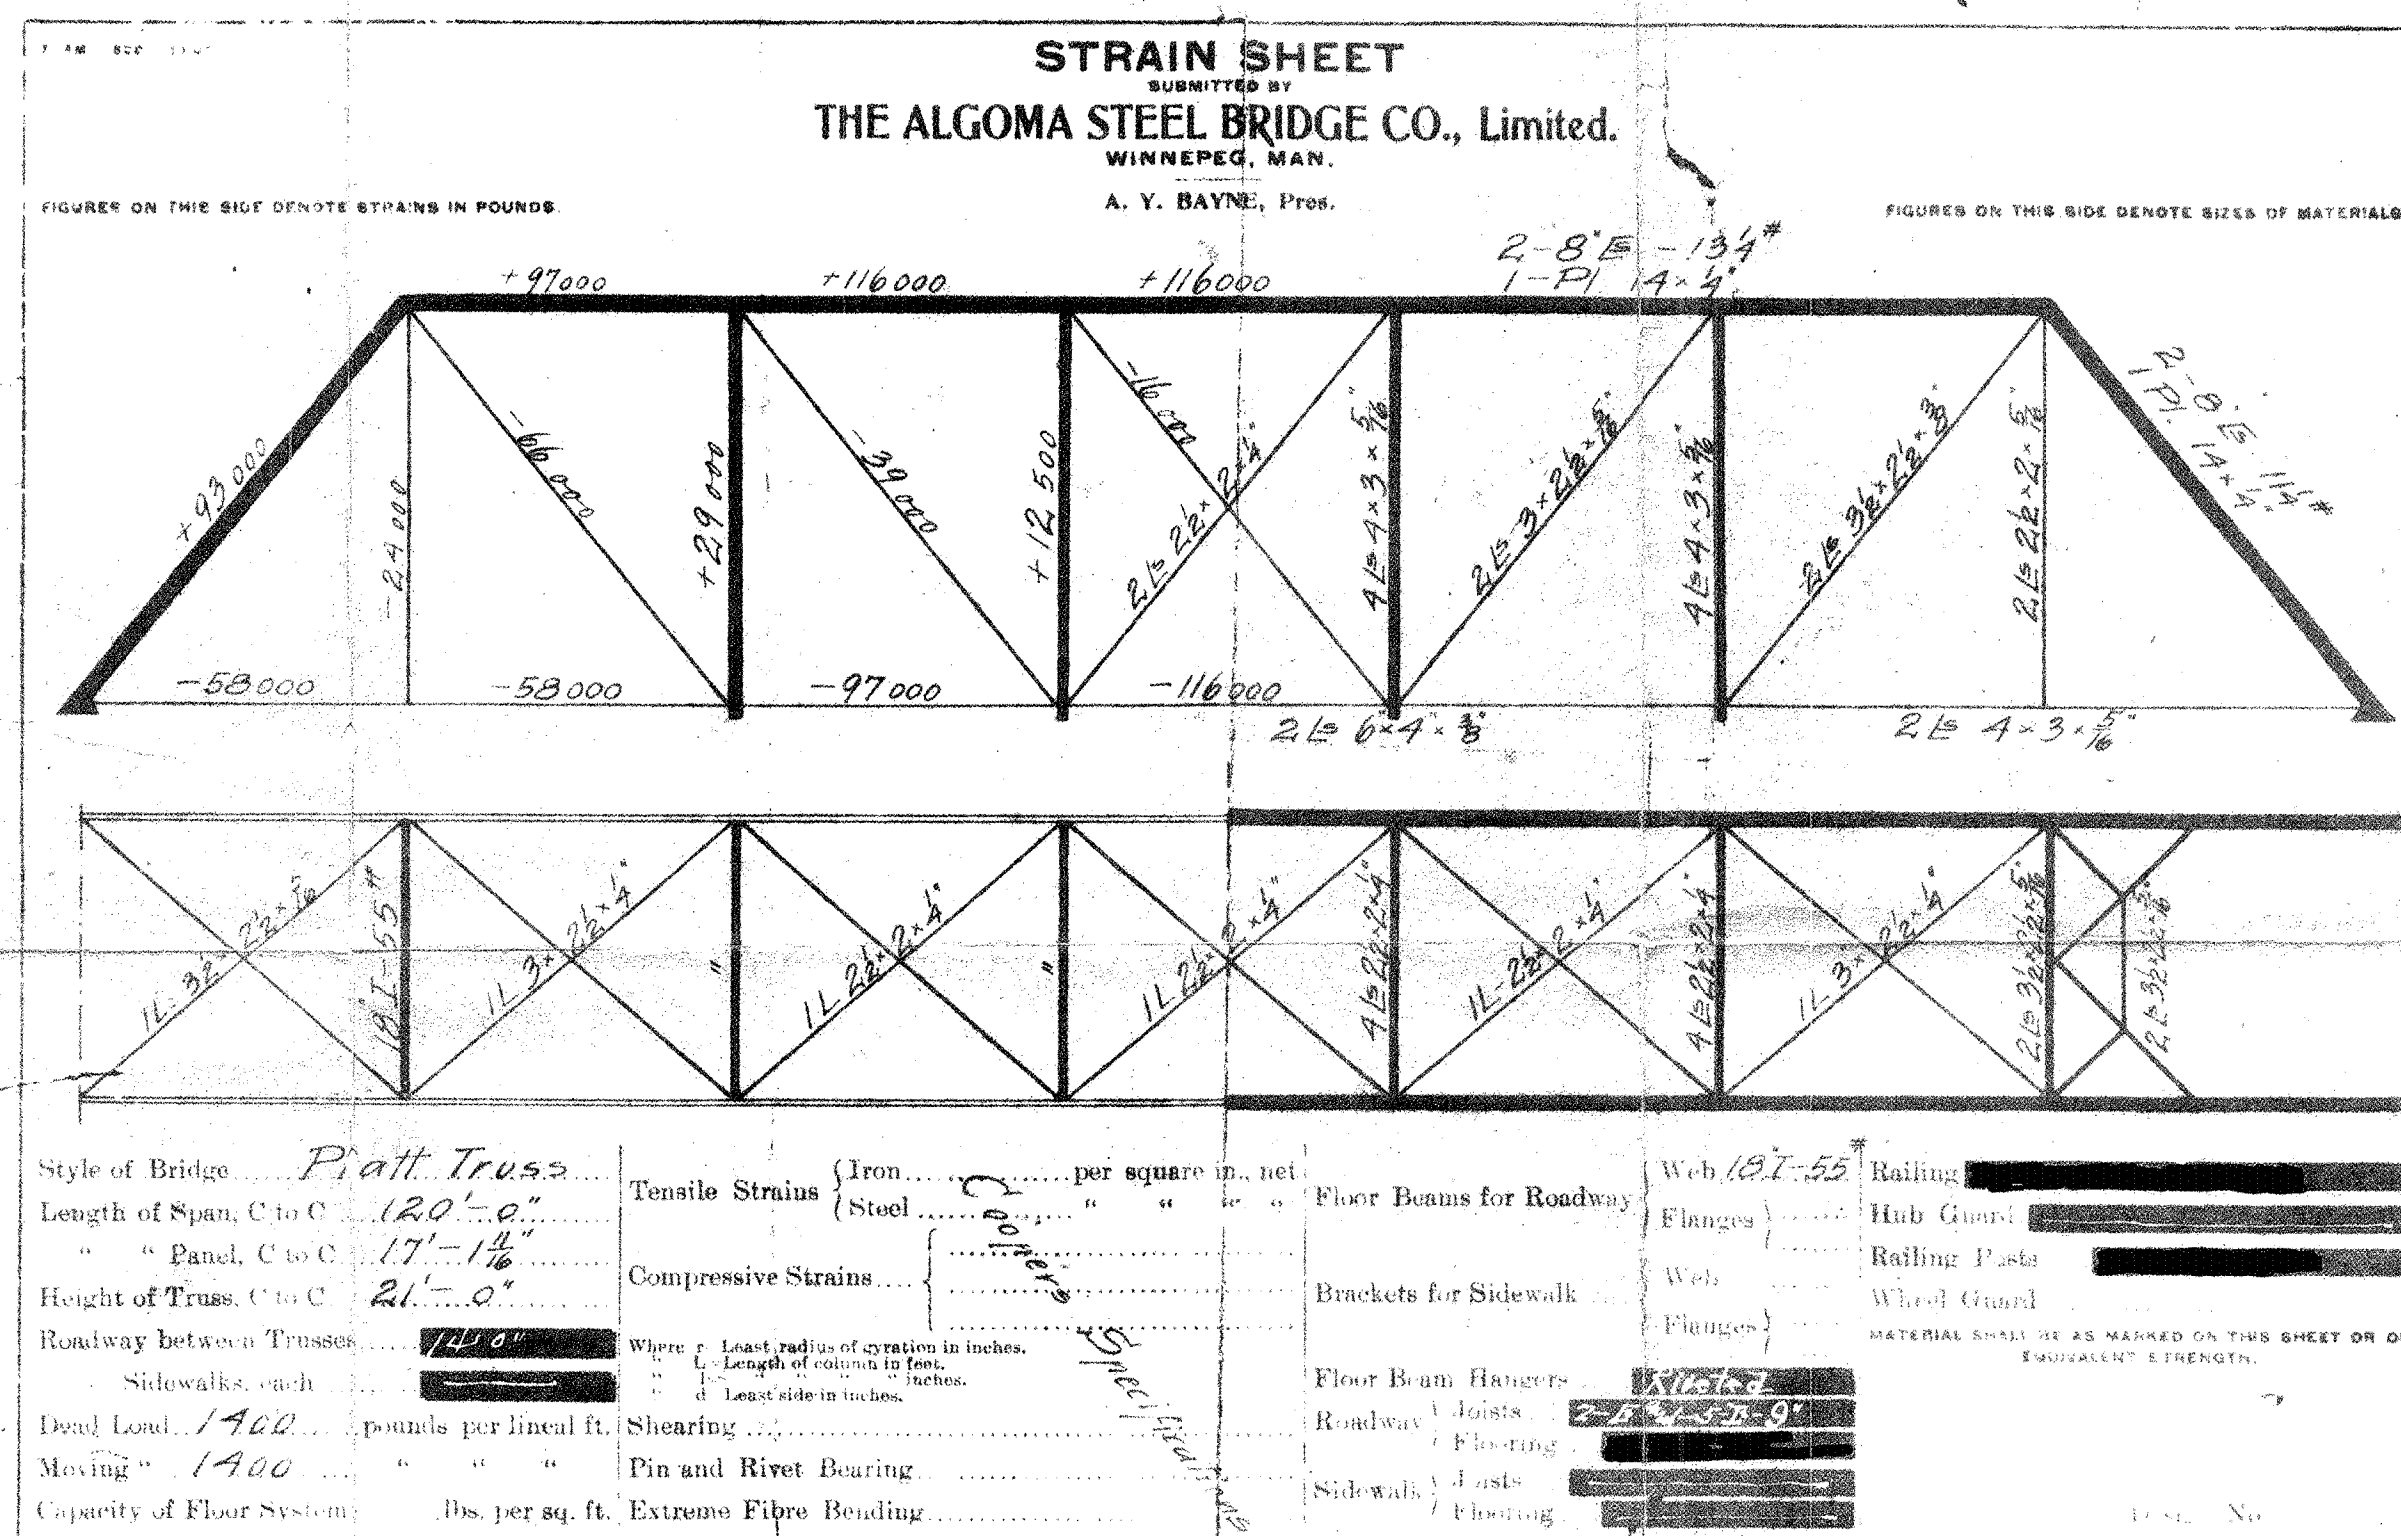
ELEVATION AND PLAN OF ONE TRUSS N.T.S.

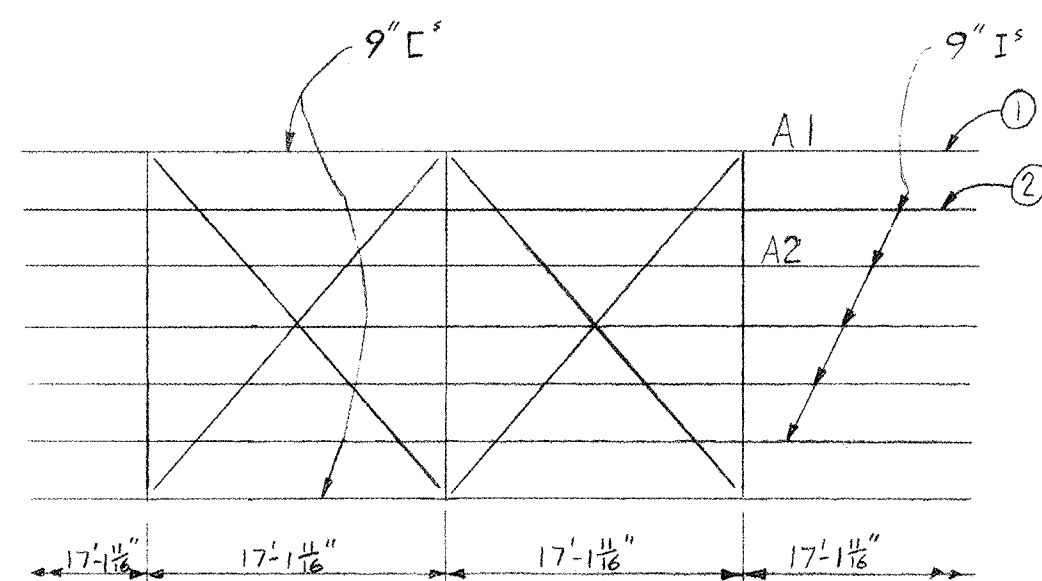
DETAIL OF FLOOR SYSTEM N.T.S.

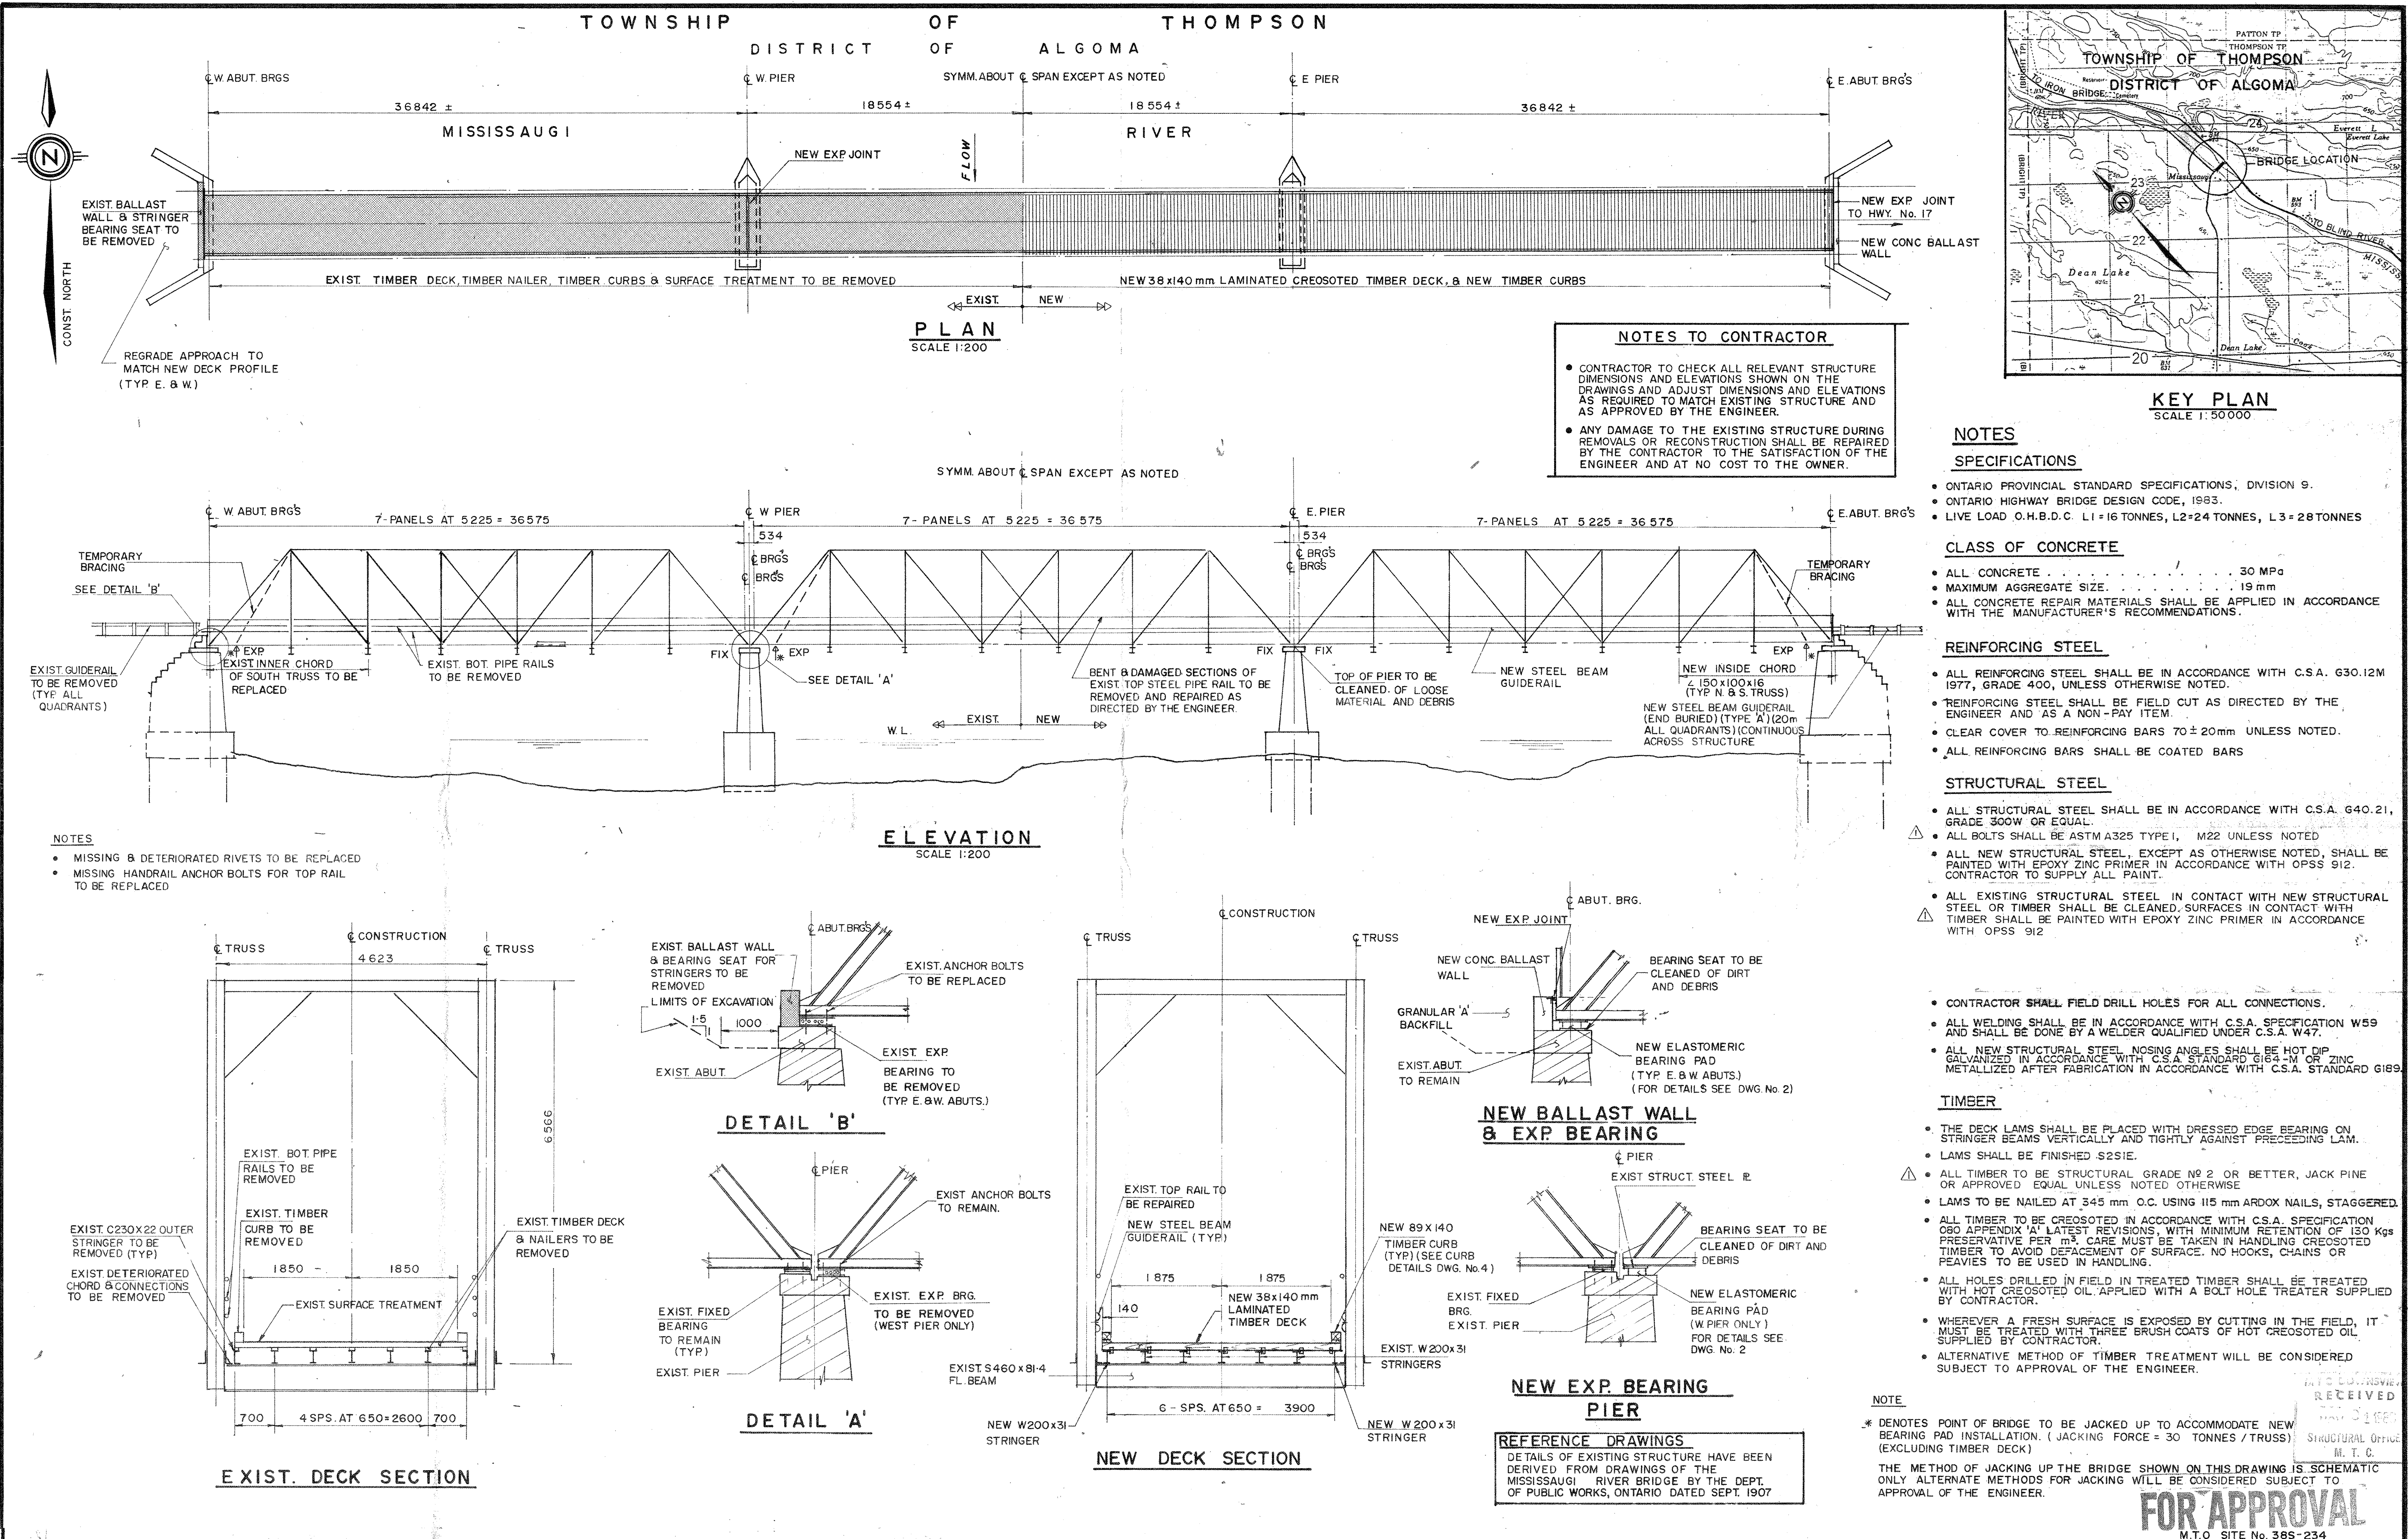
**GENERAL ARRANGEMENT**

- Circa 1988: Kresin Engineering provided repair drawings that outlined the existing timber deck including the surface treatment was to be removed and replaced with another transverse nail laminated timber deck and new timber curb. The new timber decking was called out to be a 38mm x140mm laminated creosote timber deck. It should be noted that the original seven (7) stringer beams were shown spaced equally across the width of the decking. A loading note on these drawings indicated that the bridge was to remain posted with a 16 / 24 / 28 tonne load posting as per the Ontario Highway Bridge Design Code 1983. In addition to the decking replacement, the drawings also showed the following repairs:

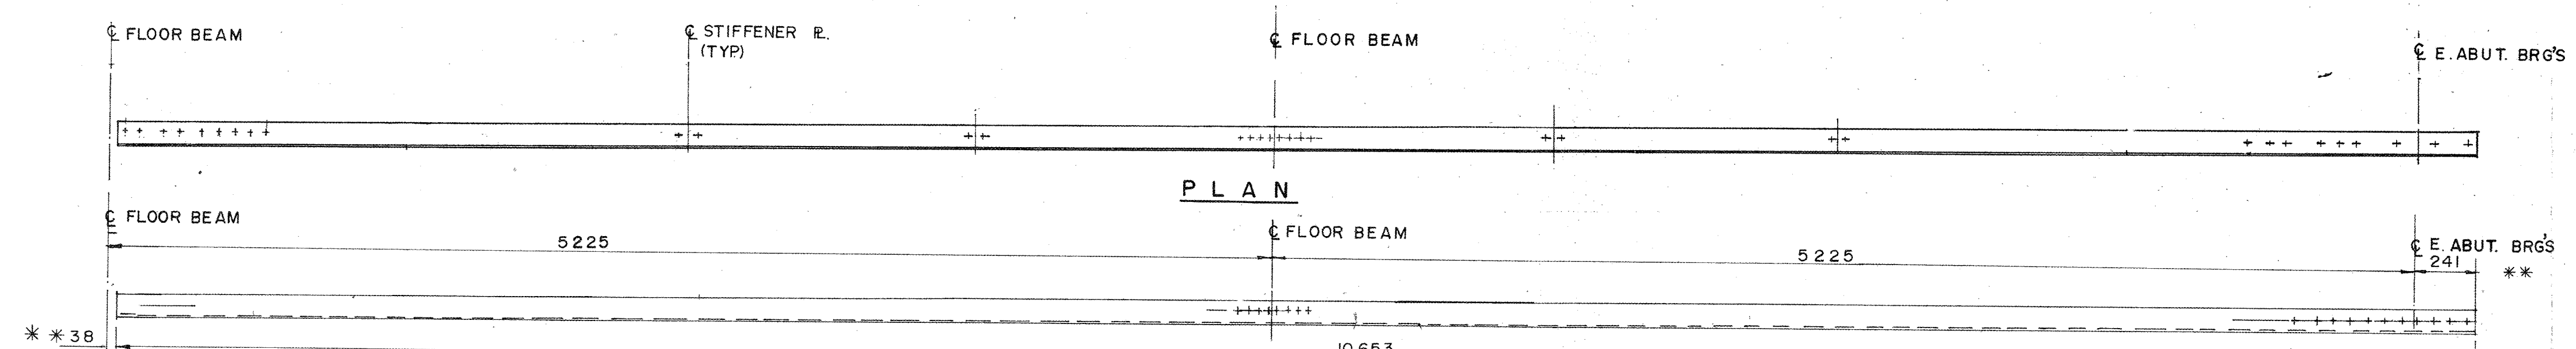
**150x100x16 BOT. CHORD DETAILS**

- The exterior channel stringers were removed and replaced with new W200x31 steel stringers. The inner bottom chord of the trusses at the north end and south ends of the bridge were partially replaced.
