## Dean Lake Bridge

# Steel Coupon and Concrete Core Testing Results For Rehabilitation Planning

Municipality of Huron Shore

Dean Lake Bridge, Iron Bridge, ON

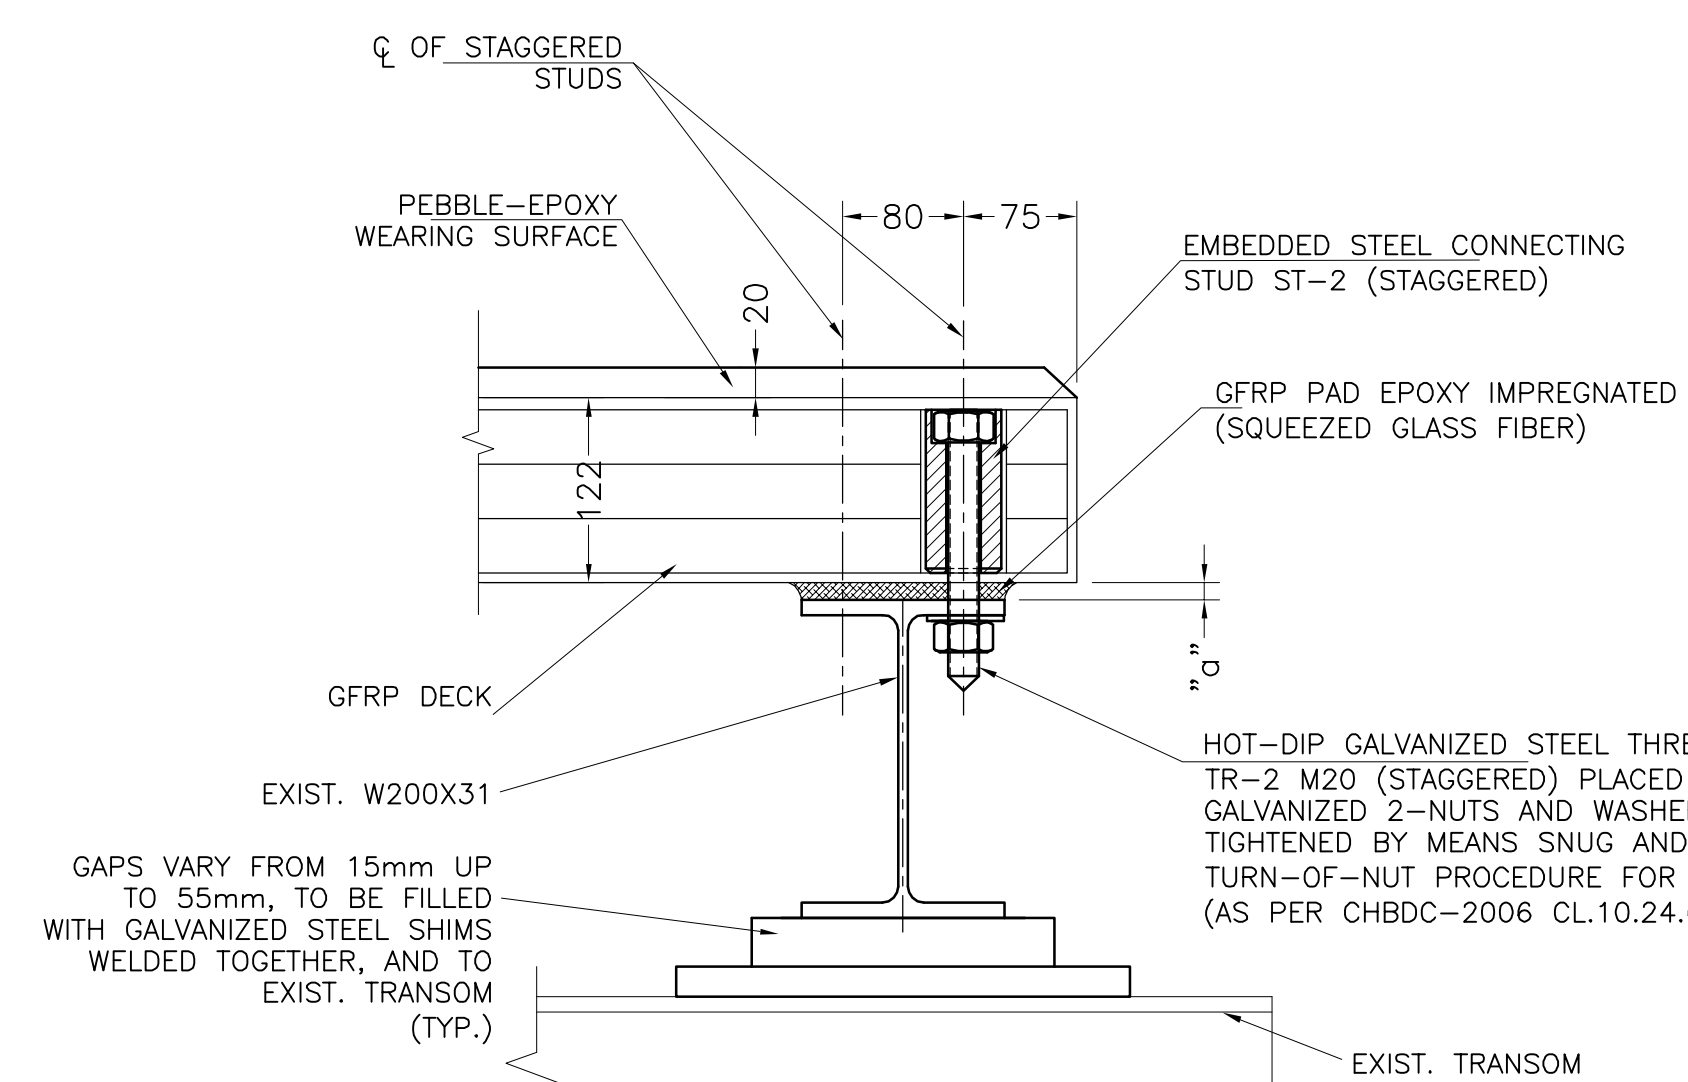
DETAIL 1  
DETAIL OF CONNECTION PANEL  
TO EXIST. BEAM W200X31  
NTS

NOTES:  
ALL IN-DECK EMBEDDED ELEMENTS TO BE  
"WHITE SANDBLASTED"  
"a" - VARIABLE

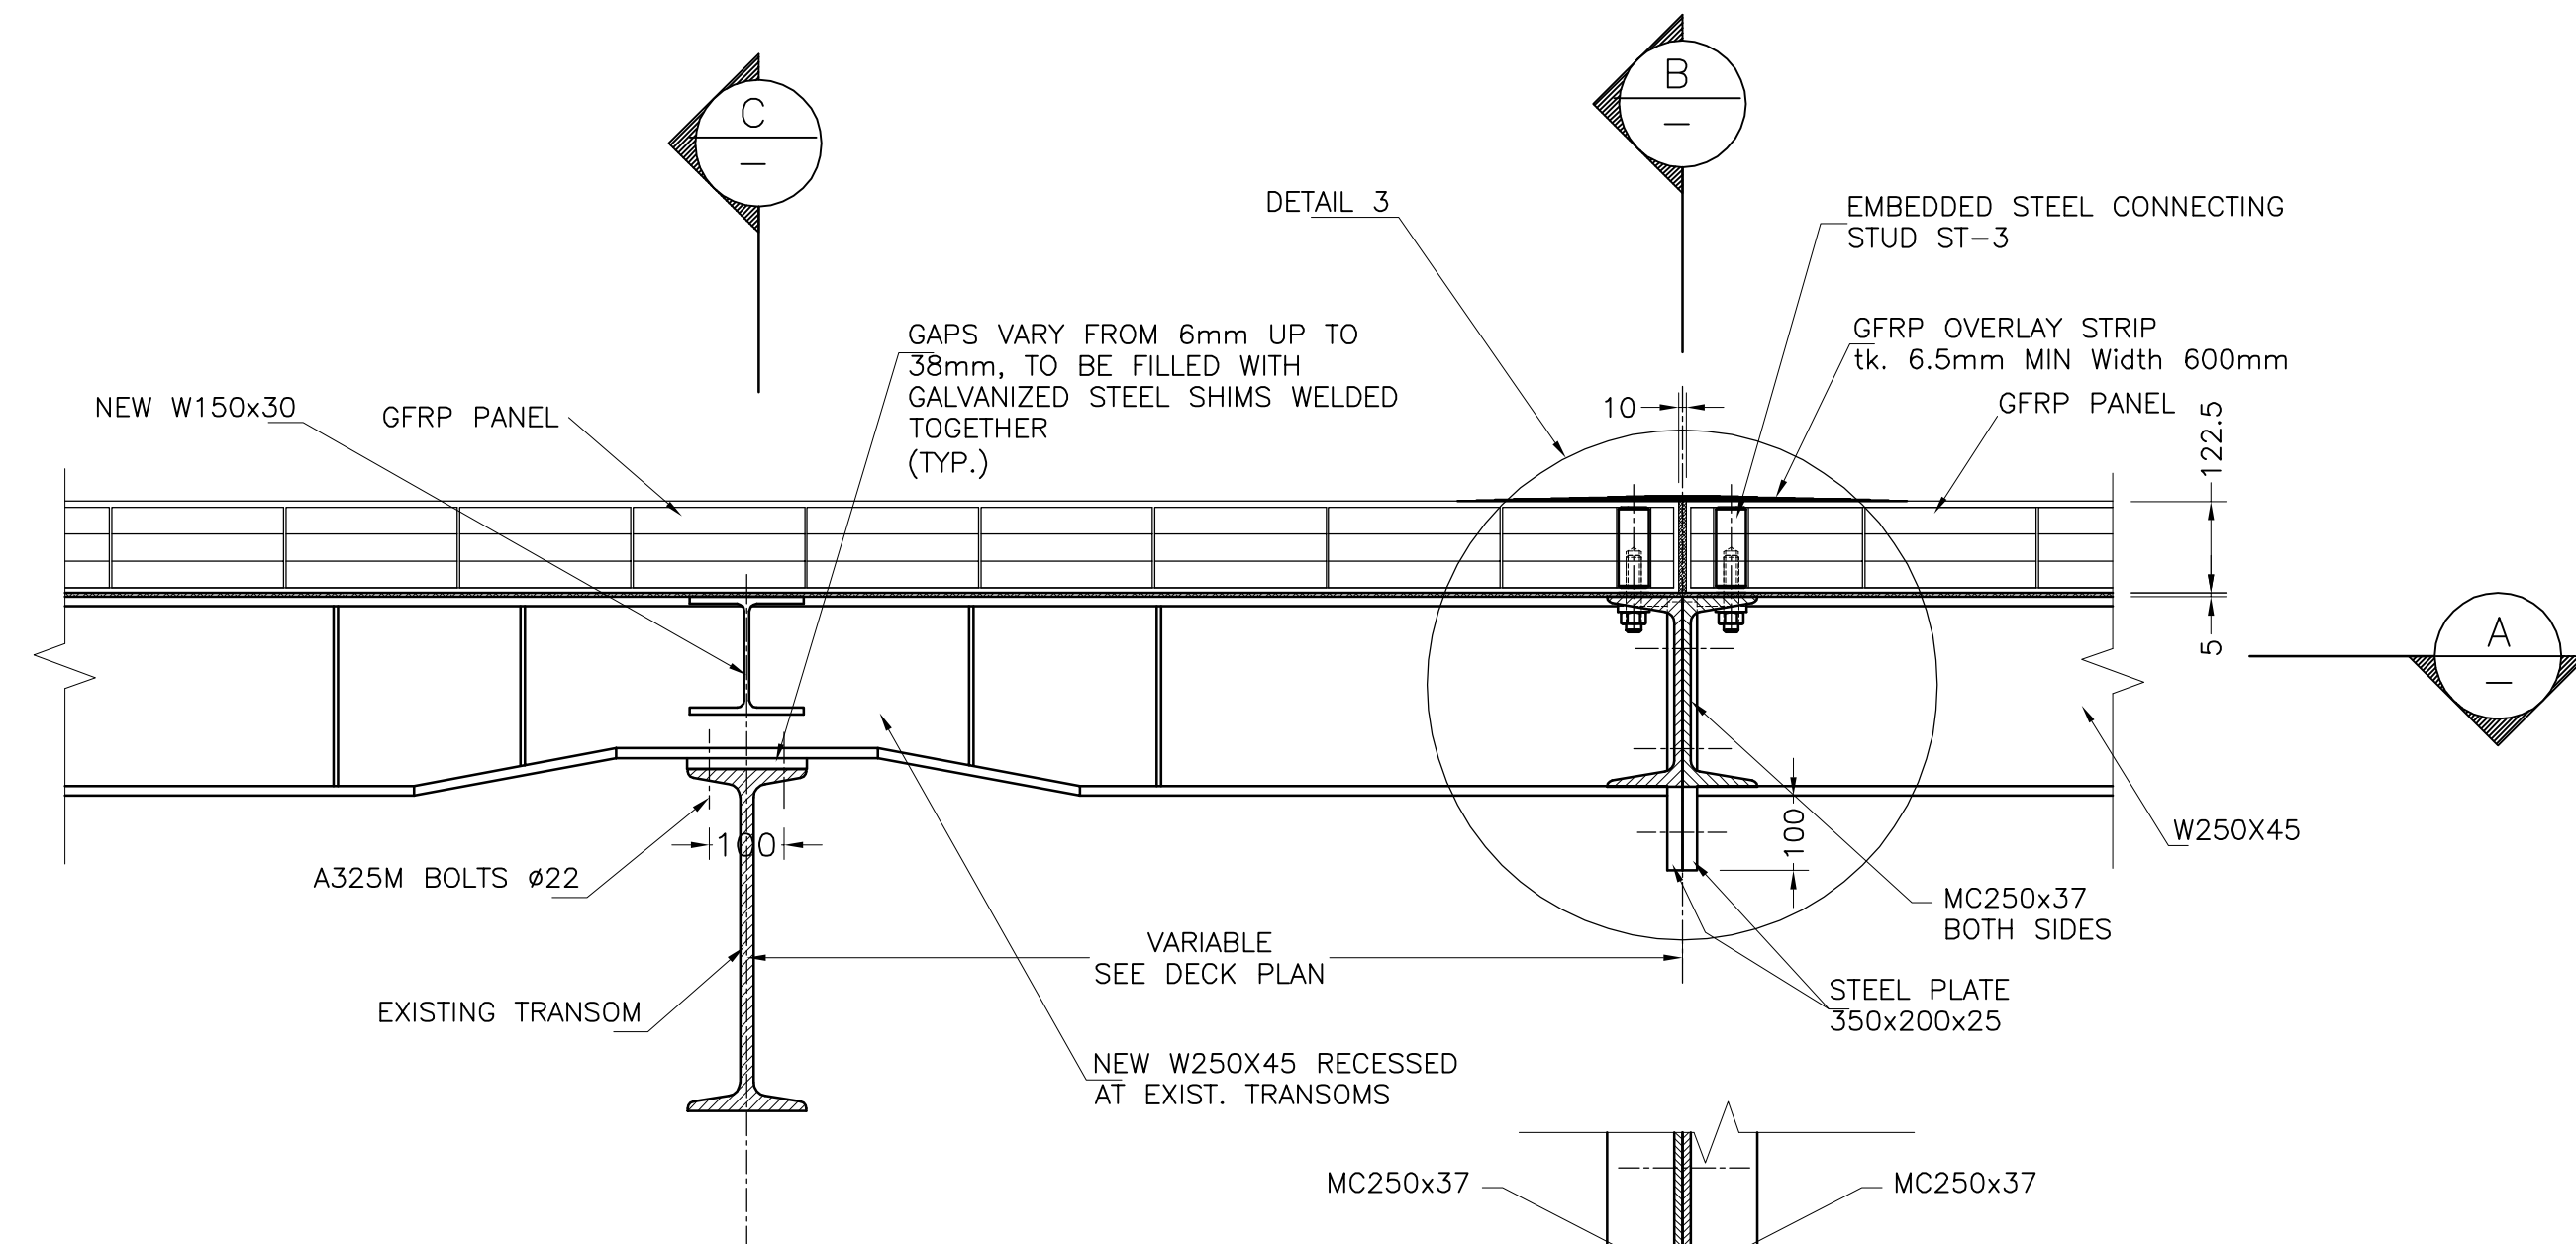
SECTION A  
NTS

DETAIL CONNECTION "DECK TO DECK"  
NTS

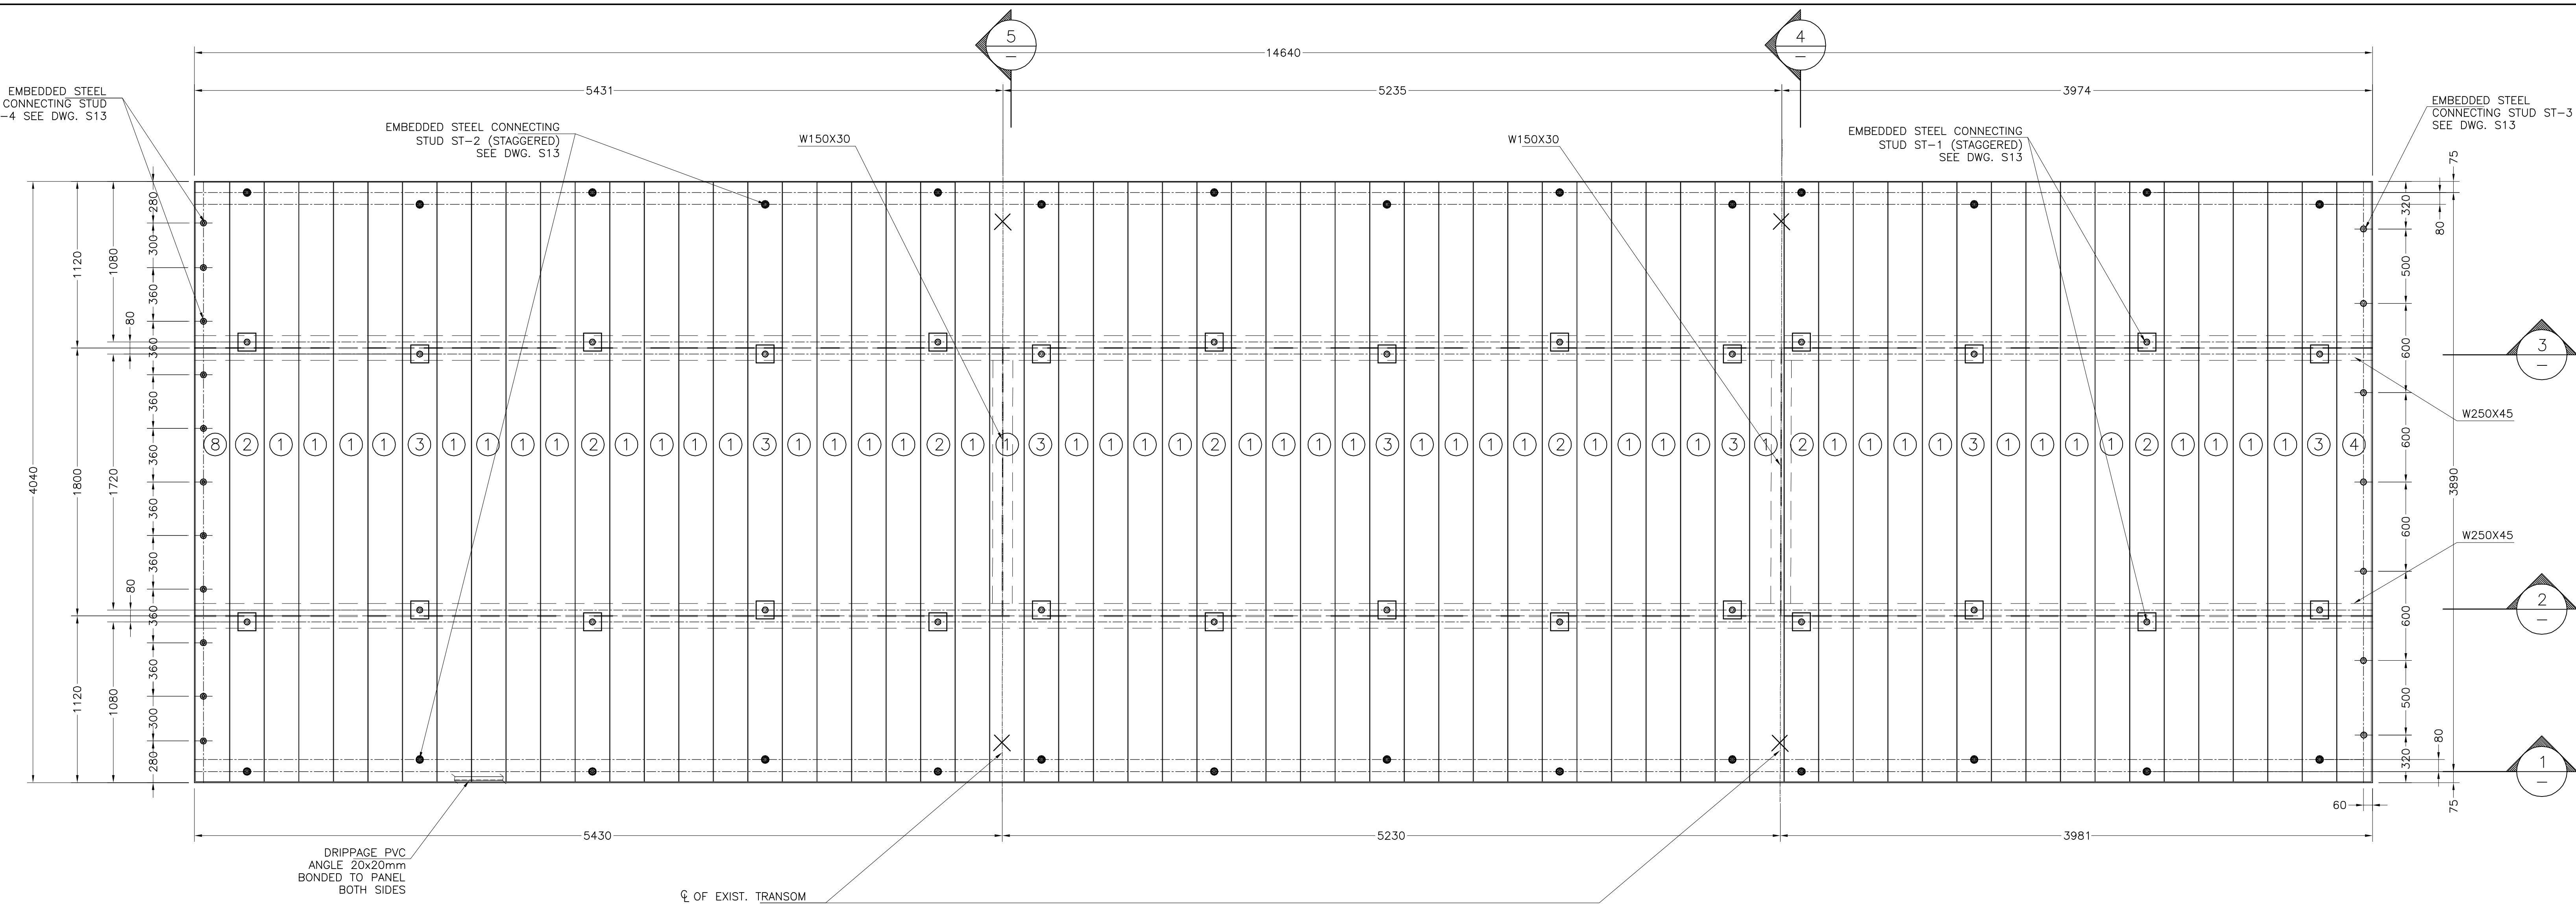
PLAN SCALE:1:20

GFRP DECK PANEL-D1a

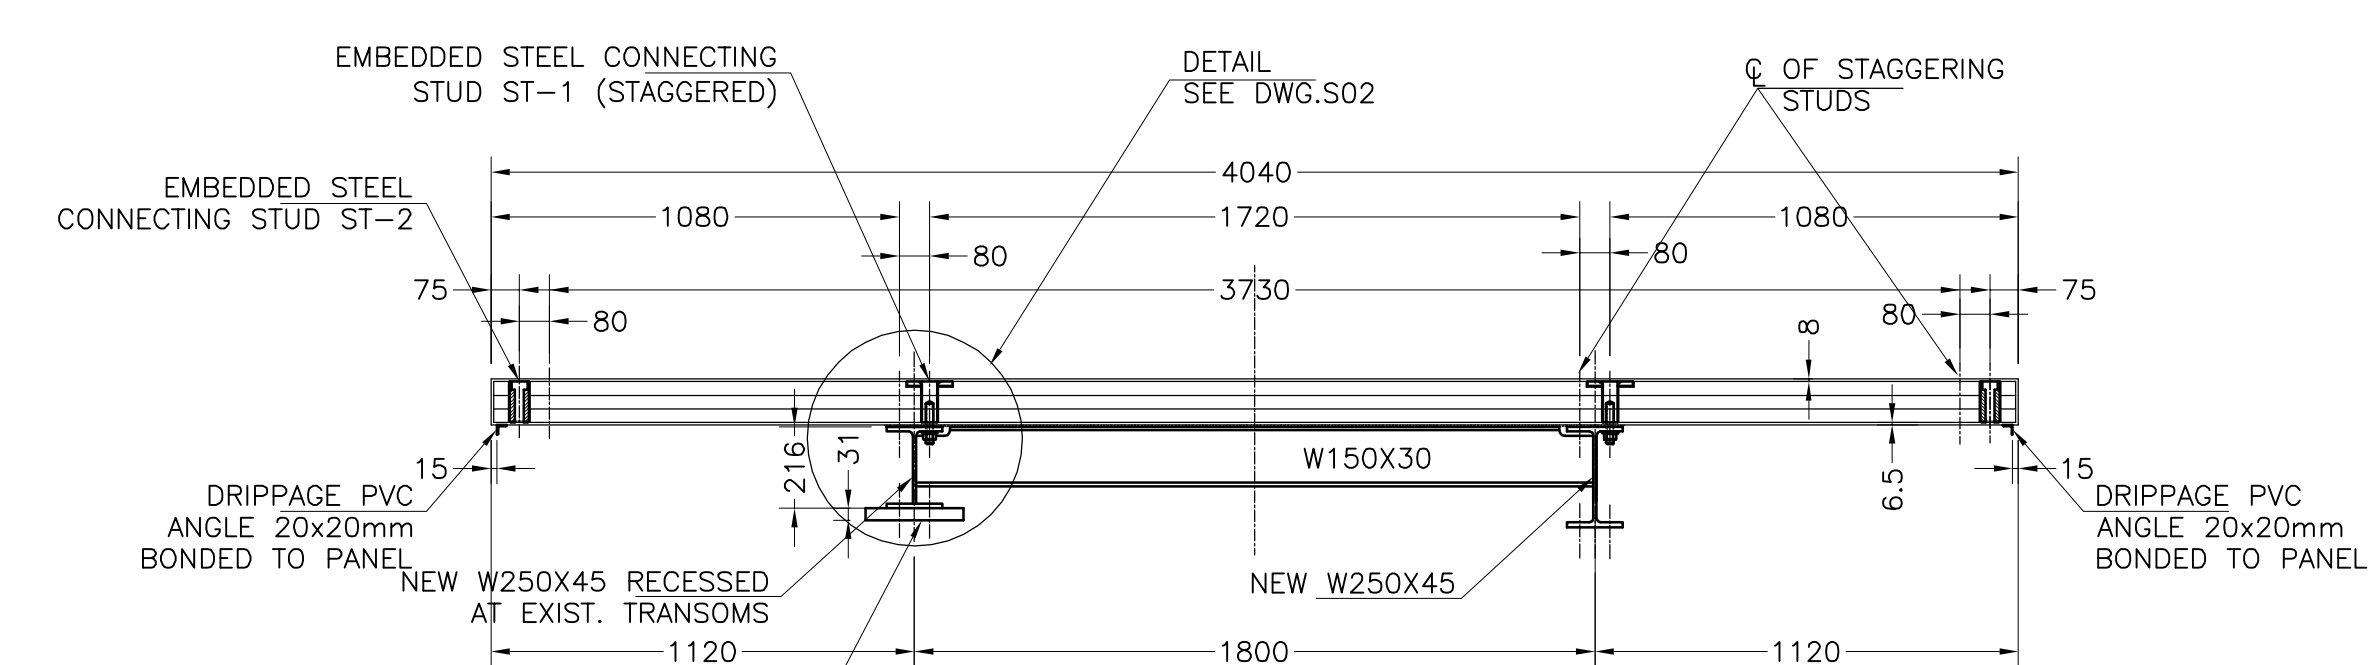
SECTION 5  
SCALE 1:20

GAPS VARY FROM 6mm UP TO 38mm, TO BE FILLED WITH GALVANIZED STEEL SHIMS (MIN. SIZE OF THE ONE SHEET 250x150x6) WELDED TOGETHER TO BE INSTALLED ON SITE (TYP.)

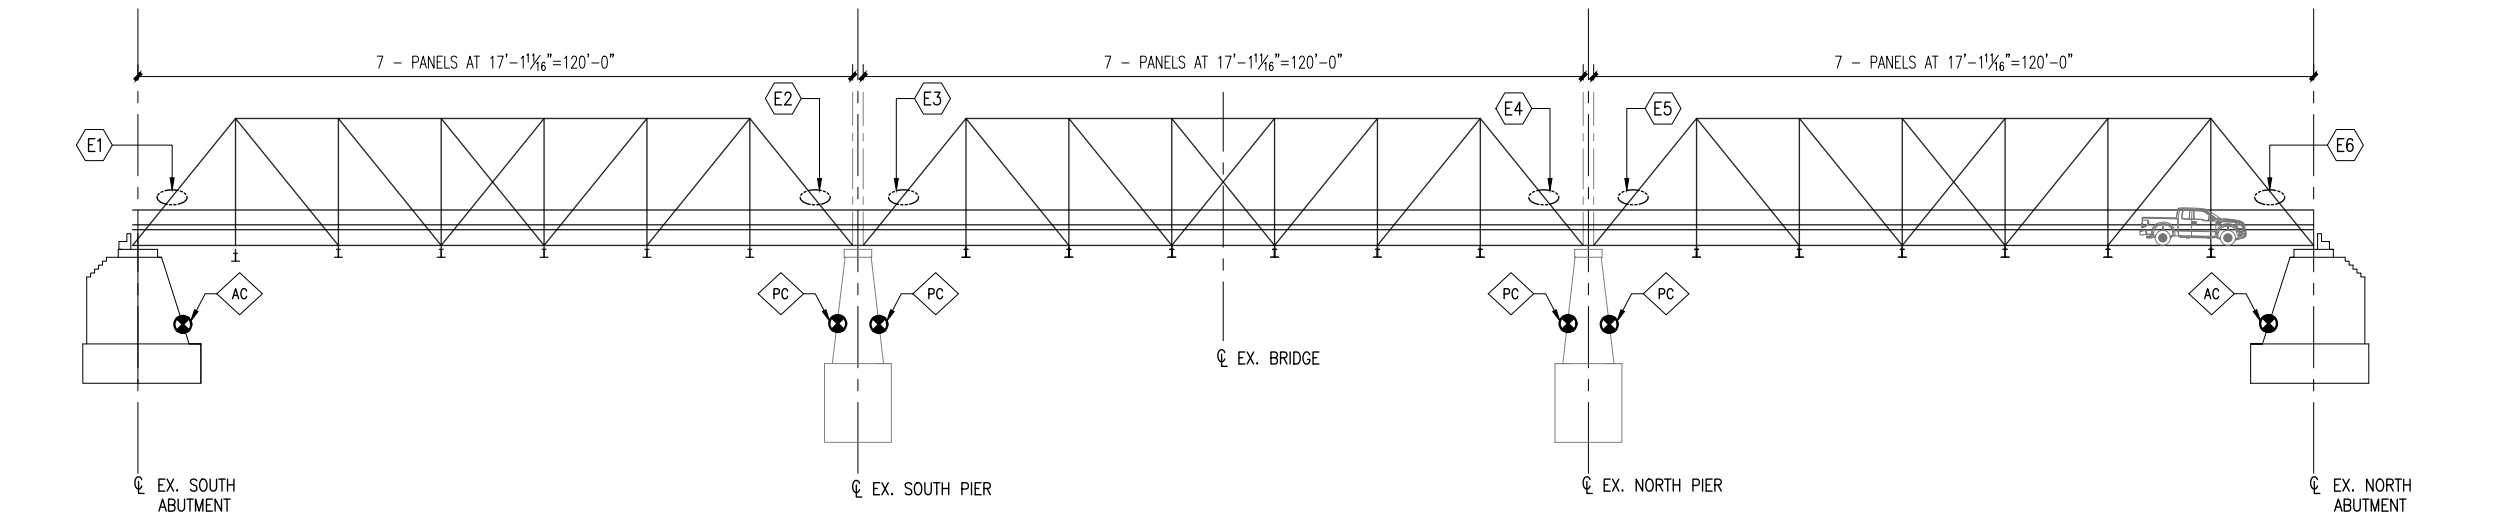
**EAST ELEVATION**  
SCALE: 1/32" = 1'-0"  
EAST TRUSS (AS SHOWN)  
WEST TRUSS (OPPOSITE HAND)

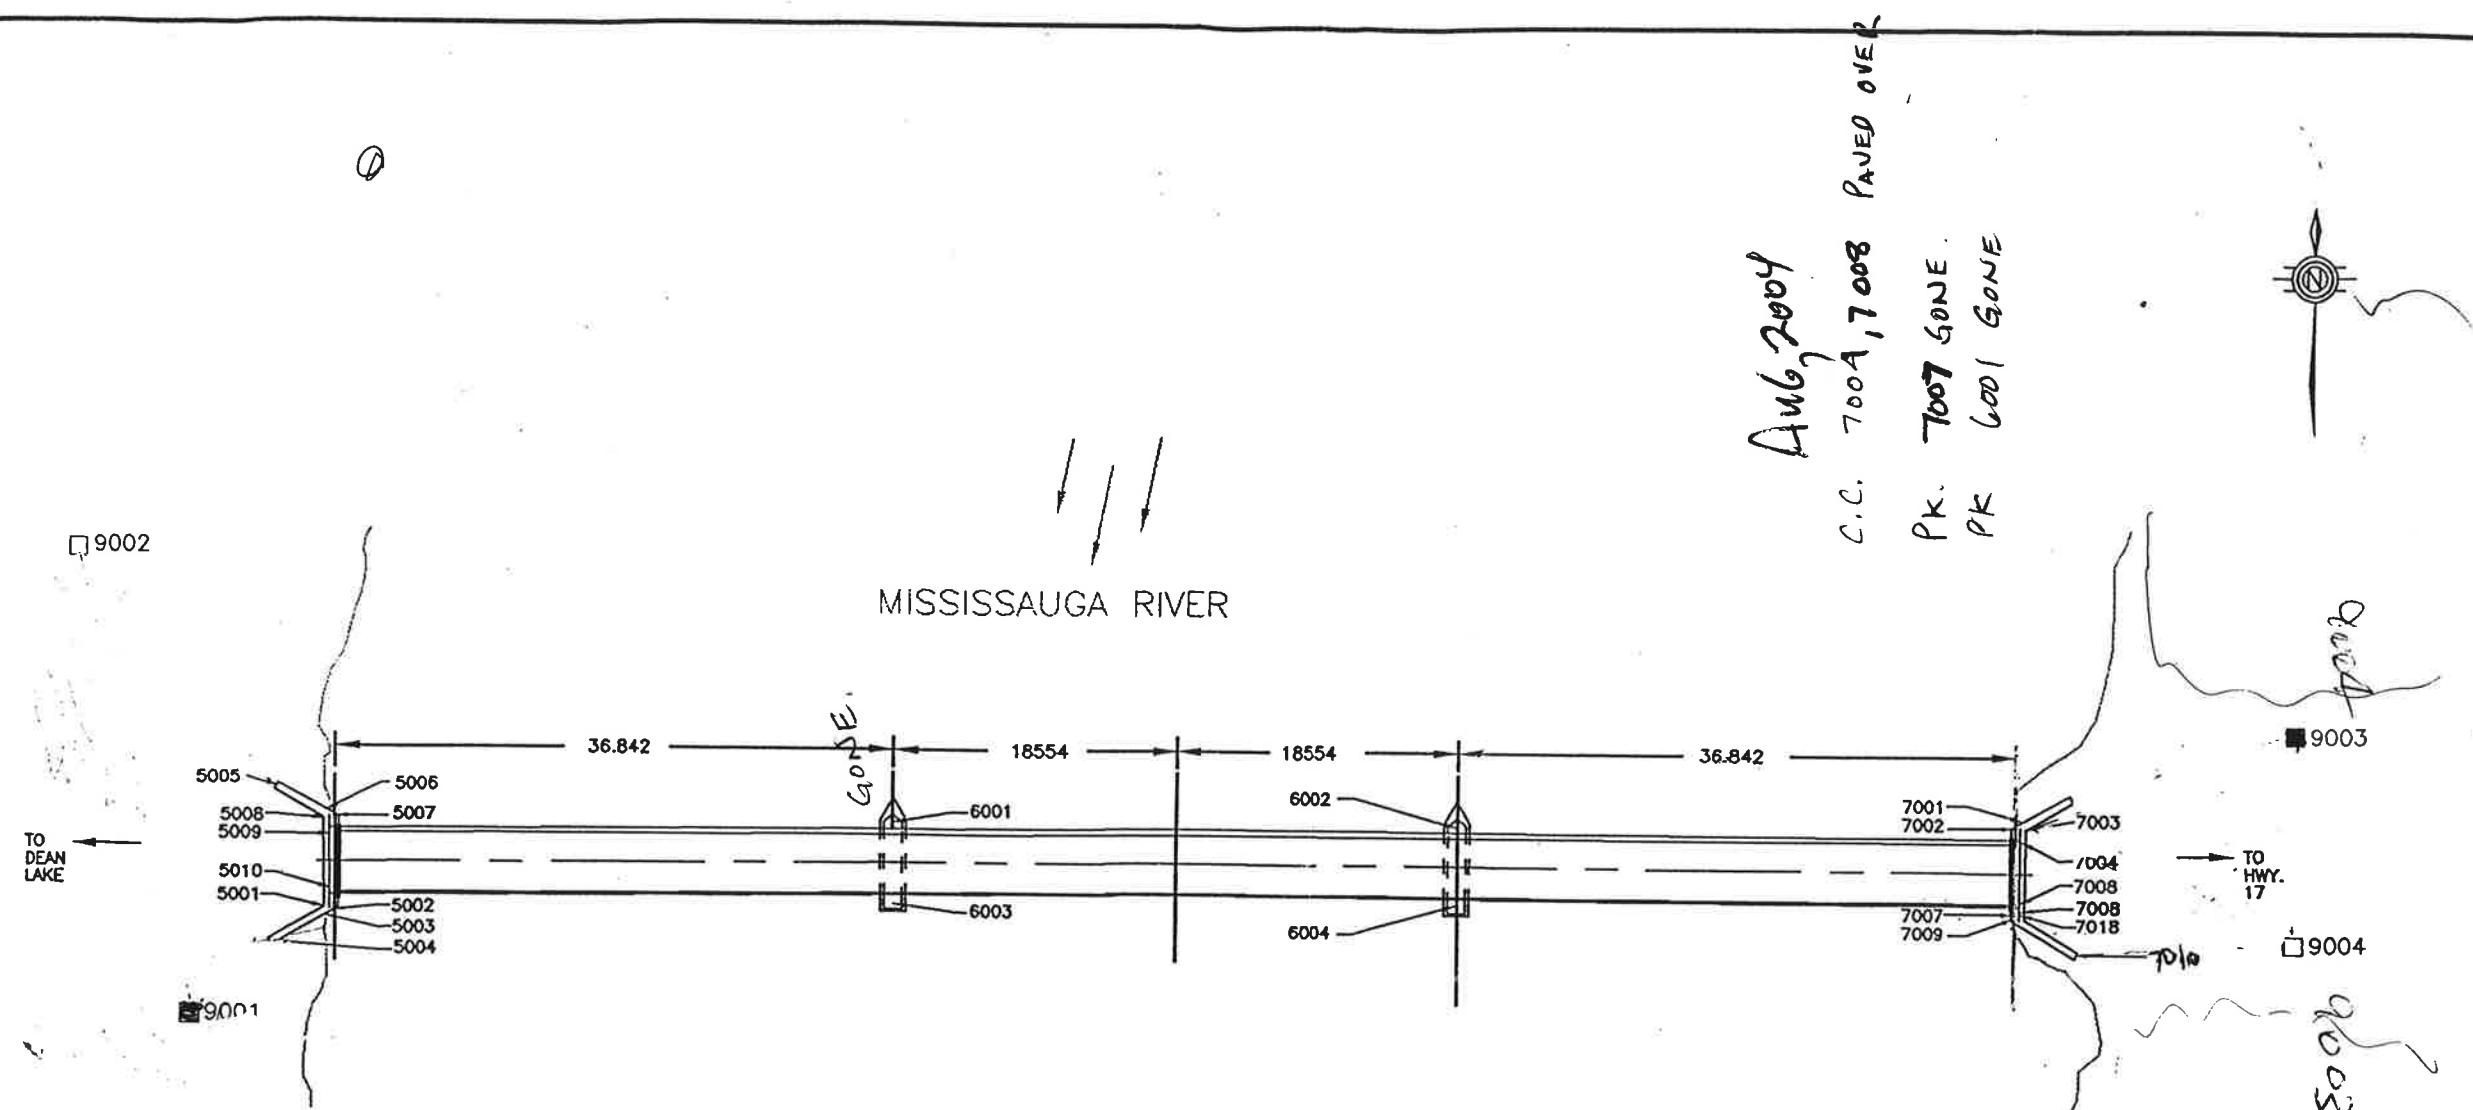
PLAN  
1:500

Aug 2004  
C.C. 700A, 7008 PAVED OVER  
PK. 7007 GONE  
PK 6001 GONE

Further to your request we have completed a check of the monitoring points on the Dean Lake Bridge. The survey was completed on August 19<sup>th</sup> and August 24<sup>th</sup> 2004. The control monuments that were used from the last report completed in 1996 were used to tie in the monitoring points. Each point was tied in from both ends of the bridge and the results averaged. You will note that when reviewing results that two point numbers 6001 and 7007 were missing and two others 7004 and 7008 were paved over. Therefore there are no comparisons to be made for these points. I have attached a spreadsheet which summarizes the coordinates and elevations for the points in August 2004 as well as from 1996 and 1989. Comparison is made from August 2004 to June 1989 and from August 2004 to July 1996. Results are shown in metres.
